## Inspection Report

### Company Name Sample Report

**Property Address:**  
1234 Main Street  
Central VA 12345

**Burgess Inspections, Inc**

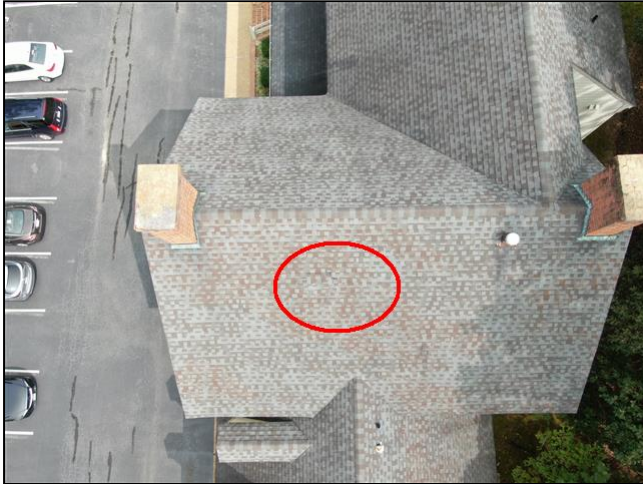
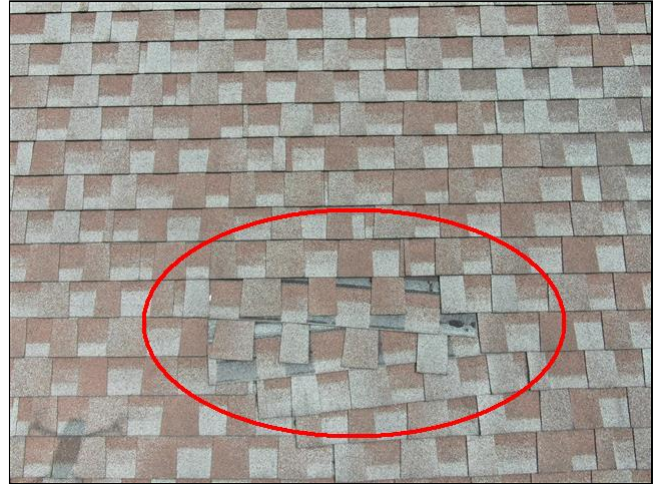
🏠 (3) There were a few shingles that are not secured and are slipping out of place located at the upper roof over Southside Insurance. Refer to photos.

(2) Have a qualified licensed contractor repair or replace all roofing, Roof Structure, Chimney items as needed, the following was noted:

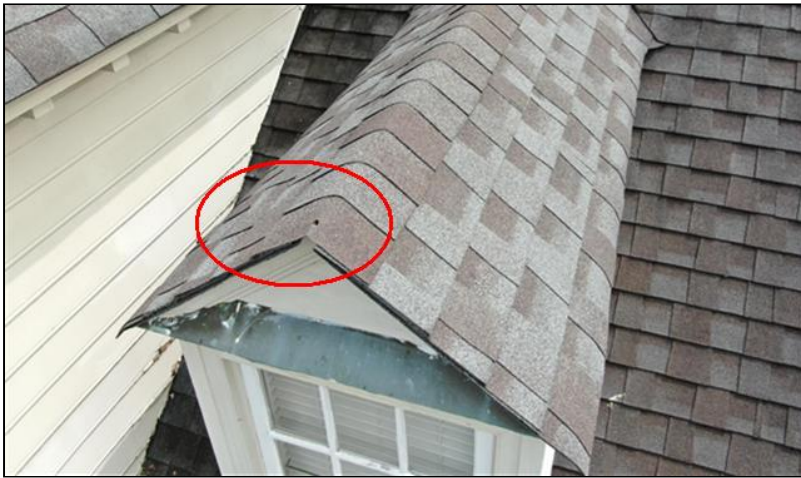
1.0 Item 4(Picture)

🏠 (4) There was a damaged ridge shingle noted over the roof dormer at Southside Insurance and over the rear gable end.

(4) There was a damaged ridge shingle noted over the roof dormer at Southside Insurance and over the rear gable end.
-

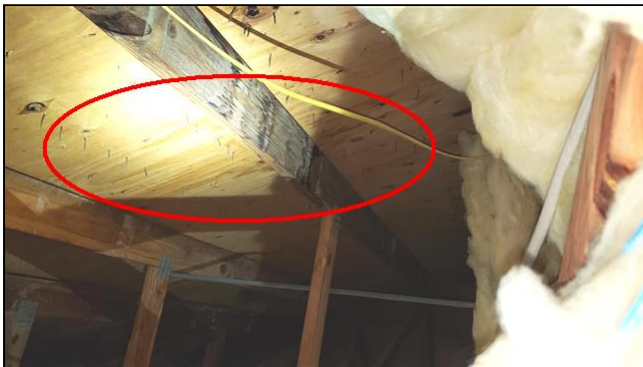
1.0 Item 10(Picture)

(6) Southside Insurance Suite:

Some moisture stains noted in the knee wall attic space at the back office and also at the sides of the rear chimney chase in the upper attic. They were dry at the time of the inspection but it's beyond the scope of this inspection to determine if they will leak in the future.

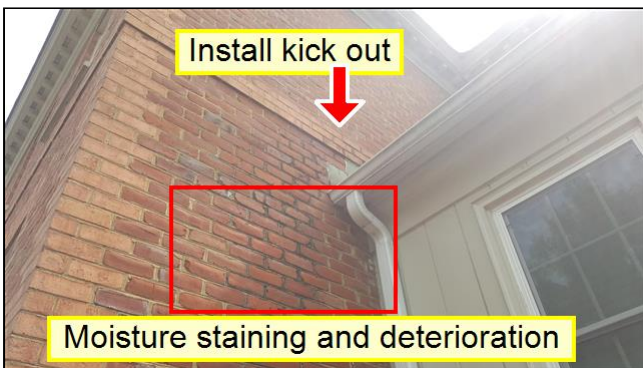
1.1 Item 4(Picture)

📍 (2) Moisture damage and staining was noted under the gutters that terminate against the siding. Install kick out flashing to help prevent moisture from overloading the gutter and running down the exterior wall.

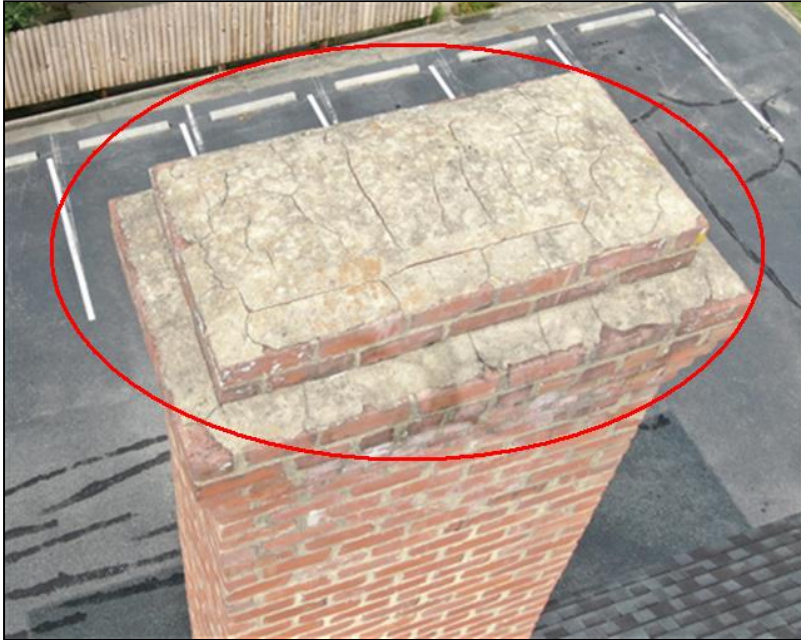
1.2 Item 1(Picture)

(1) The crown on all chimney caps are deteriorated and cracked. Have a qualified mason to repair all chimney caps as needed. Refer to photos for examples.

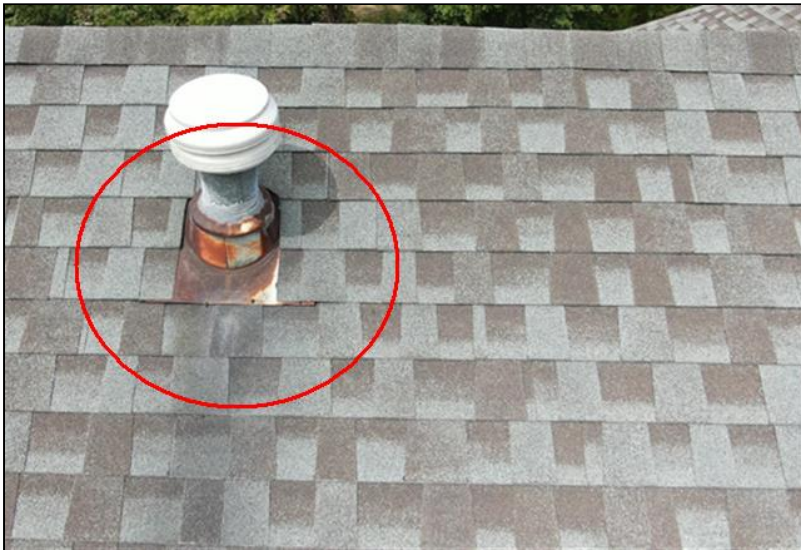
1.2 Item 3(Picture)

(2) The gas flue vents and flashings at the roof showed significant rusting. Refer to photos for examples.

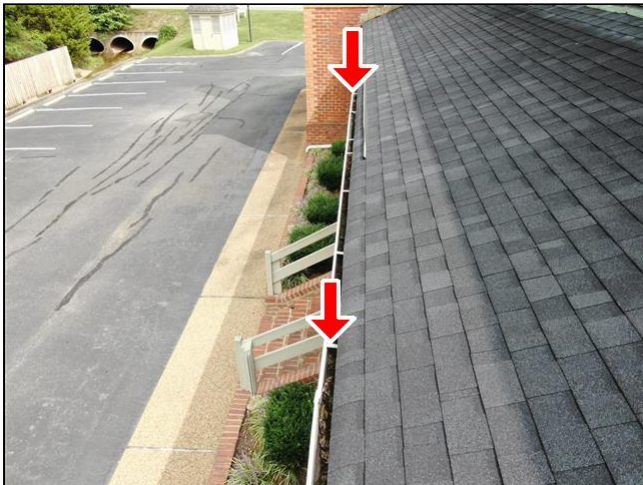
1.4 Item 2(Picture)

(2) The upper roofs did not have a gutter system. The only roof that had a drainage system was the low roof at the front main entry. It's recommended to keep the gutters and downspouts cleaned.

(3) Recommend installing gutters where not present for prevent maintenance,

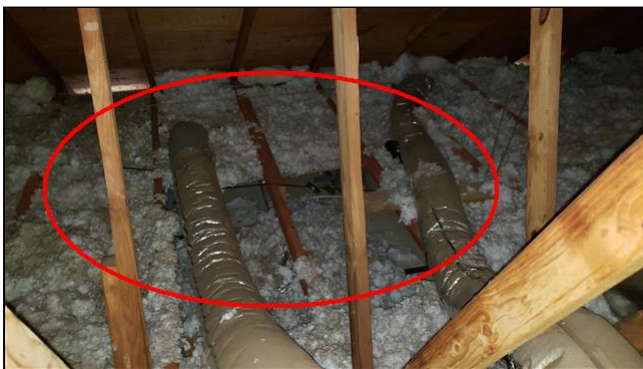
1.6 Item 1(Picture)

There were multiple random areas in the attic that were missing insulation.

Note- There were multiple areas where the drywall had collapsed as noted in section 5.0 allowing the insulation to fall through.

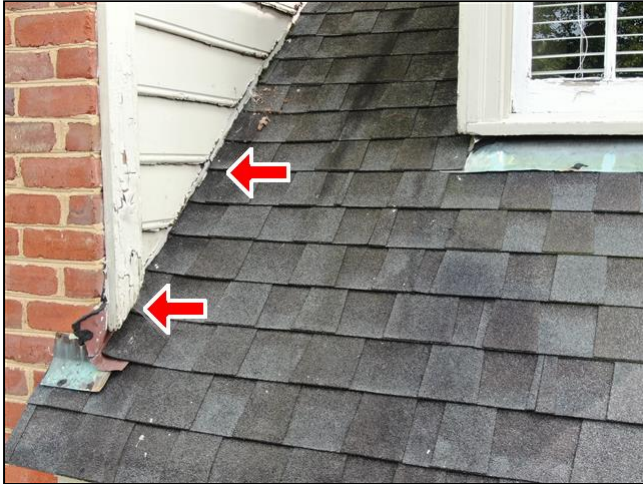
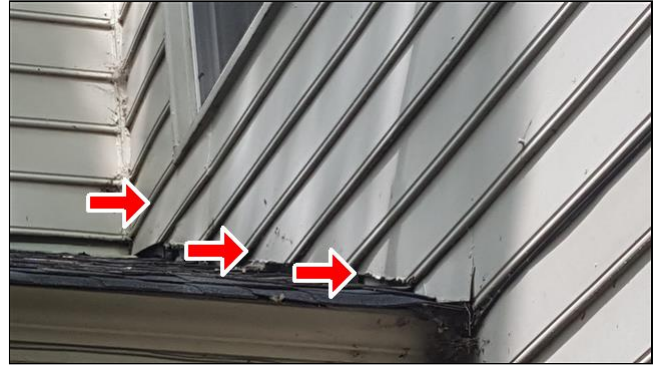
🏠 (2) Wood rot noted at multiple locations where the siding and trim sits above the lower roofs. It's recommended to maintain about two inches of clearance between the siding and the roof.

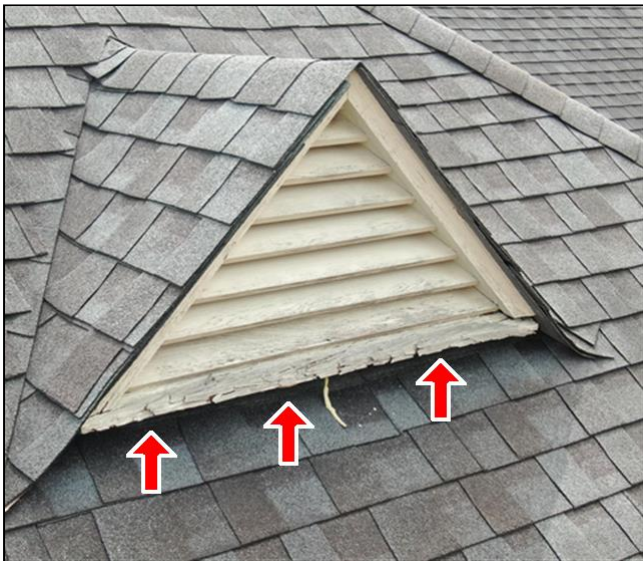
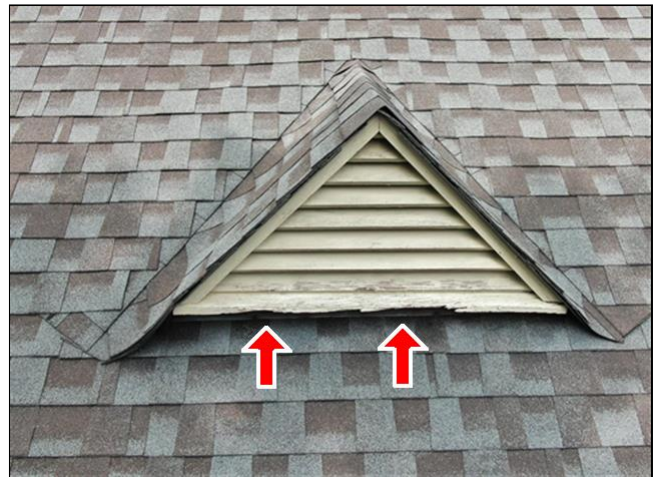
🏠 (3) Wood rot noted at the trim on a couple of attic ventilation dormers. The remaining dormers show bare wood in areas from paint peeling.

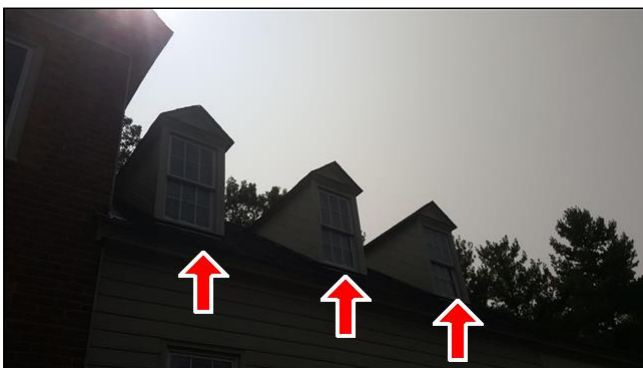
2.0 Item 5(Picture)

🏠 (4) Right side dormers show significant siding damage from moisture. Windows sills and brick molding shows some rot as well.

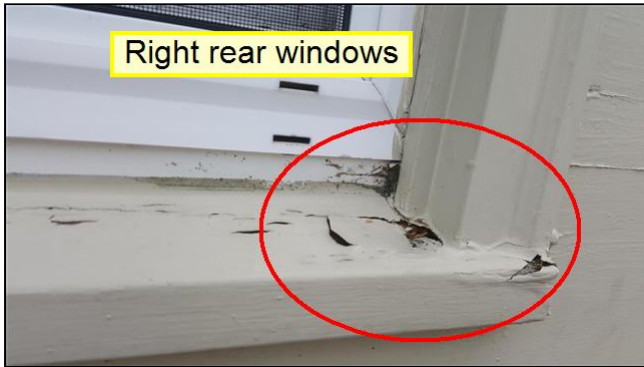
2.0 Item 6(Picture)

🏠 (5) Wood corner trim boards, crown moldings and window trim showed significant rot in areas. Damaged crown moldings indicate possible roof leaks in these areas. See photos for examples with locations. Correct all as needed. There is also bare wood in some areas from paint peeling, evaluate and seal all areas as needed.

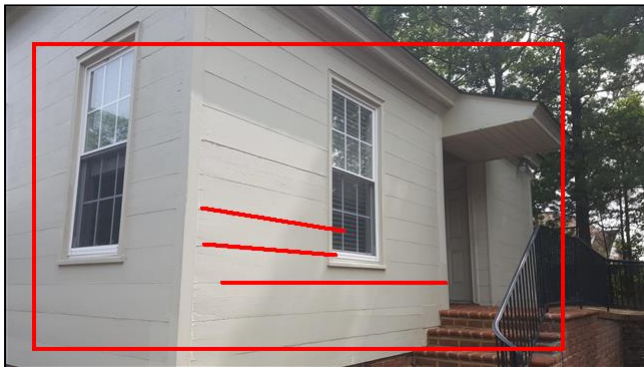
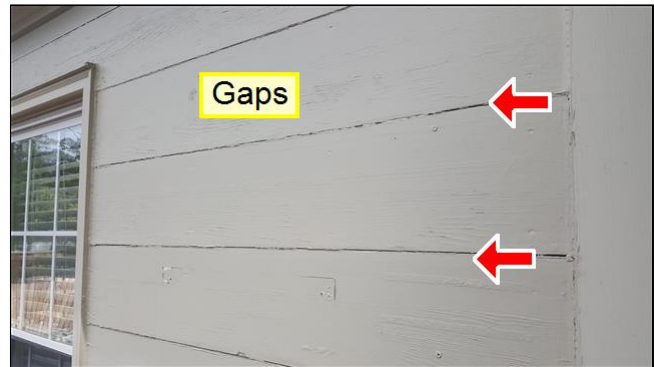
🏠 (6) Right rear and rear wood siding is not lapped and does not appear to have any flashing installed. Gaps between the cladding pieces were noted. Seal all areas to prevent moisture intrusions.

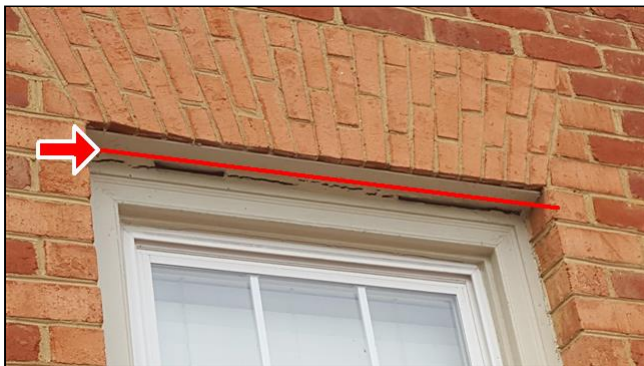
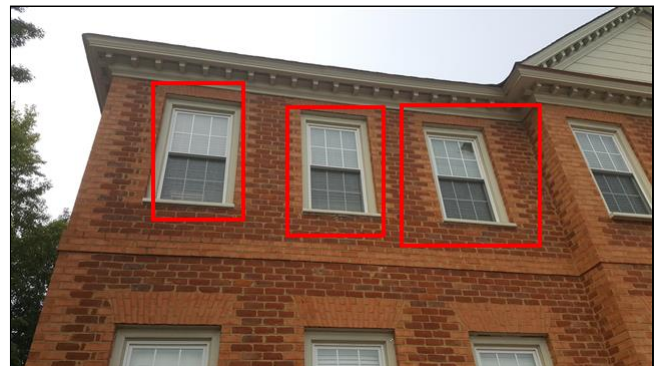
🏠 (7) All of the windows , incased in the brick veneer, show damaged sealant around the hole window. Correct all as needed.

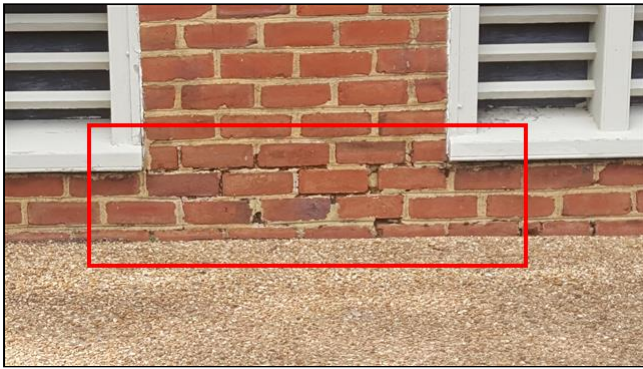
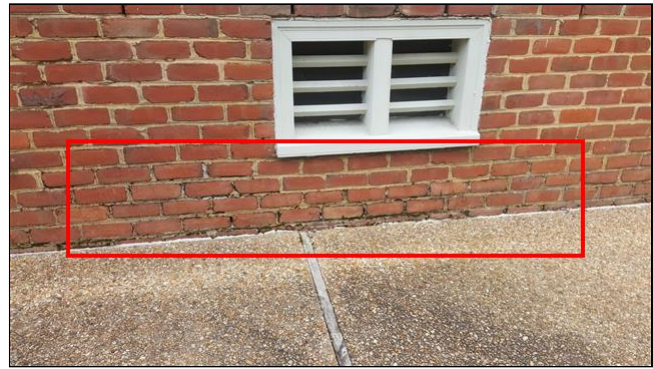
🏠 (8) Damaged and/or missing mortar was noted in multiple areas around the bottom of the brick veneer in the front and on the right front. Evaluate and correct all as needed.

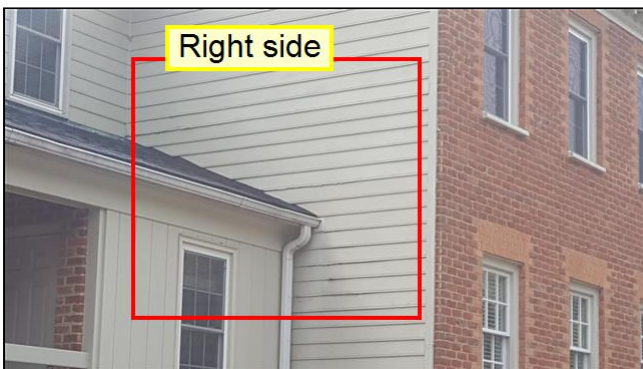
2.0 Item 26(Picture)

🏠 (9) Significant moisture damage and soft areas were noted on the right and left sides of the building at the composite siding. Evaluate and correct all as needed.

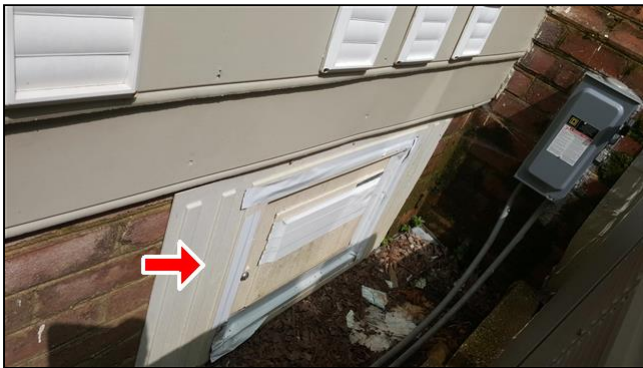
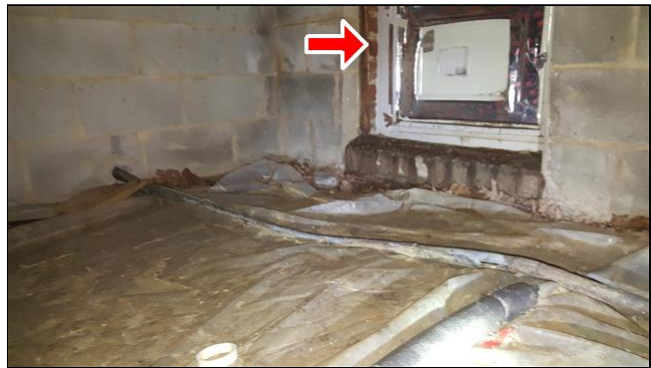
- 🏠 (1) Left side, front crawlspace door is damaged and duct taped shut.

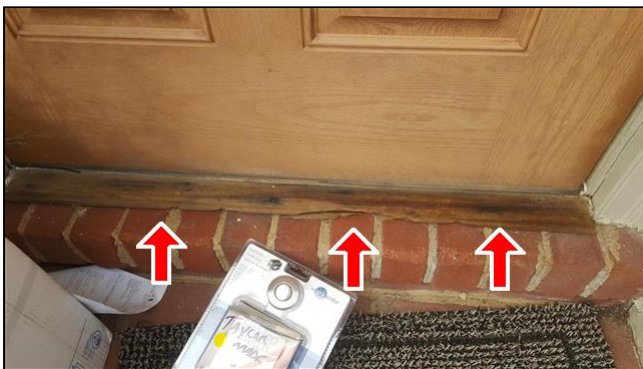
2.1 Item 3(Picture)

- 🏠 (2) Front door threshold is damaged and needs replacement. I could not access the door to operate it because it was locked.

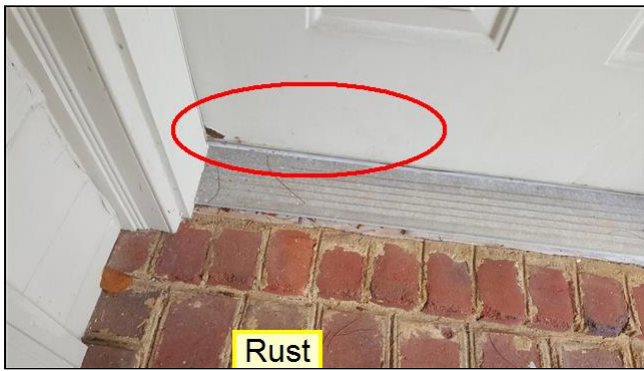
2.1 Item 4(Picture)

🏠 (3) Minor rust was noted on the left side, rear entry door. Also, secure the handle as needed.

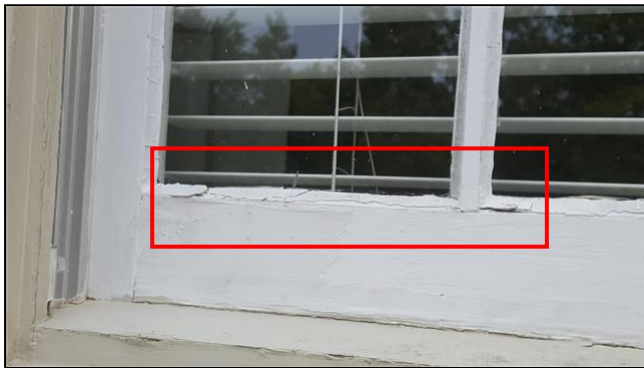
2.2 Item 1(Picture)

🏠 (1) Most of the single pane windows showed significant deterioration and glazing damage. Evaluate and correct all as needed.

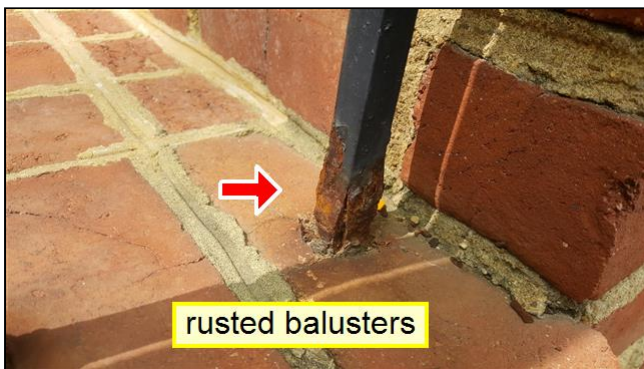
2.4 Item 1(Picture)

🏠 (1) Front entrance porch railings show significant rust at the bottom of the balusters. The railing columns have been previously repaired.

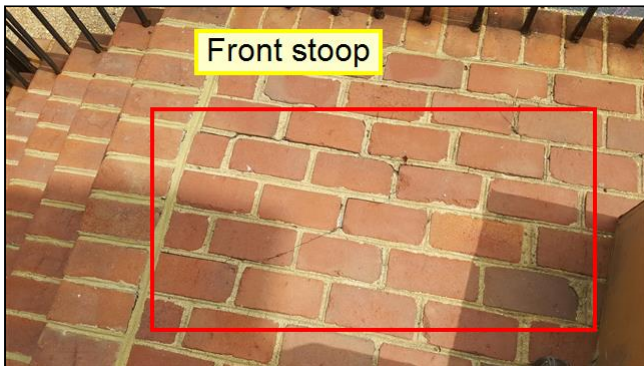
2.4 Item 4(Picture)

(2) All of the brick entrances and the rear ramp show minor to moderate damaged and/or missing mortar in areas. Correct all as needed to prevent future water penetration and settlement. Seal all of the holes that penetrate the rear stoop and ramp where the railing columns are installed.

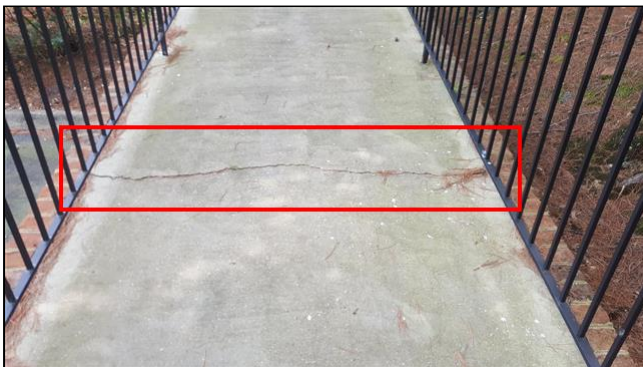
2.4 Item 11(Picture)

(4) Seal the cracks in the rear ramp concrete to prevent moisture intrusion and settlement.

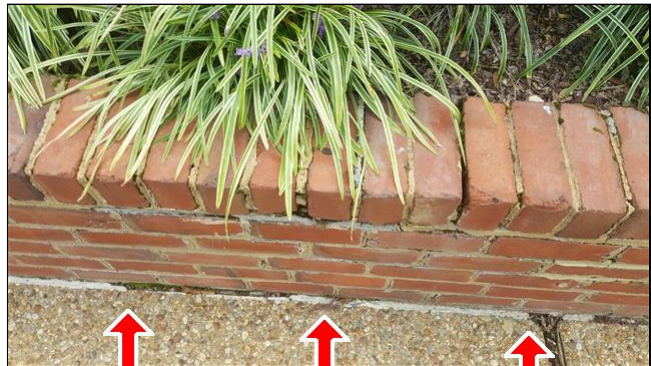
2.5 Item 4(Picture)

- (1) Sealed aggregate walkway around the building shows significant damaged and/or missing sealant where it meets the brick veneer and retaining walls. Seal all as needed to prevent moisture from eroding the compacted soil beneath these areas.

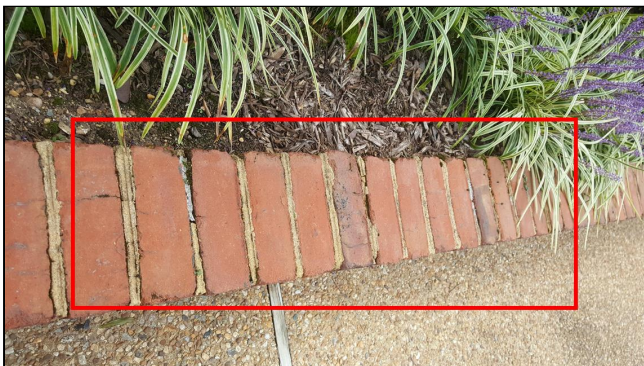
2.5 Item 5(Picture)

- (2) Damaged and missing mortar was noted in the retaining wall cap. Correct and seal all as needed.

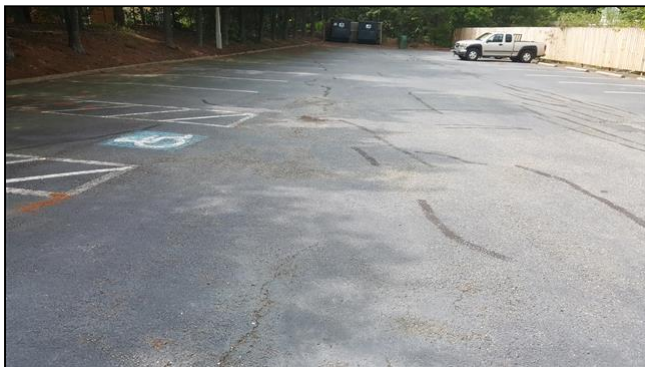
2.5 Item 6(Picture)

(4) The parking lot shows some cracking. Repairs have been completed in the past. Routine maintenance will be needed to extend the life of the asphalt materials.

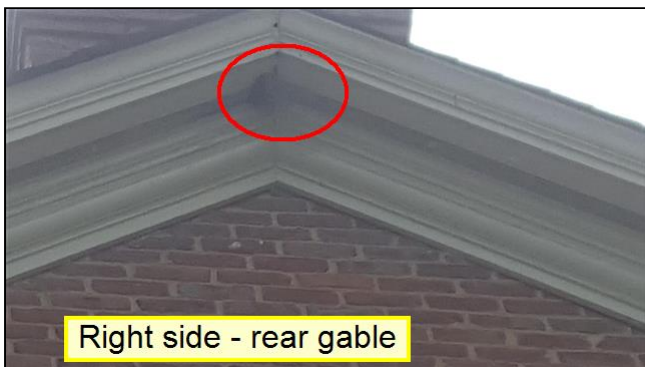
2.6 Item 1(Picture)

(1) Some holes and/or gaps were noted in the soffit area leading to the under side of the roof. Seal all areas to keep rodents, birds and insects from intruding in though these areas.

Right side - rear gable

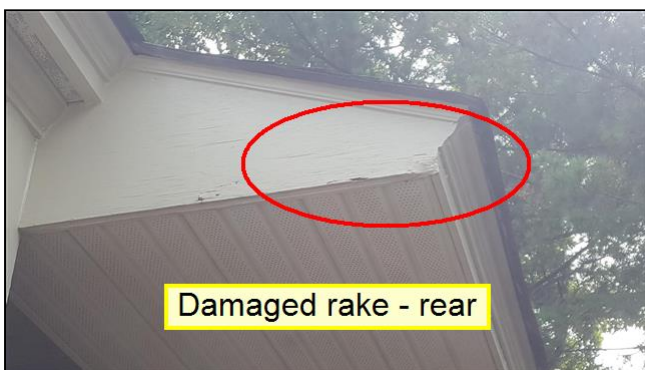
2.6 Item 3(Picture)

(2) Some damage corner boxes and rake molding were noted on the rear and left sides.

Damaged rake - rear

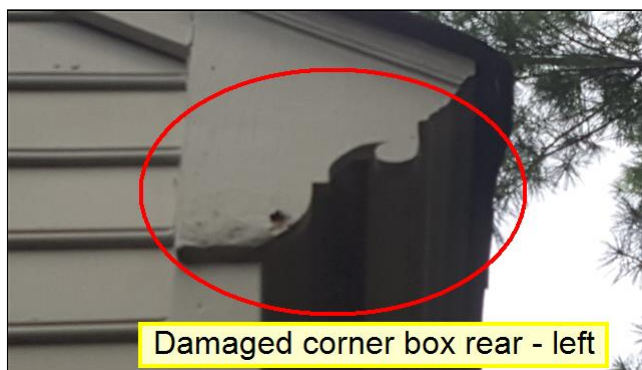
2.6 Item 4(Picture)

Damaged corner box rear - left

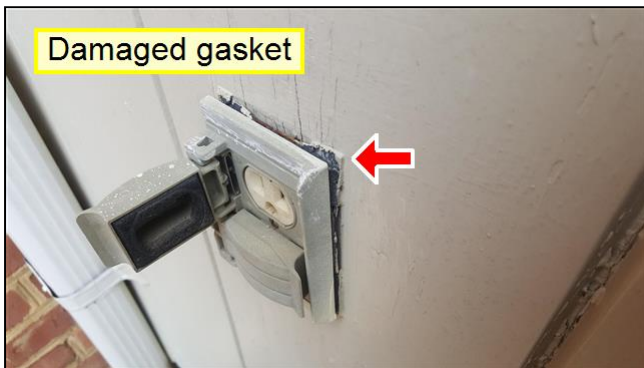
2.8 Item 1(Picture)

(1) None of the exterior receptacles are GFI protected. Install GFI protection for safety to all exterior receptacles. Also, the cover gasket is damaged on all of the receptacles as well.

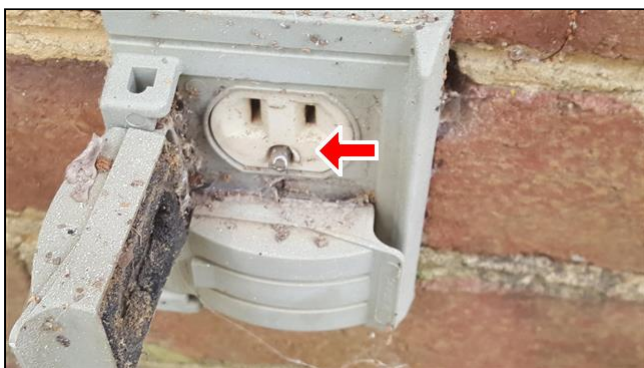
2.8 Item 2(Picture)

(2) One receptacle on the right rear side has a plug prong broken off in the receptacle. Correct as needed.

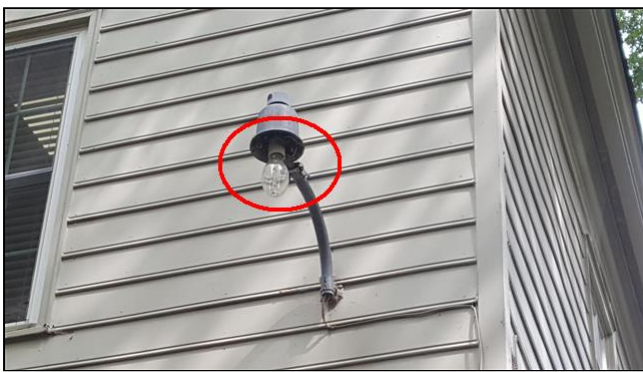
2.9 Item 1(Picture)

- ⚡ (1) Rear left side flood light is missing the exterior protective globe.

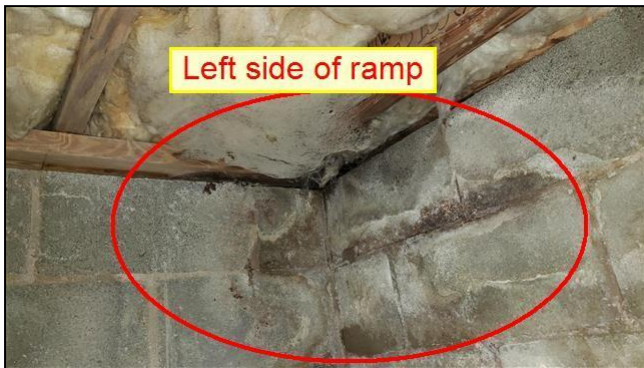
3.0 Item 7(Picture)

**Crawlspace-**There is significant amount of wood rot at the sill plate due to moisture intrusion noted on both sides of the ramp. It appear to be actively leaking due to the dampness of the wall and the wood. Have a qualified licensed contractor evaluate to determine the cause and correct as needed.

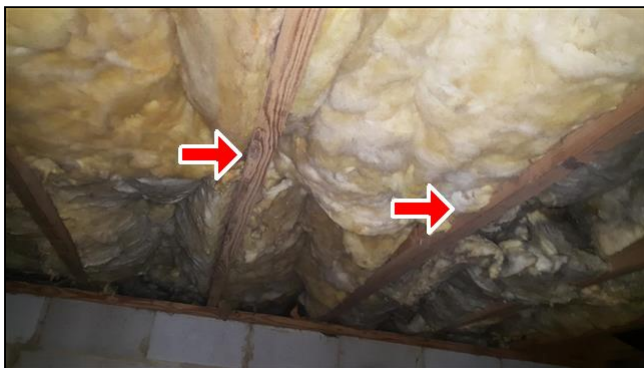
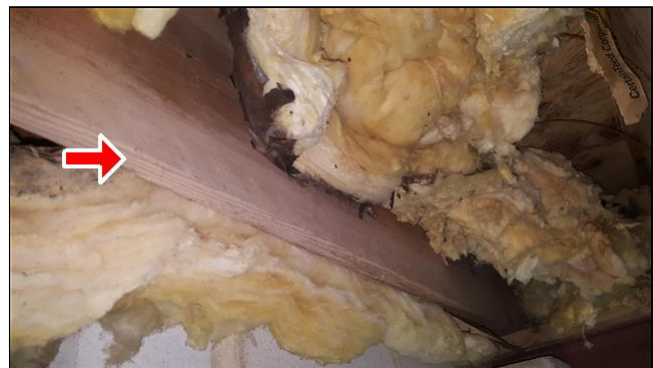
(3) Some mild fungi growth was noted in the front crawlspace. This was minor. If you have concerns, have a qualified company evaluate and correct as needed.

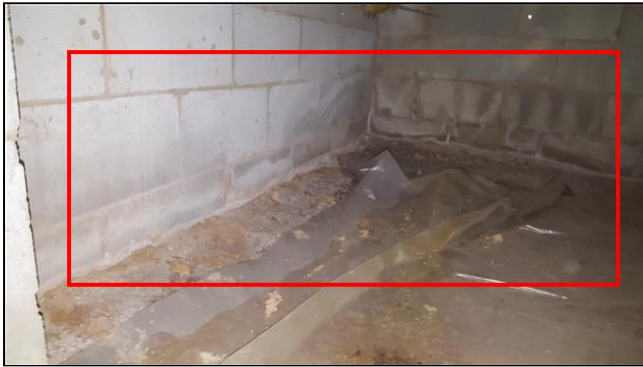
3.0 Item 10(Picture)

(4) White efflorescence (powder substance) on block wall indicates moisture is in contact with the masonry. This does not necessarily indicate that intrusion will occur. I recommend checking the gutters and the downspout drain lines for proper operation. Also, a water proofing paint could be applied to the interior side of the block if necessary. Efflorescence is found on many homes without water intrusion occurring inside the building. But, it should alert you to the possibility that future steps may be needed.

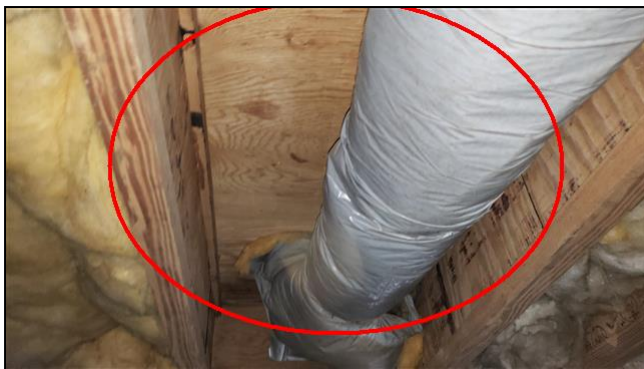
3.5 Item 1(Picture)

There were multiple sections of insulation that were missing or have fallen down throughout the crawlspace. Some of the insulation has been damaged and pulled down by rodents. Also, some areas towards the front have fallen due to previous and/or active high moisture content. Some areas in the front crawlspace had insulation installed upside down, with the vapor barrier to the ground. Correct all floor insulation as needed.

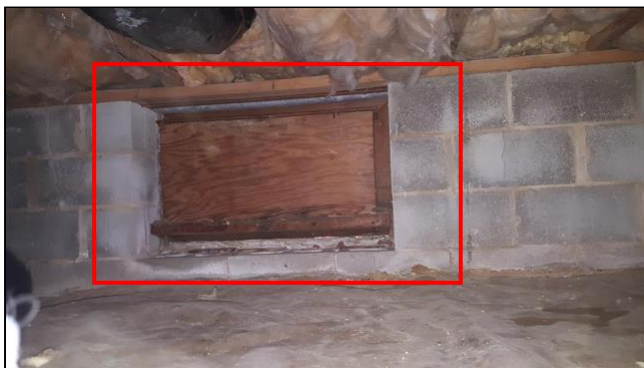
3.7 Item 1(Picture)

(1) Most of all of the foundation vents are seized in place and could not be operated.
- (2) Note: The front and left front and right front foundation vents have been covered from the inside.

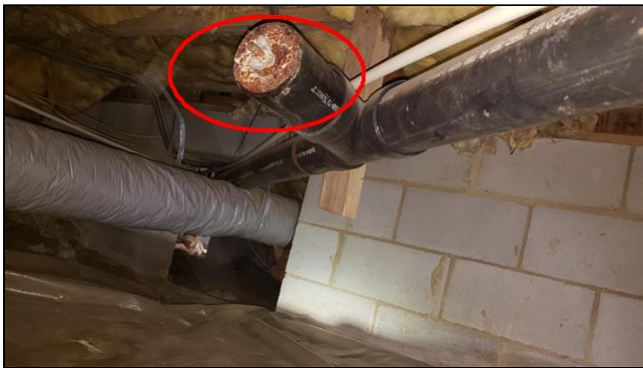
4.0 Item 1(Picture)

**Crawlspace-**There is a clean out plug on a waste line that is leaking.

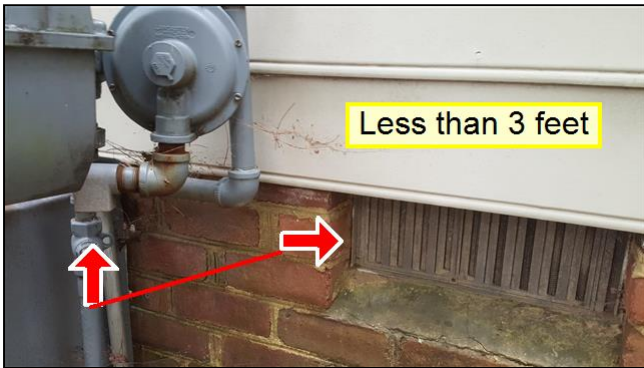
4.4 Item 1(Picture)

(1) Gas meter vent is located too close to one of the foundation vents on the right side of the building. The rear meter. Have the gas company install a vent extension on the meter to comply with current safety standards.

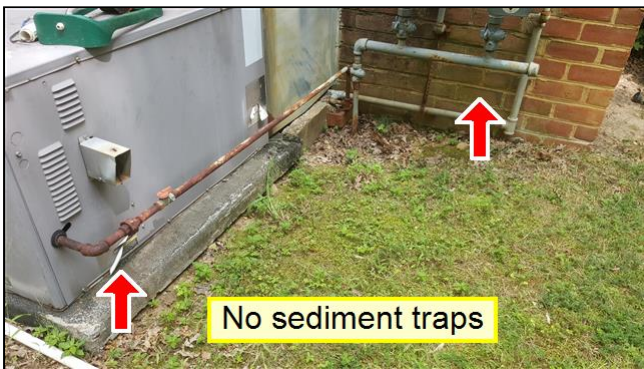
4.4 Item 2(Picture)

(2) The sediment traps for the gas piping are missing or insufficient. Install sediment traps to all of the gas piping in the rear where needed.

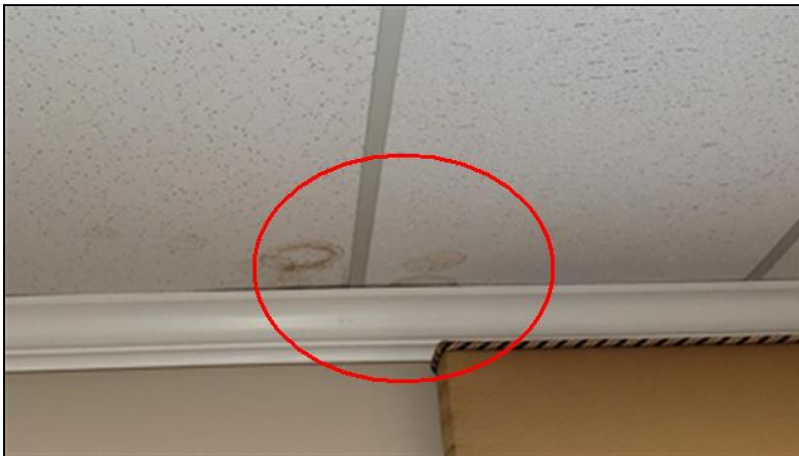
5.0 Item 1(Picture)

Ceiling tile moisture stain noted in rear right office. It appears it may be caused by bathroom exhaust duct located directly above the stain.

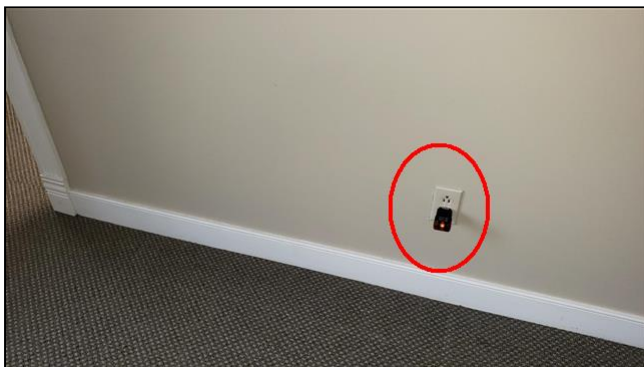
5.6 Item 1(Picture)

Ungrounded Outlet noted in rear office.

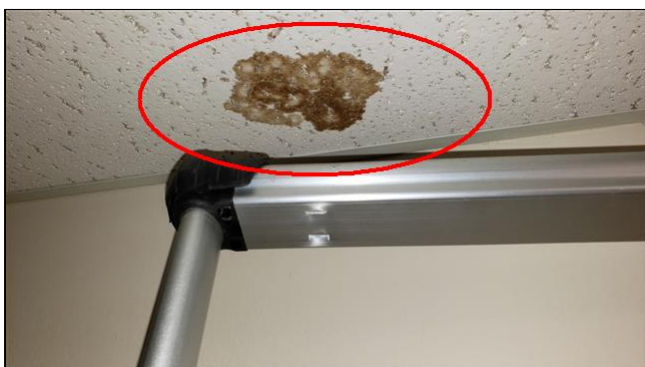
6.0 Item 1(Picture)

Moisture stain noted at the ceiling. Most likely due to bathroom exhaust ducts located directly above the ceiling stain.

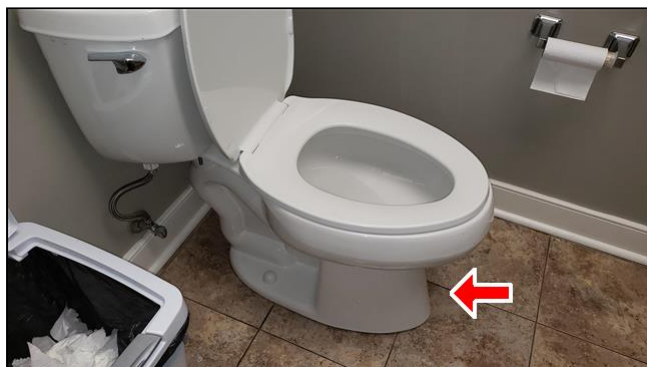
6.6 Item 1(Picture)

Toilet is loose at the floor. Repairs may involve re-setting with a new wax ring.

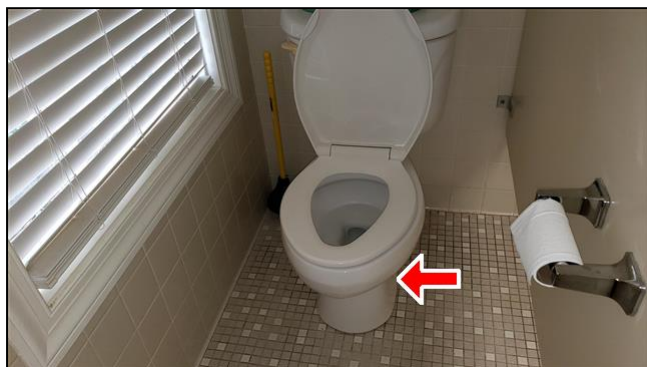
6.6 Item 2(Picture)

Toilet is loose at the floor. Repairs may involve re-setting with a new wax ring.

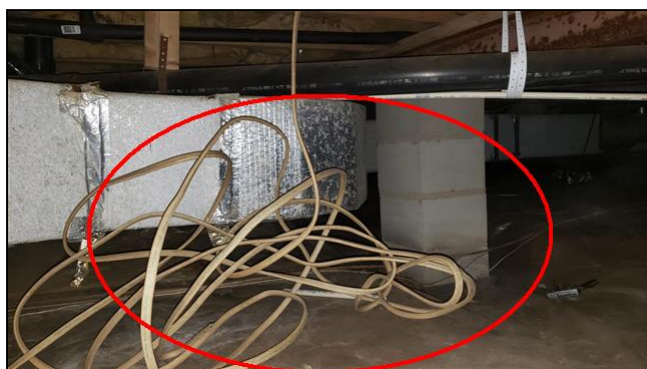
7.3 Item 3(Picture)

There was excess electrical wire noted throughout the crawlspace at multiple locations that was not properly terminated. Have a licensed electrical contractor remove all unused wire and properly terminate all wiring that is in use.

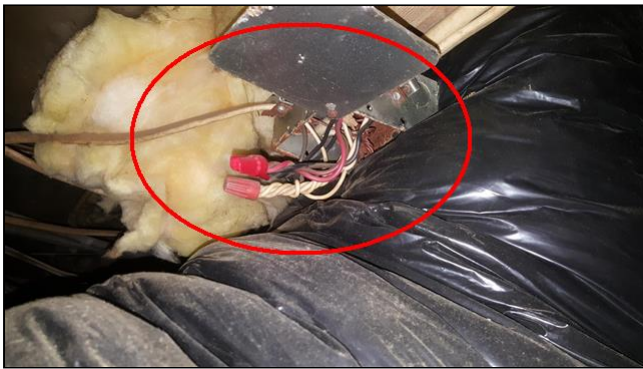
7.3 Item 9(Picture)

⚡ (4) Damaged and/or exposed junction boxes and unsecured lights were noted in the middle and front crawlspaces. Correct all as needed.

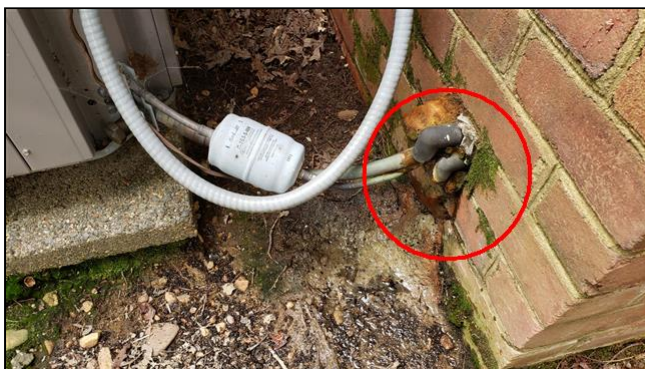
8.0 Item 25(Picture)

(15) Recommend to have condensate lines terminate at least 4-5 feet from the edge of the foundation.

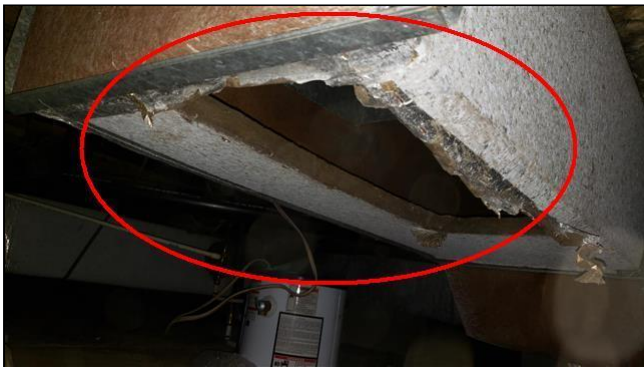
8.5 Item 4(Picture)

Return air duct in crawlspace has a large opening in the bottom of the duct. Also, some of the seams are coming loose at other sections of the duct. Have a qualified company correct as needed.

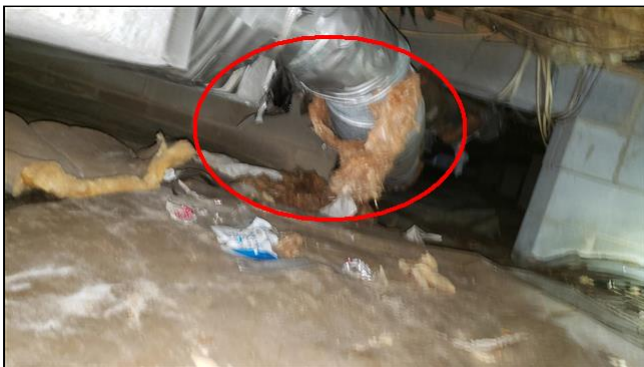
8.5 Item 6(Picture)

(4) The insulation is damaged/ coming loose on HVAC ducts noted in multiple locations through out crawlspace
