Burgess Inspections, Inc.

Job: 123 Main St., Richmond, Va. 23220

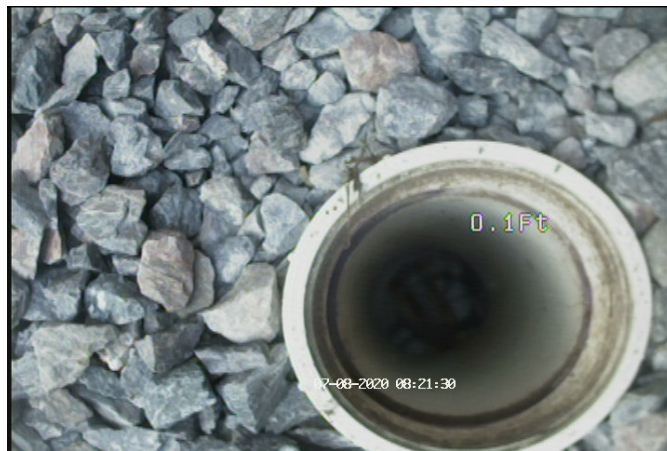
Entry point from cleanout by rear of the home

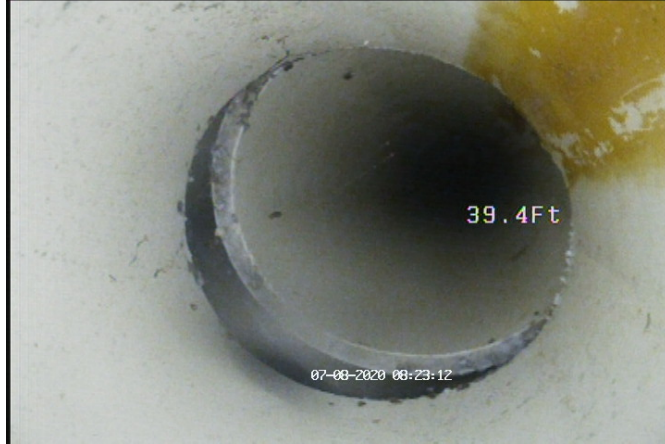
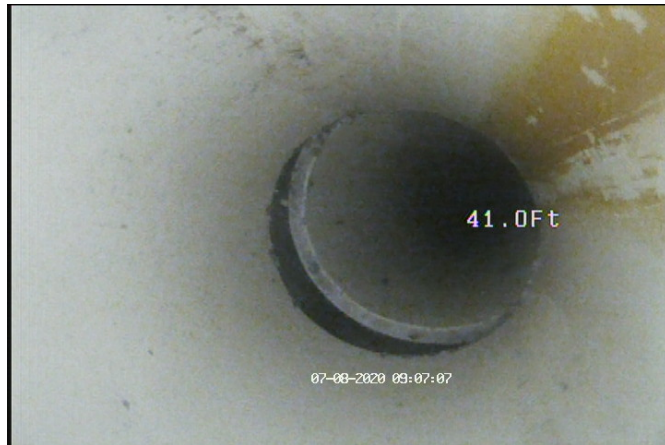
The sewer line runs underneath 238 S Pine Street, the commercial building next to the home. There is a break in the PVC piping at approx. 39 feet from the cleanout. The sewer line will need to be rerouted, and a new city lateral will need to be installed.

All PVC piping, there is a break in the pipe

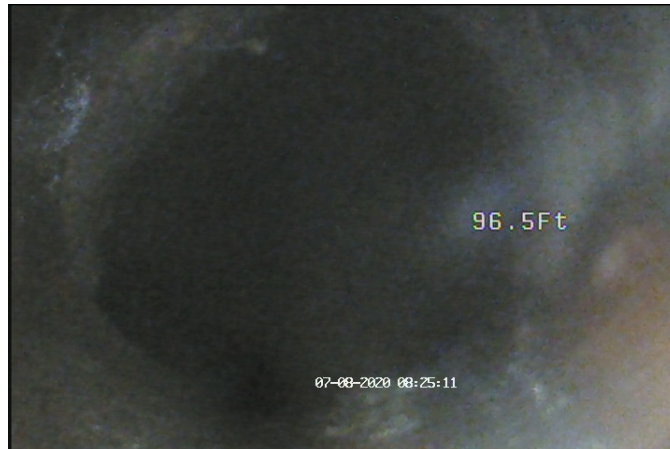
End of the main sewer pipe Approx. 97ft. to the city lateral
