Moisture Inspection Report

12345 Main Street
Richmond, Virginia 23112

Burgess Inspections, Inc

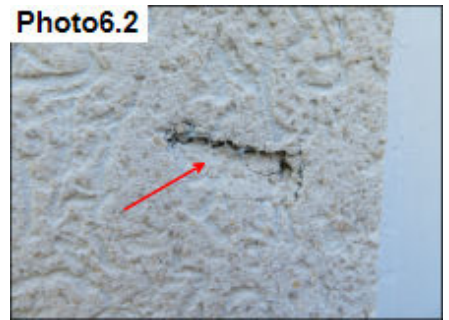
Damage

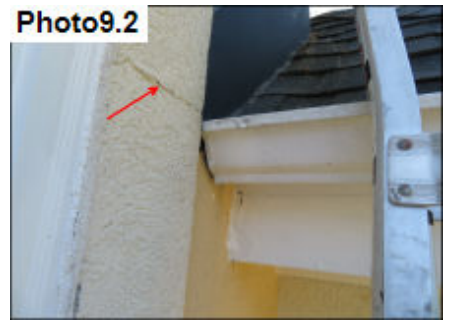
Compression crack

| Grid Location | Item Description | Moisture Readings | Substrate Condition | Observations |
|---|---|---|---|---|
| 4H | Compression | | | Compression wrinkle(s) noted. This is typically a cosmetic issue unless it breaches the system. |

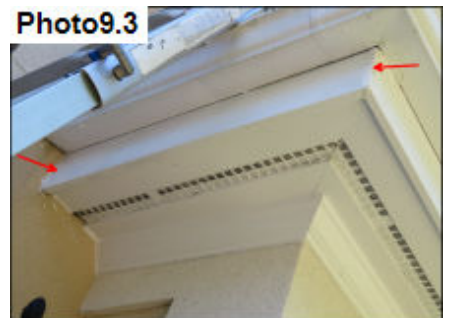
Wood rot

| Grid Location | Item Description | Moisture Readings | Substrate Condition | Observations |
|---|---|---|---|---|
| 4H & I | Wood rot | | | External wood rot needs to be repaired. |

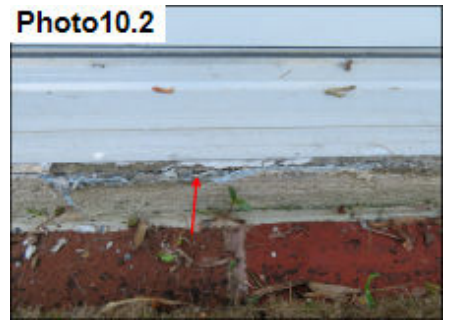
Door threshold not sealed

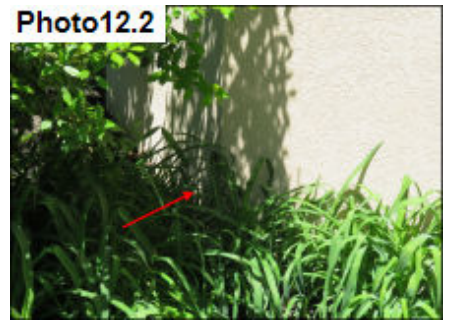
Wood substrate below grade

| Grid Location | Item Description | Moisture Readings | Substrate Condition | Observations |
|---|---|---|---|--|
| 8A-G | | | | This area goes below grade and had a wood substate |

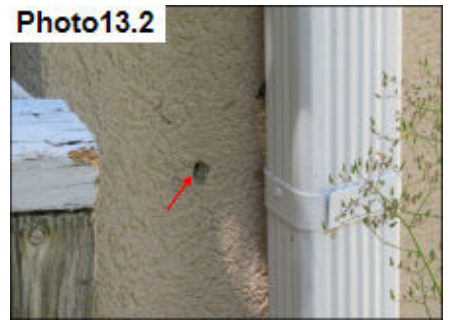
Holes from gutter downspout

| Grid Location | Item Description | Moisture Readings | Substrate Condition | Observations |
|---|---|---|---|---|
| 7C | | | | Downspout is loose and hole needs to be sealed. The nail fastener did not penetrate the masonry |

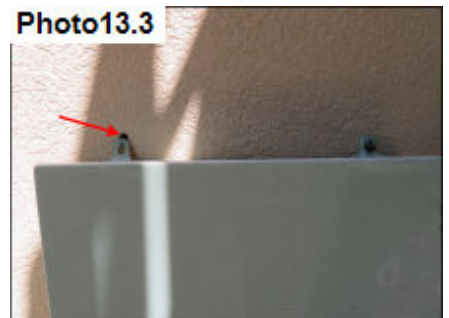
Holes need to be sealed

| Grid Location | Item Description | Moisture Readings | Substrate Condition | Observations |
|---|---|---|---|---|
| 6H & 7H-I | | | | All holes need to be sealed |

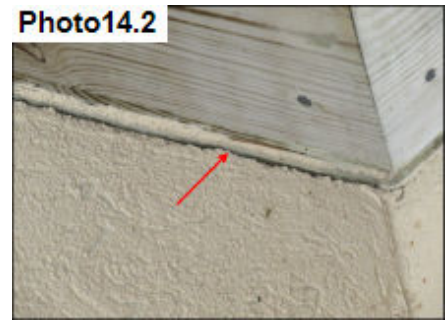
Not sealed below deck

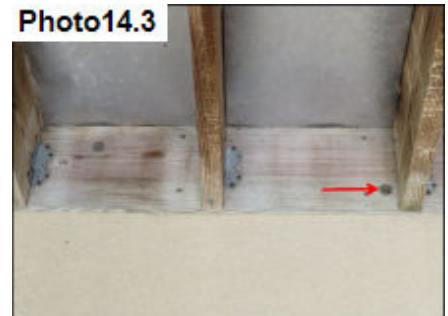
Deck is attached to the house

| Grid Location | Item Description | Moisture Readings | Substrate Condition | Observations |
|---|---|---|---|--|
| 2A-J | Deck | | | Deck is attached to the house, not flashed and is not sealed |

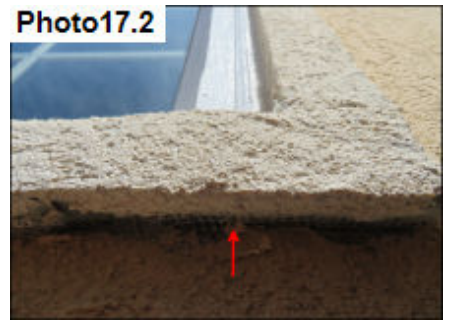
Exposed mesh

| Grid Location | Item Description | Moisture Readings | Substrate Condition | Observations |
|---|---|---|---|---|
| 7E | Probe | 10 | Firm | Exposed mesh needs to be sealed |

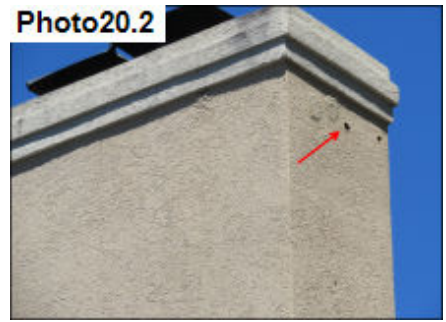
Holes need to be sealed on chimney

| Grid Location | Item Description | Moisture Readings | Substrate Condition | Observations |
|---|---|---|---|---|
| 6G | Probe | 10 | Firm | There are holes on both sides of the chimney near the top that need to be sealed see caption photos |

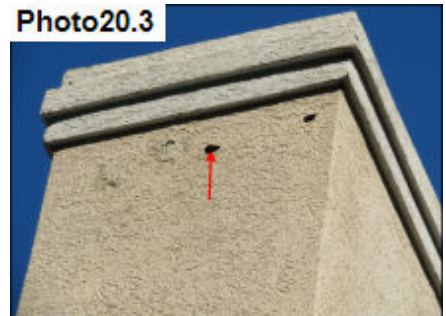
Holes need to be sealed

| Grid Location | Item Description | Moisture Readings | Substrate Condition | Observations |
|---|---|---|---|---|
| 3-4D | | | | Hole needs to be sealed |

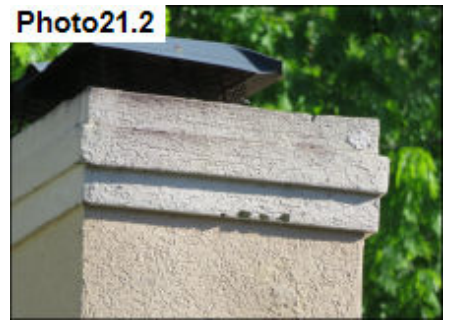
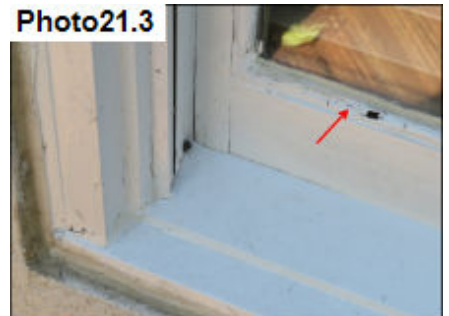
Wood rot

| Grid Location | Item Description | Moisture Readings | Substrate Condition | Observations |
|---|---|---|---|--|
| 7B-C-D-F-G-H-I | Windows | | | External wood rot needs to be repaired. |

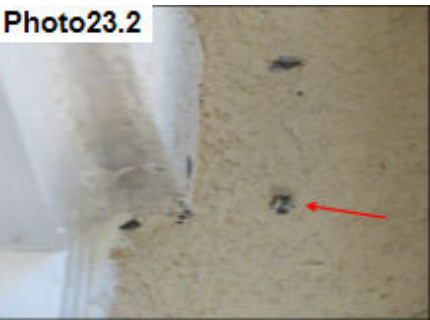
Holes need to be sealed

| Grid Location | Item Description | Moisture Readings | Substrate Condition | Observations |
|---|---|---|---|---|
| 5 & 7C | | | | Holes from old downspout need to be sealed |

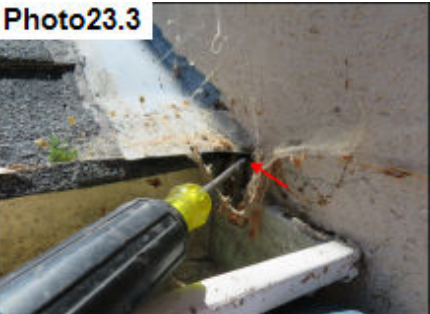
Gap under flashing & gutter

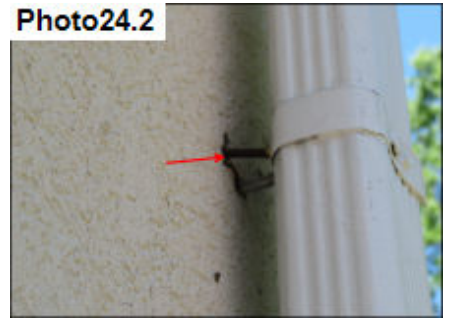
Not sealed

| Grid Location | Item Description | Moisture Readings | Substrate Condition | Observations |
|---|---|---|---|--|
| 4I | Gutters | | | Downspout loose and pulling out and not sealed |

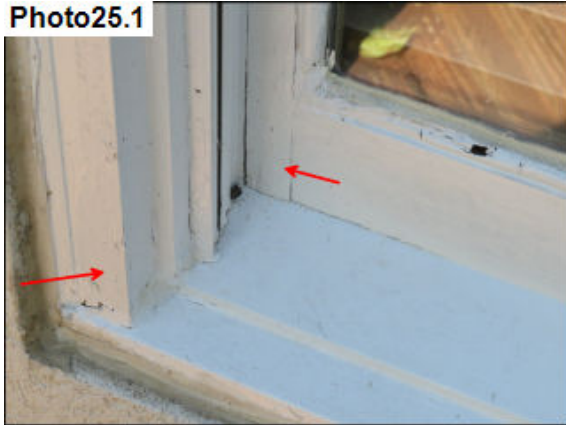
Photo25.1

Wood rot at windows

Any wood rot on the windows, doors, and trim must be repaired and all perimeter and construction joints must be sealed.

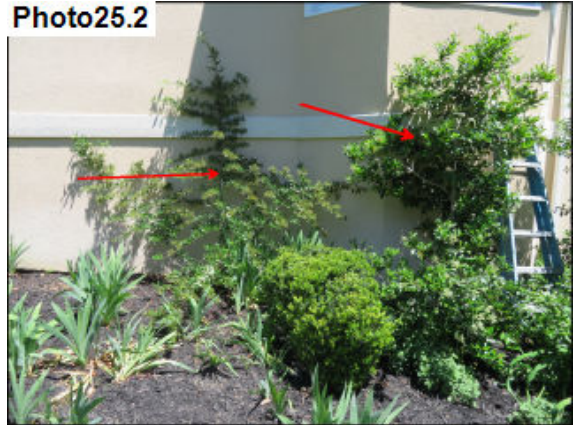
Photo25.2

Keep shrubbery cut back off house 18 to 24 inches.

The shrubs and a tree are over grown and contact the exterior walls; this impedes access around house for inspection, contribute to moisture problems, and can damage the finish of EIFS system. Ideally, shrubs need to be cut back 2 feet from the house.

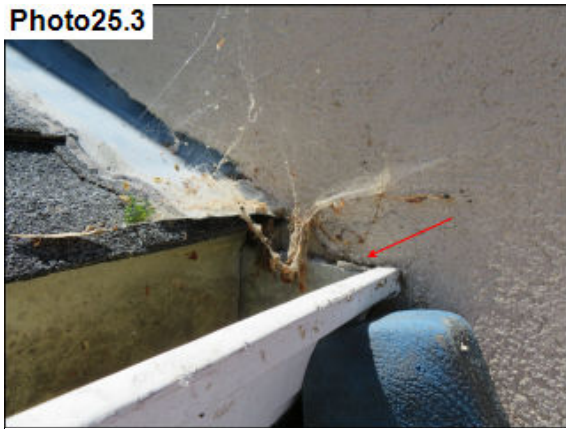
Photo25.3

No kickout flashings were installed at the roof wall intersections according to general industry guidelines. This may allow any rainwater flowing down the roof to enter behind the EIFS system, defeating the concept of a barrier system. The inspection noted evidence of water intrusion and soft substrate under the roof rakes. In addition, the current configuration of the counter flashing installed on the EIFS surface relies heavily on improper sealant with an improper joint. This method of flashing is common for masonry construction, but is not an approved design detail for EIFS. In my opinion, it would be appropriate to upgrade the kickout flashings when the other repairs are done. The kickout flashings should be installed to current manufacturer's or EIMA specifications including the required expansion joints and approved sealant.

Kickouts are not installed

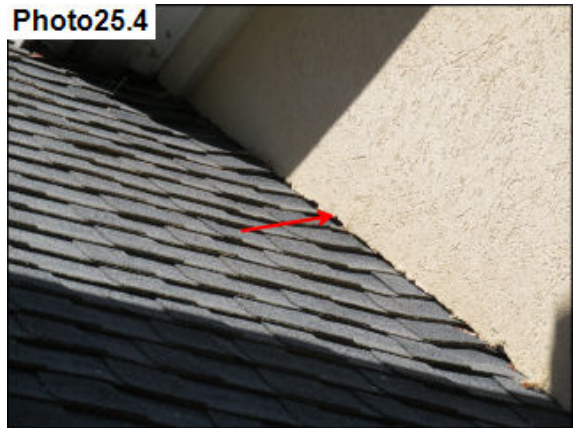
Photo25.4

The EIFS was in contact with the shingles and did not appear to be not back wrapped properly. The industry recommends a 2-inch gap between the EIFS and shingles to keep water from getting behind the EIFS. This minimum space keeps debris from being lodged between the EIFS and roofing material by allowing rain to flush the space clear. This space is a positive design feature to minimize water entering the EIFS system at the roofline. In addition, there might be a problem when re-roofing becomes necessary because the EIFS may be damaged when the shingles are removed. Because no moisture damage was noted on the EIFS above the roof no modifications are suggested at this time. These sites should continue to be monitored for moisture entrapment.

The EIFS runs to the shingles in some areas

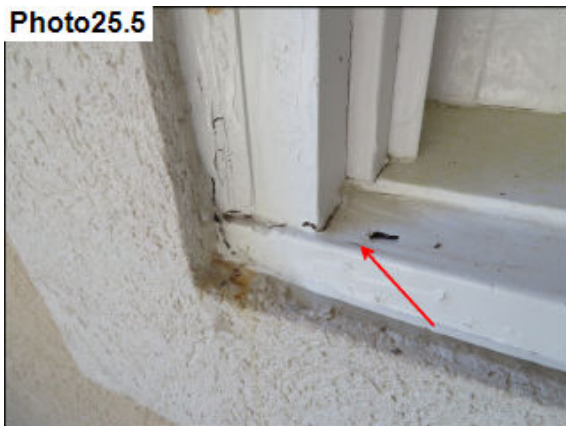
Photo25.5

Wood rot

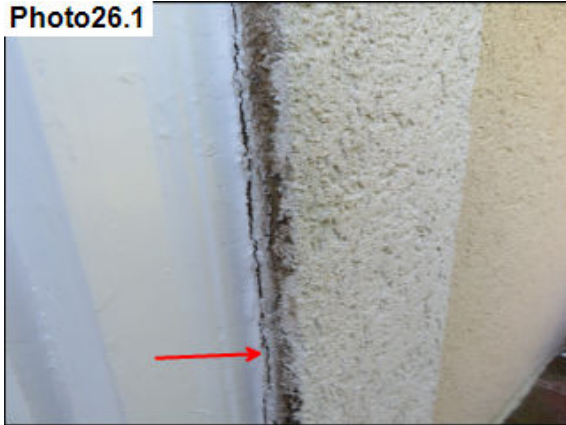
Photo26.1

Sealants (specialized EIFS approved caulking) were not consistently installed at dissimilar materials, some sealants were the improper type, and EIFS and sealants were failing at some joints between dissimilar materials (see grids for locations). Sealants should be installed where failing or improper and at all dissimilar materials that are in contact with the EIFS system, the frieze and fascia boards, the doors, ends of the deck, etc., and all small penetrations where needed and as noted in the report.

Sealant failure

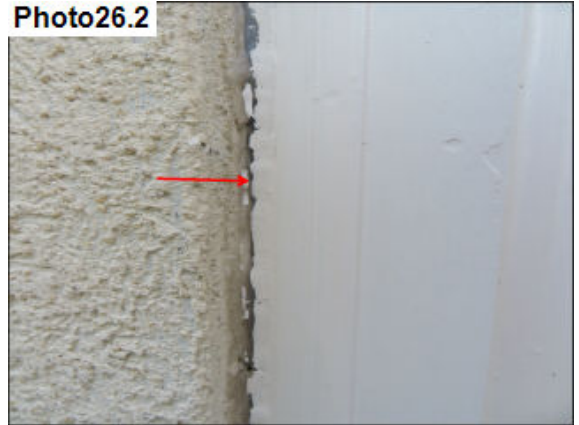
Photo26.2

If caulking is going to be used as the only means of preventing moisture infiltration then all the potential entry points of moisture must be sealed. The windows perimeter sealant must have the sealants repaired or installed if missing. All the window joints and mullions need to have a bead of sealant applied to them to seal possible sources of moisture intrusion. For single or double hung windows, seal all vertical joints from the head of the window to the sill, prime the bare unfinished wood on the jamb behind the sash track at least 8” up from the sill and caulk the joint between the jamb and the sill. Then seal (caulk) at least 6” up the vertical joints behind the track. The use of sealants does require recurring maintenance and the caulking will only last as long as the paint does and the wood remains sound.

Sealant has been painted

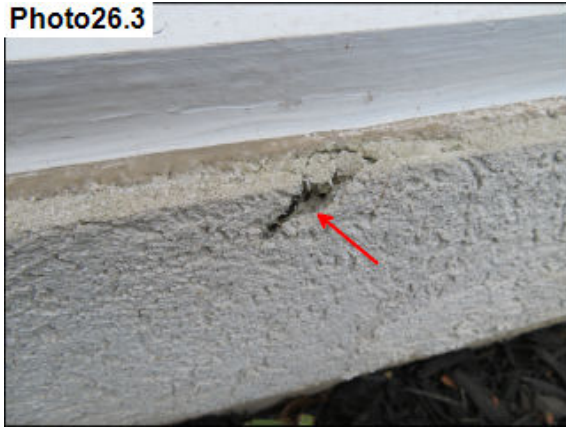
Photo26.3

All areas with cracks, exposed mesh, holes, and impact damage should be sealed or repaired. Water intrusion is likely to occur in these areas.

Damage typical where noted in the report

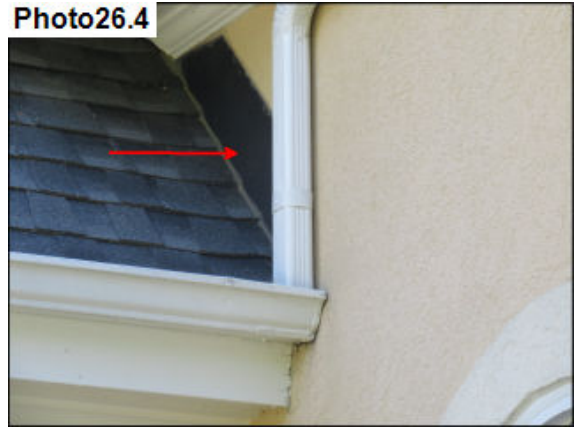
Photo26.4

Counter flashing is installed instead of a kickout flashing

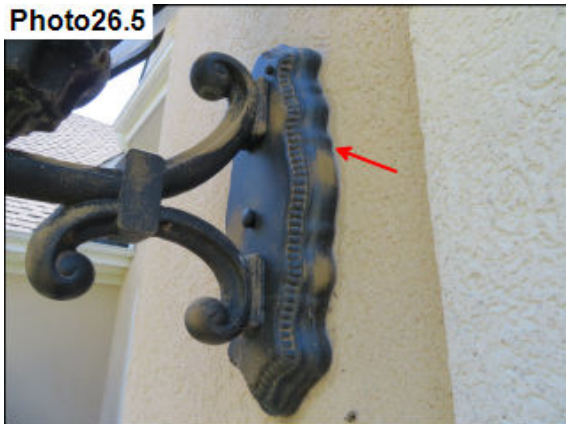
Photo26.5

Lights Are sealed

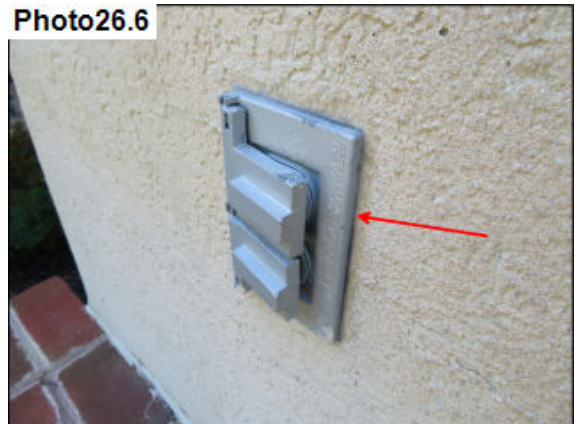
Photo26.6

Outlets are sealed
