Confidential Inspection Report

Property Address:
123 Main St
Richmond, VA 23236

Inspector Name
State License: 3380001234 NRS Exp 1-31-2024
Burgess Inspections
530C Southlake Blvd
N. Chesterfield, VA 23236
(804) 794-1423

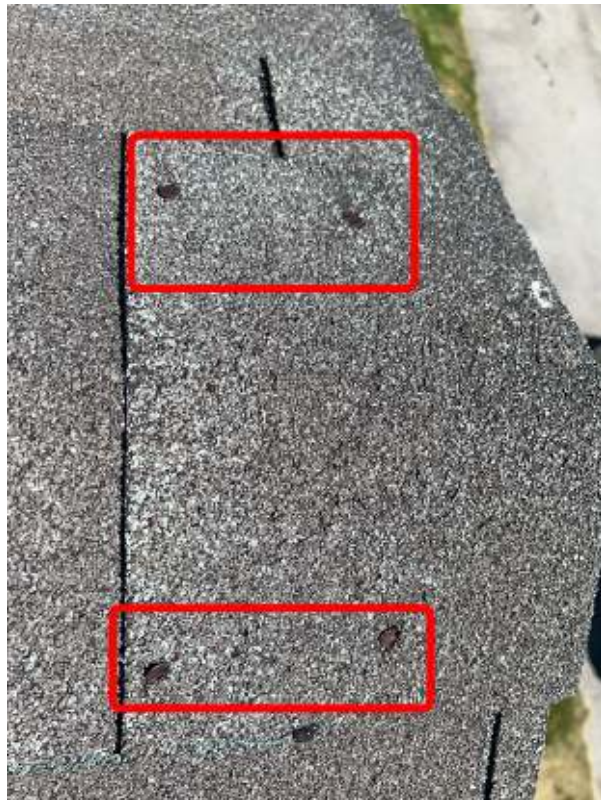
10: Exposed nail pops at several ridge caps.- \$100-300

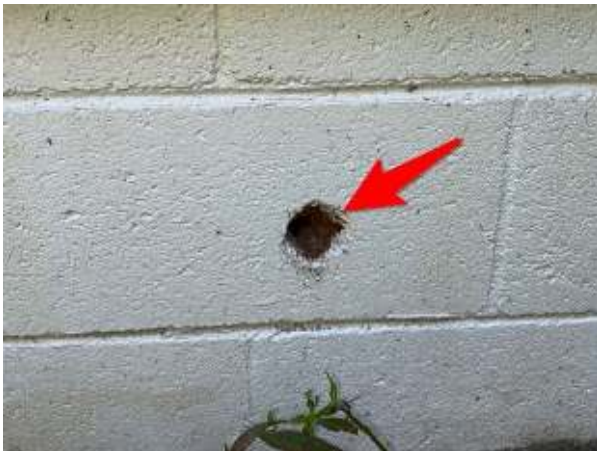
16: An open hole noted in the block wall at the rear of the home that needs to be sealed to avoid animal intrusion.- \$100

s-16: An open hole noted in the block wall at the rear of the home that needs to be sealed to avoid animal intrusion.- \$100

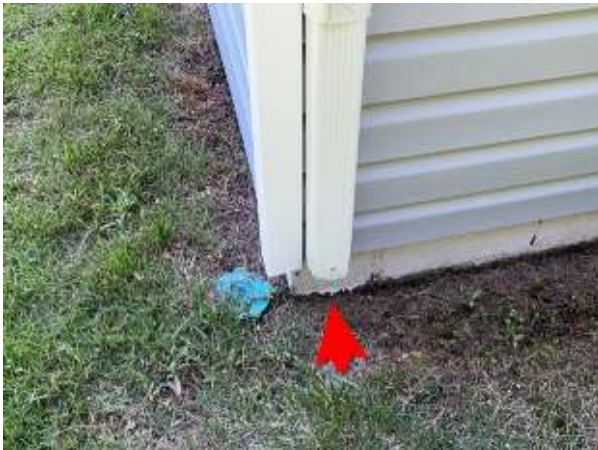
20: The downspout at the back left corner of the house need an elbow extension installed to divert the water away from the foundation.- \$100

s-20: The downspout at the back left corner of the house need an elbow extension installed to divert the water away from the foundation.- \$100

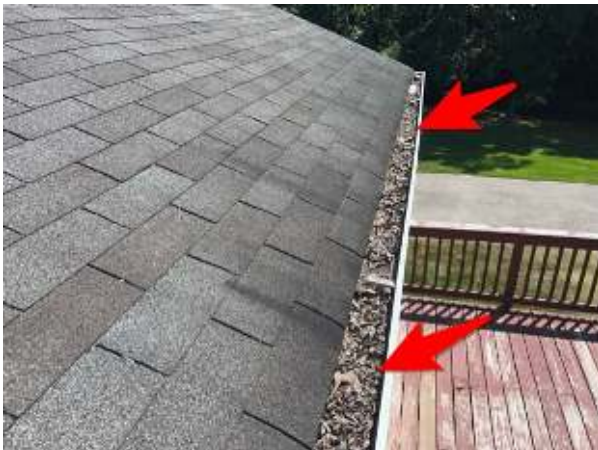
21: The gutters were full of debris and need to be cleaned.- \$100

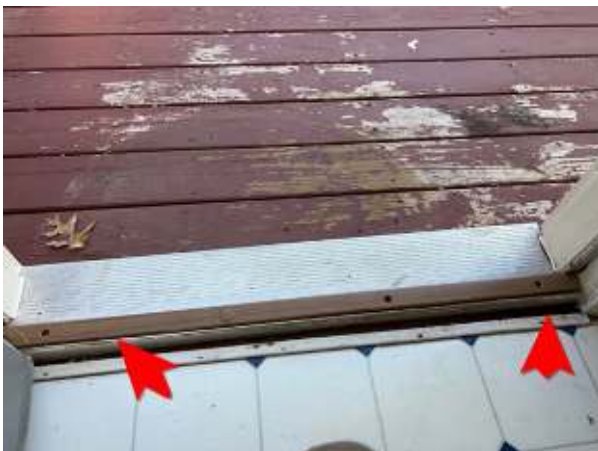
22: The back door threshold is loose. Also, the flooring below appeared to have minor rot.- \$200-300

s-22: The back door threshold is loose. Also, the flooring below appeared to have minor rot.- \$200-300

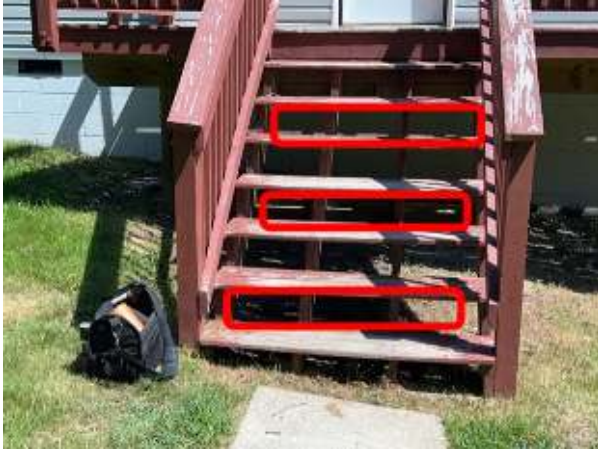
23: The front and rear stairs had an open riser, creating openings under each step. The openings exceeded the 4-inch space rule. The maximum space allowed will not let a 4-inch object pass through the area.- \$200

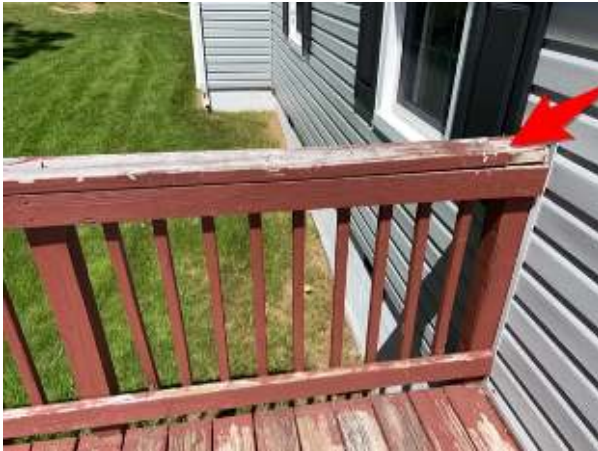
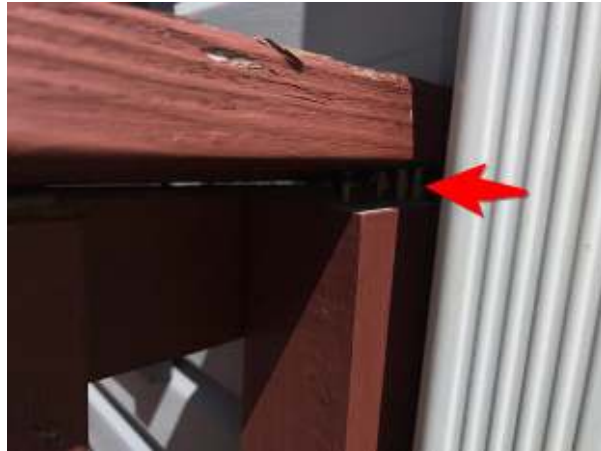
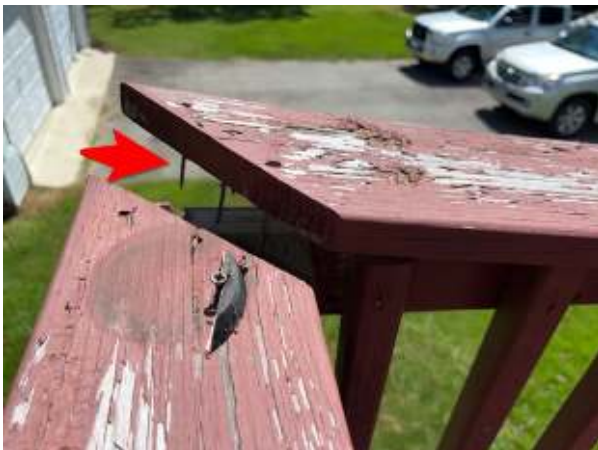
24: The back deck top rails were warped and loose.- \$100-300

s-24: The back deck top rails were warped and loose.- \$100-300

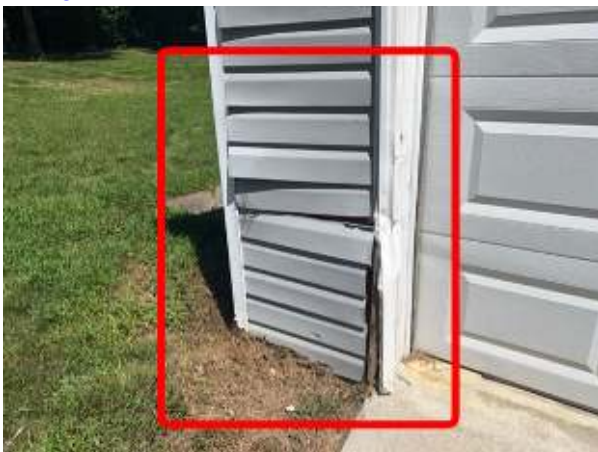
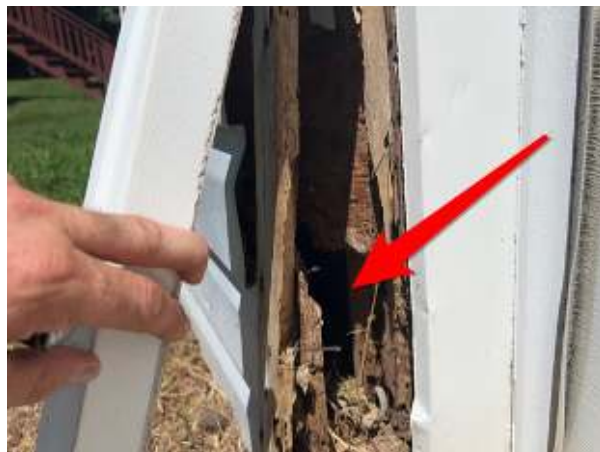
30: The front left corner of the garage has been damaged. The garage door frame has been compromised along with the front left wall.- \$800-1500

s-30: The front left corner of the garage has been damaged. The garage door frame has been compromised along with the front left wall.- \$800-1500

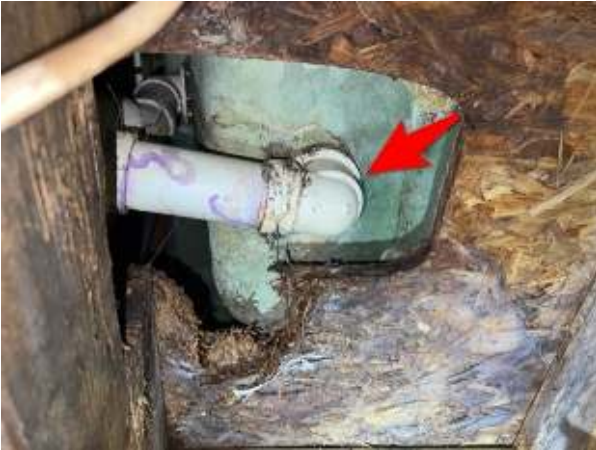
64: The hallway bathroom tub/shower drain is leaking visible in the crawl space.- \$300-500

s-64: The hallway bathroom tub/shower drain is leaking visible in the crawl space.- \$300-500

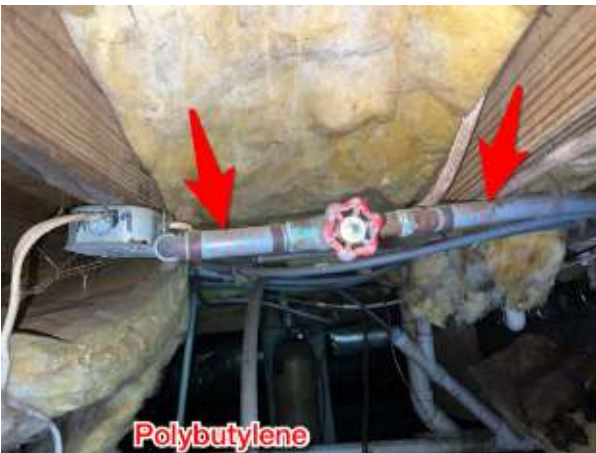
65: Most of the supply pipes for the house were plastic. It is beyond the scope of this inspection to determine what type of pipes you have. Some types have been know to prematurely fail. Polybutylene is one type that has a higher rate of failure than some others. If you have any questions or concerns about this, we recommend that you have them further evaluated by a qualified person.

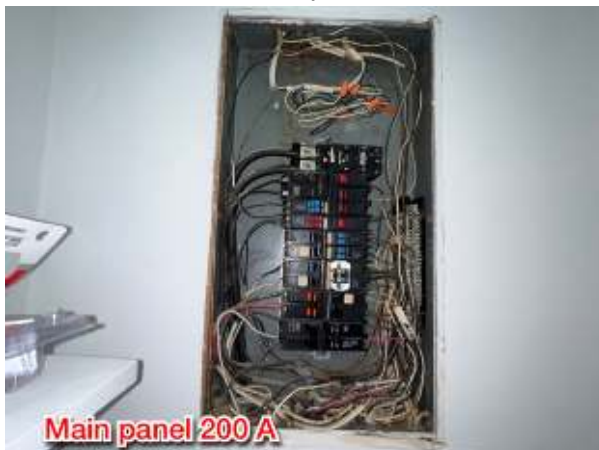
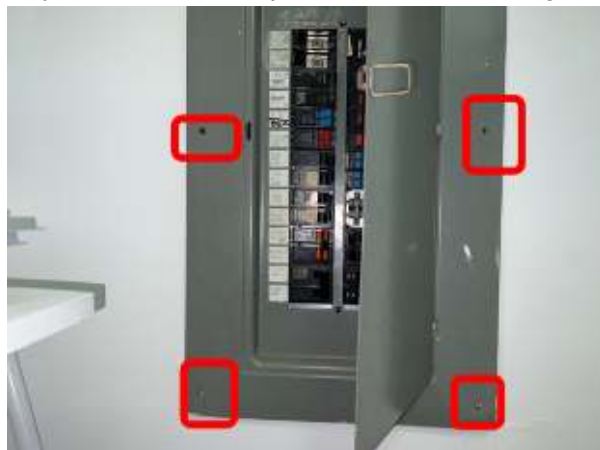
80: The main electrical panel is located in the laundry room. Also, the panel cover is missing fasteners.

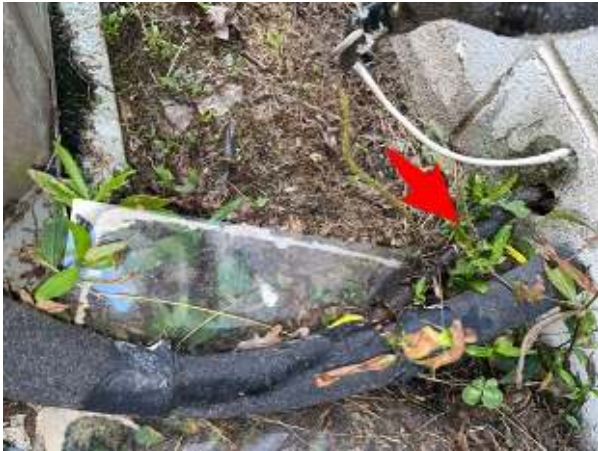
87: The foam sleeve on the suction line was missing/damaged in area(s) at the outside unit. Missing foam on suction line can cause energy loss and condensation.- \$100

s-87: The foam sleeve on the suction line was missing/damaged in area(s) at the outside unit. Missing foam on suction line can cause energy loss and condensation.- \$100

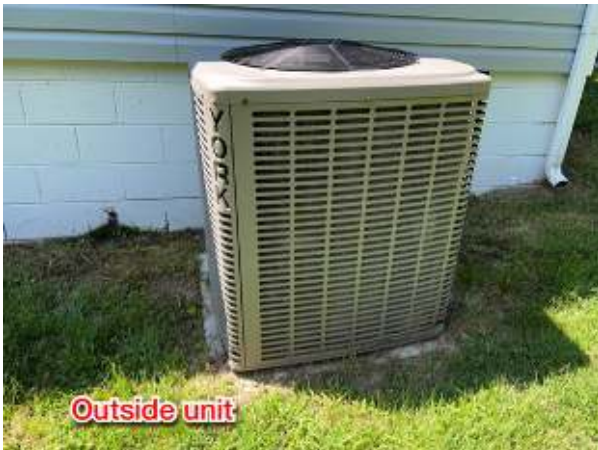
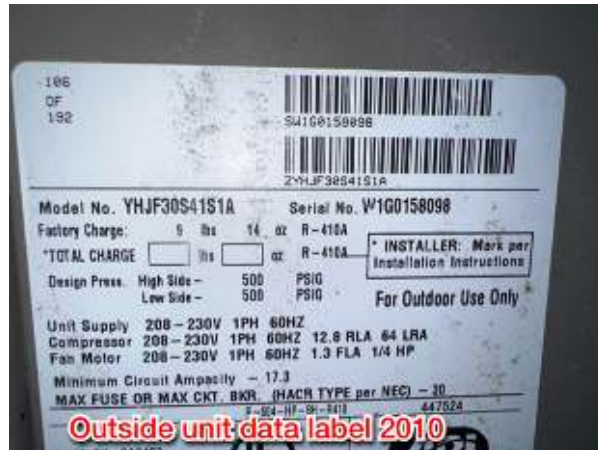
90: The heat pump was cooling adequately at the time of inspection. The filter was dirty and needs to be replaced.

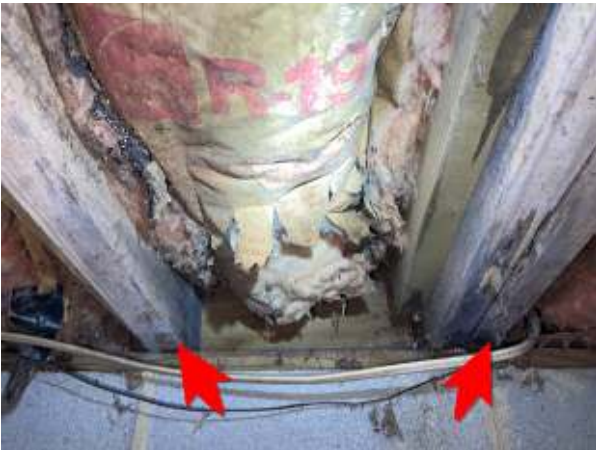
106: There were a few floor joists in the crawl space around the front porch area that have rot. Water stains noted in this area from possible water intrusion occurring around the porch area.- \$500-800

s-106: There were a few floor joists in the crawl space around the front porch area that have rot. Water stains noted in this area from possible water intrusion occurring around the porch area.- \$500-800

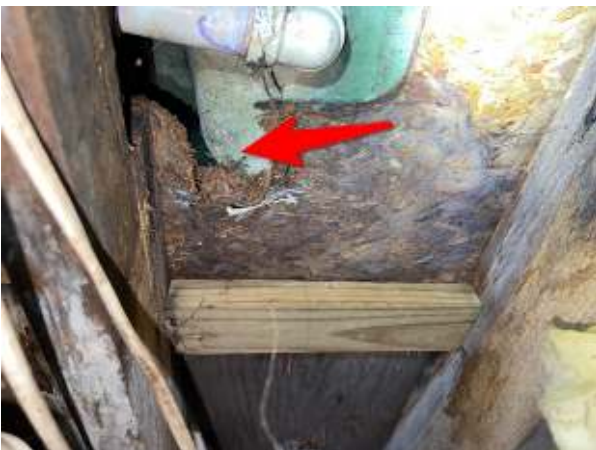
107: An area of floor sheathing is rotted due to the leak from the hallway bathroom shower drain.- \$200-300

s-107: An area of floor sheathing is rotted due to the leak from the hallway bathroom shower drain.- \$200-300
