Five Point Inspection Report

LOCATED AT:
1 Lonely Number St
Richmond, VA 23225

INSPECTED ON:
Tuesday, July 8, 2025

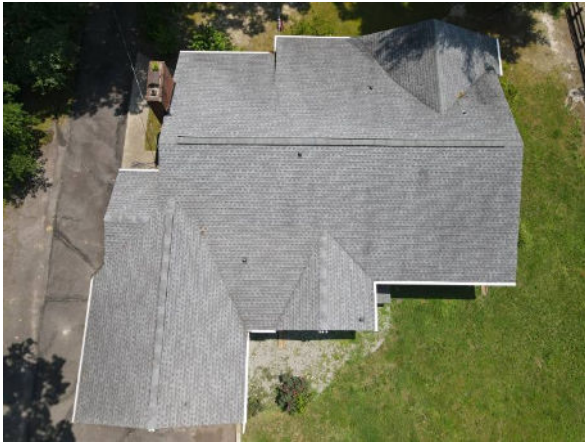
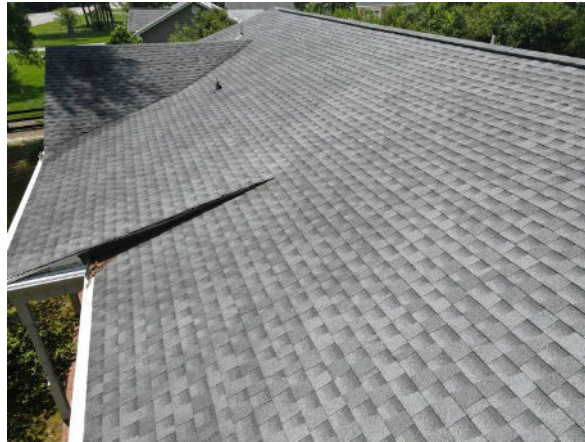
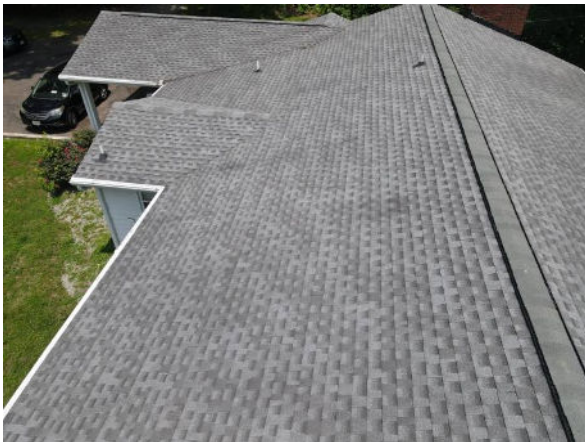
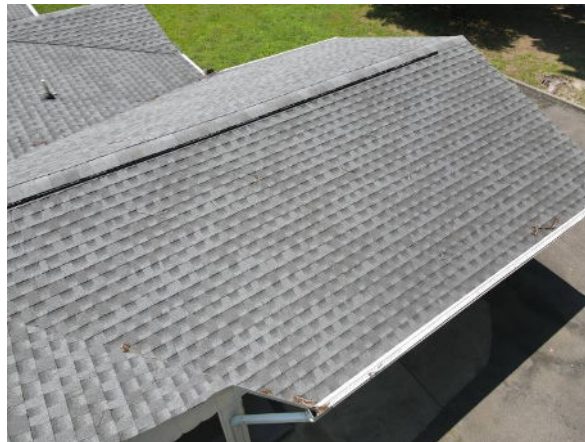
8: Roof covering was in good condition.

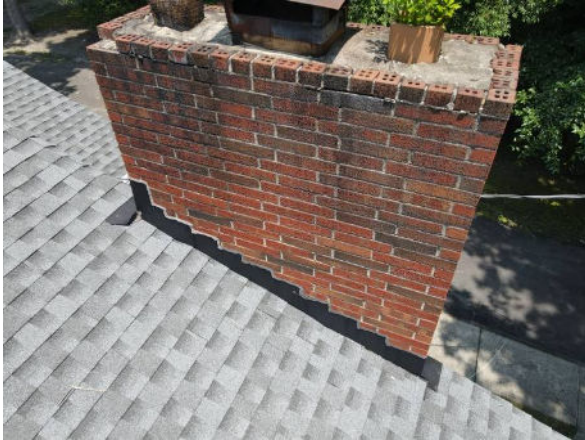
9: The flashing that was exposed for inspection appeared to be in good condition. The flashing that was concealed (not visible) could not be inspected. It is beyond the scope of this inspection to determine the condition of the concealed flashing and if those areas will leak in the future.

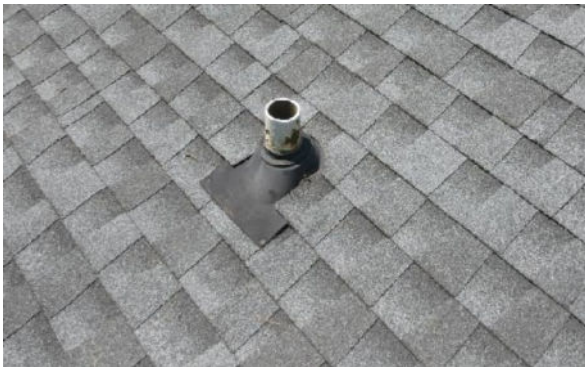
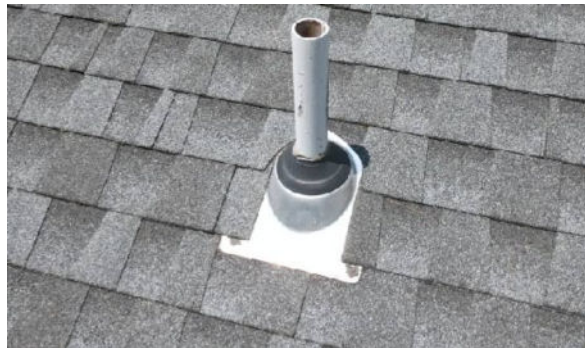
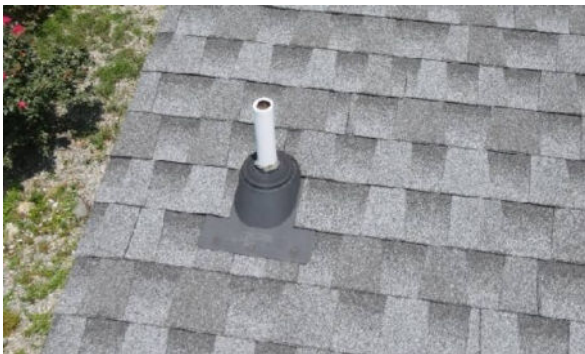
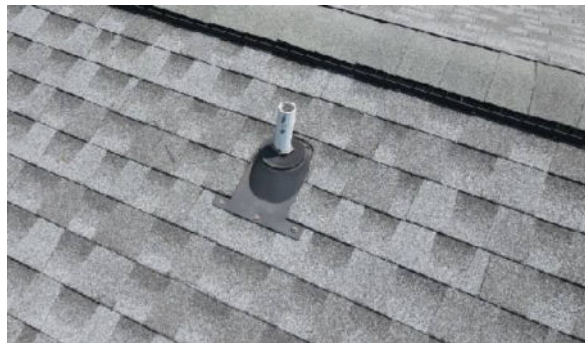
10: The plumbing vent pipe boots/seals were in good condition.

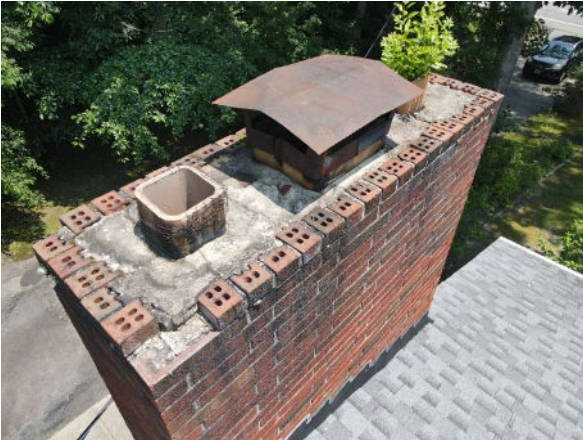
12: The crown on the chimney was deteriorated and cracked. Have a qualified mason to repair chimney cap.

s-12: The crown on the chimney was deteriorated and cracked. Have a qualified mason to repair chimney cap.

\$250 to \$350

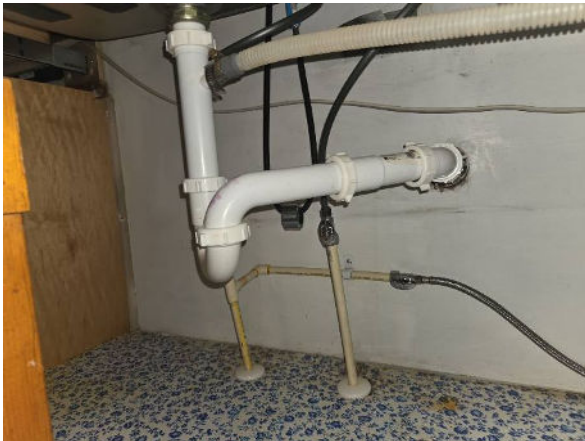
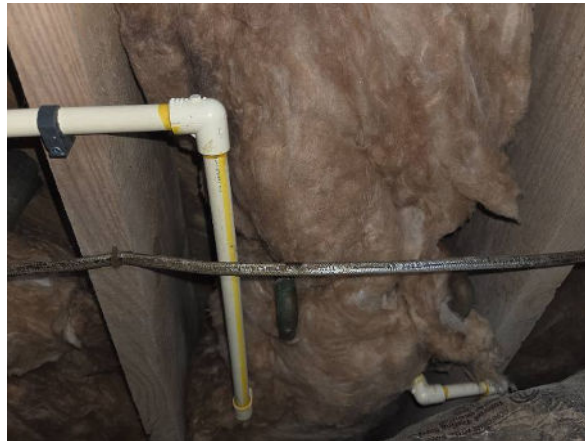
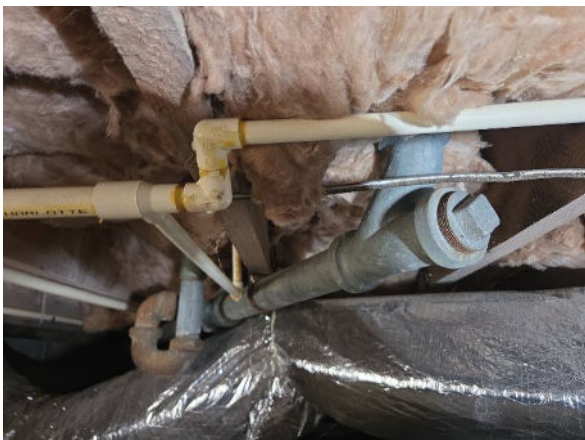
20: The plumbing drain, waste, and vents systems were in good condition.

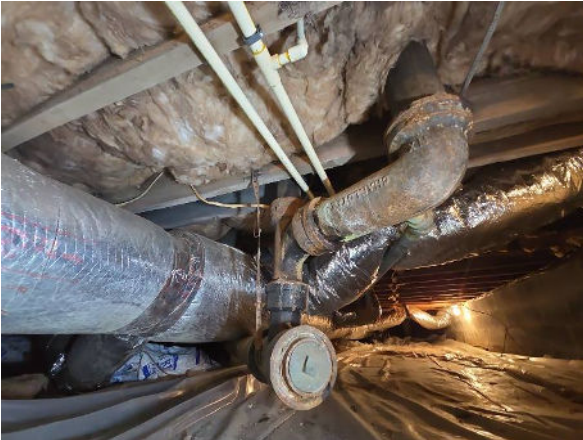
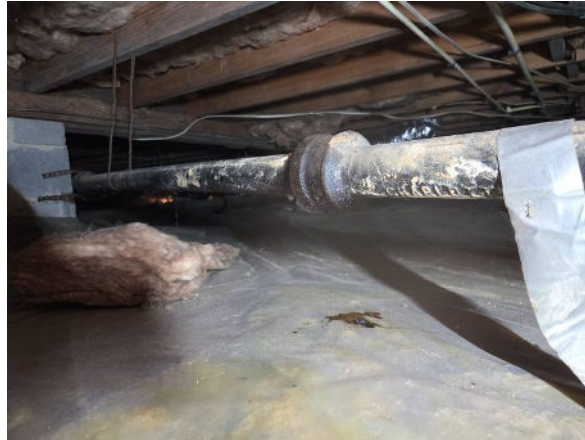
21: Part of the drain line was cast iron. Sometimes these can rust where in contact with the ground or in non-visible areas.

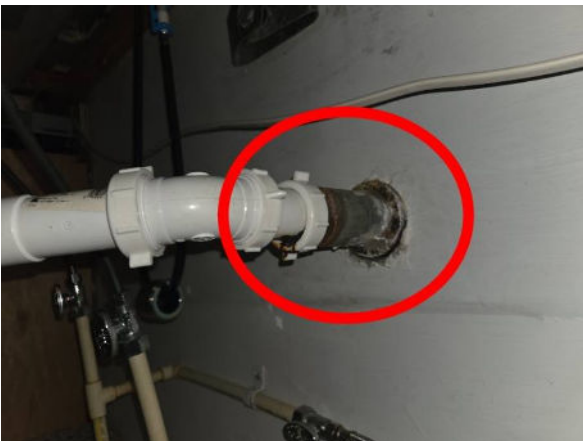
22: Galvanized pipes were noted on the drain system. These pipes can sometimes rust themselves shut. The pipes may drain properly at the time of the inspection but when you take possession they may not drain the same. That could be a result of additional load put on the drainage system or simply the pipes failed between the time of the inspection and when you took possession.

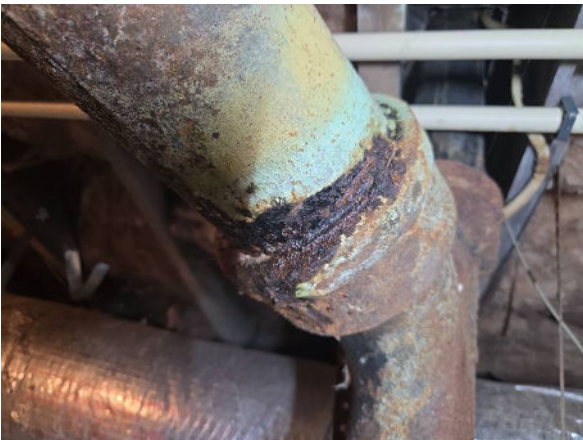
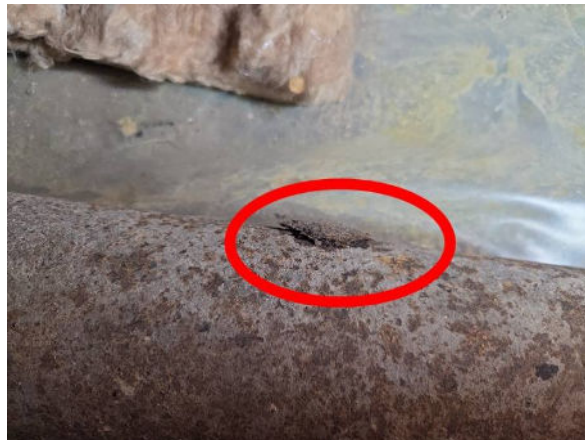
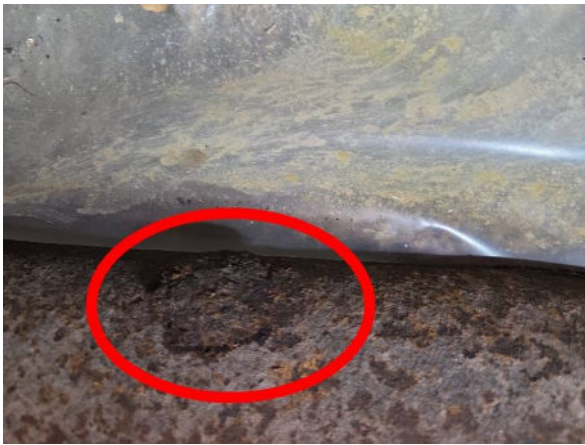
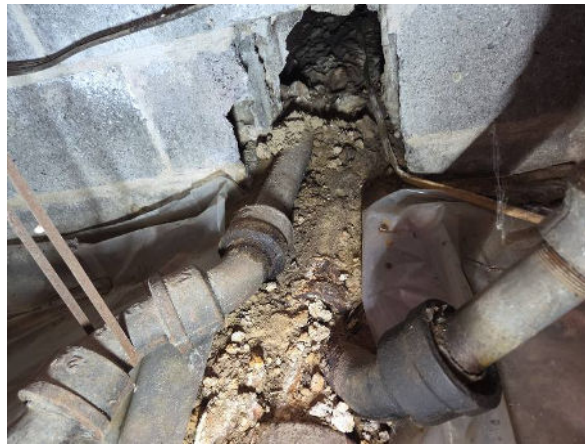
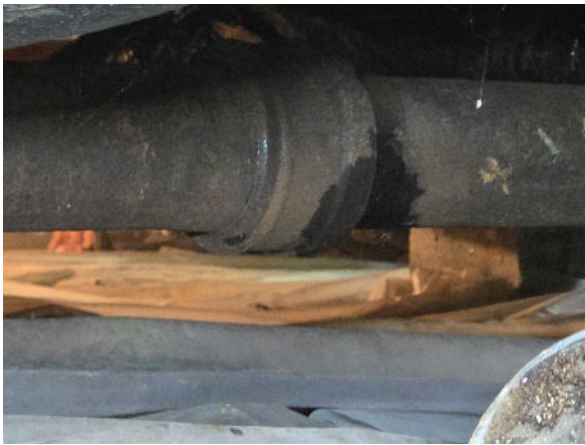
23: The cast iron drain lines were aged. There were blisters and wet spots around connections. Recommend having the cast iron drain lines evaluated by qualified professional and an estimate submitted for repair.

s-23: The cast iron drain lines were aged. There were blisters and wet spots around connections. Recommend having the cast iron drain lines evaluated by qualified professional and an estimate submitted for repair.

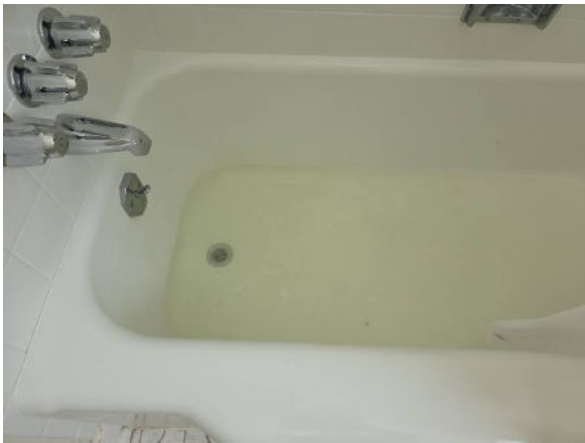
24: The hallway bathroom bathtub drain was slow or clogged.
\$75 to \$125

s-24: The hallway bathroom bathtub drain was slow or clogged.

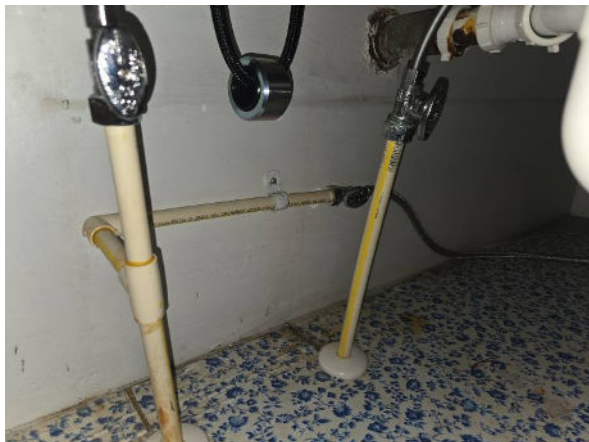
25: The plumbing water supply, distribution systems, and fixtures were properly working.

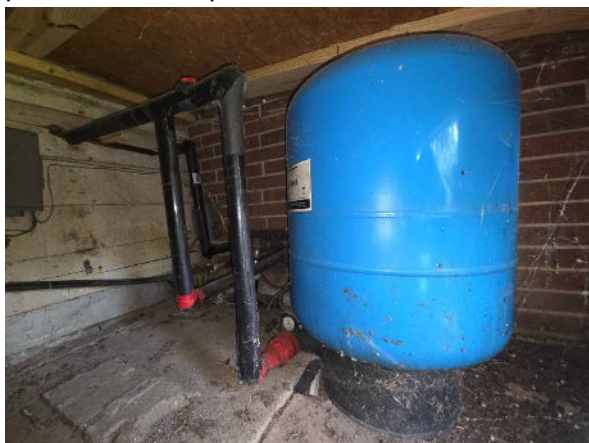
26: Inspection of the well is beyond the scope of this inspection. The pump did appear to be functioning and water was available for the home. The estimated useful life of most well pumps is 15-20 years. The age of the current pump and equipment was unknown. If concerned, recommend having a qualified professional inspect the well and associated equipment.

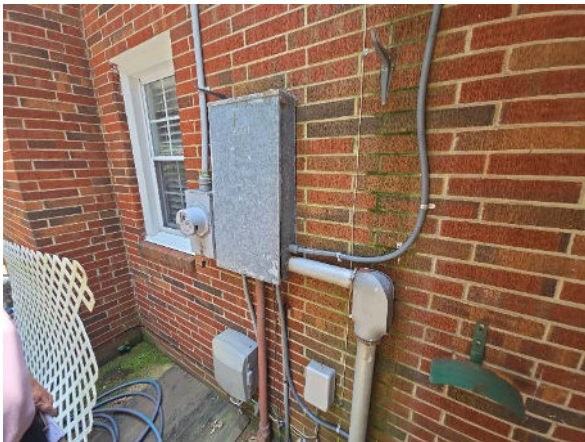
33: The service entrance conductors were in good condition.

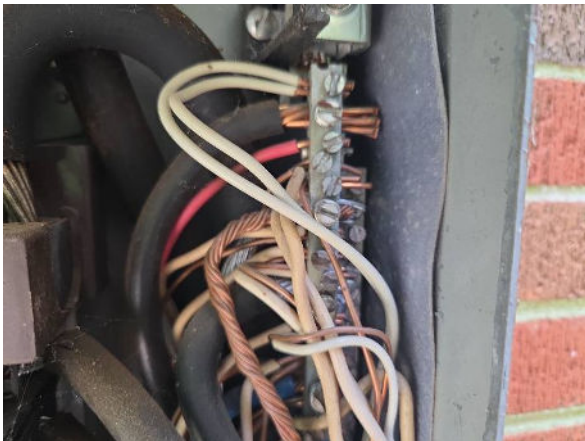
35: There were multiple neutral wires in one terminal lug.
\$150 to \$250

s-35: There were multiple neutral wires in one terminal lug.

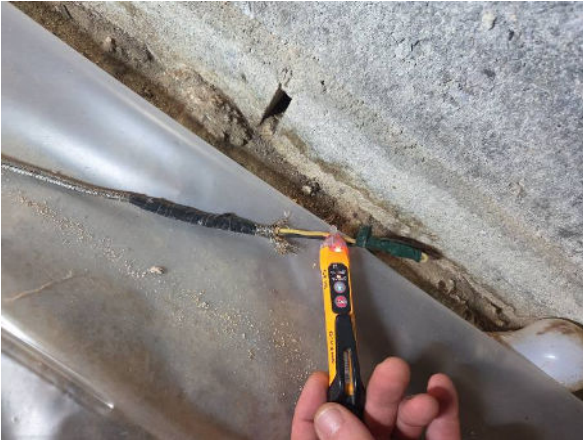
37: Electrical wire connections were not contained in a covered junction box.
\$125 to \$175

s-37: Electrical wire connections were not contained in a covered junction box.

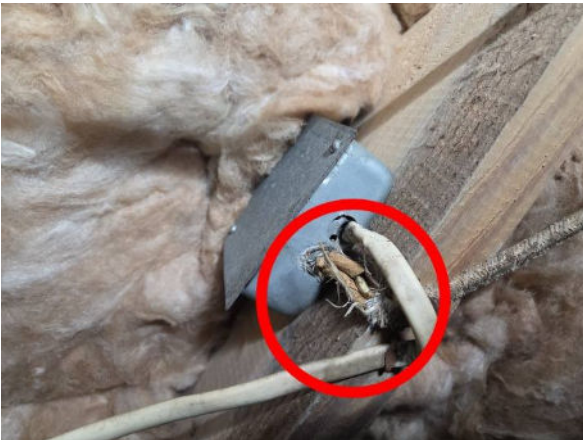
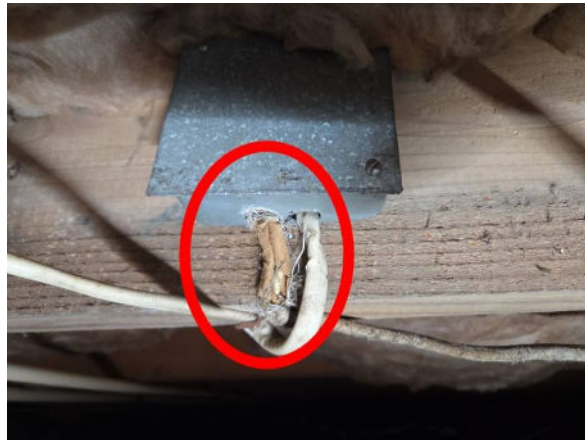
38: In the crawl space there was cloth wiring insulation that was damaged.
\$125 to \$175

s-38: In the crawl space there was cloth wiring insulation that was damaged.

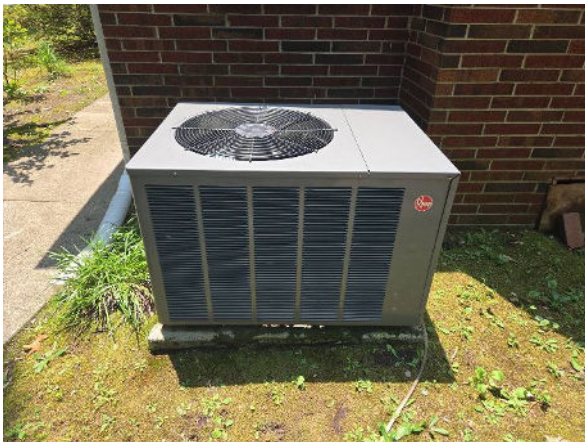
44: The heat pump system was operating but may be nearing the end of its useful life.

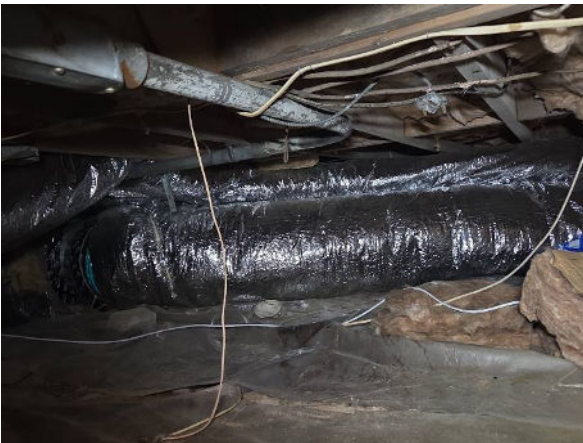
48: There was a duct that was in contact with the ground surface of the crawl space.
\$150 to \$250

s-48: There was a duct that was in contact with the ground surface of the crawl space.

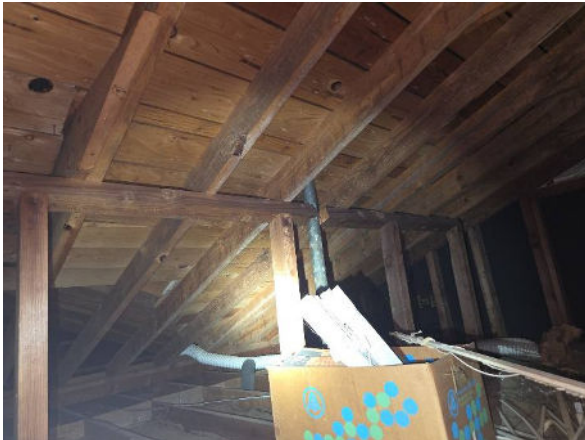
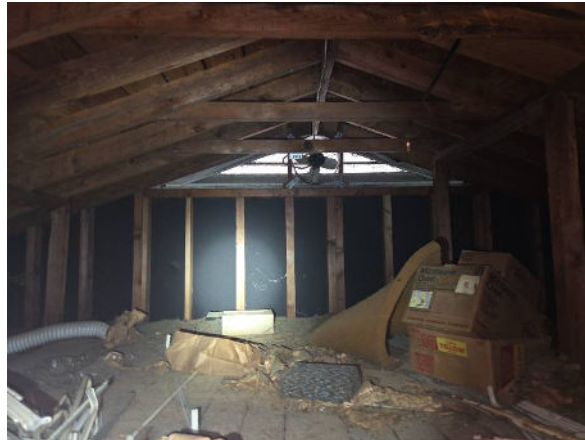
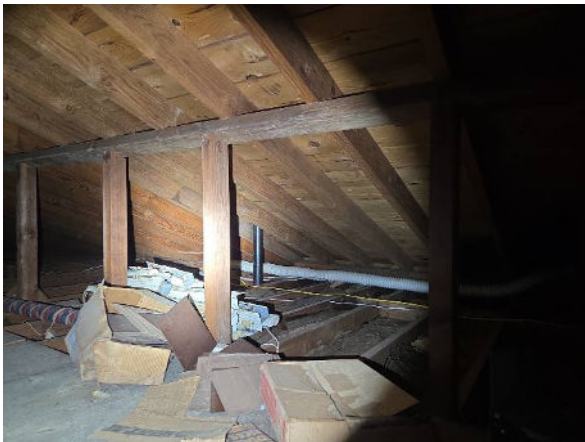
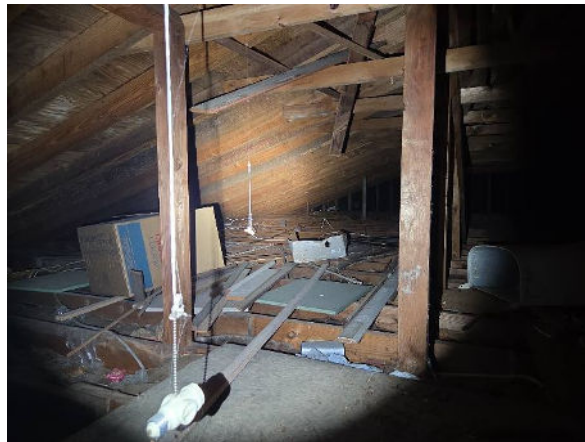
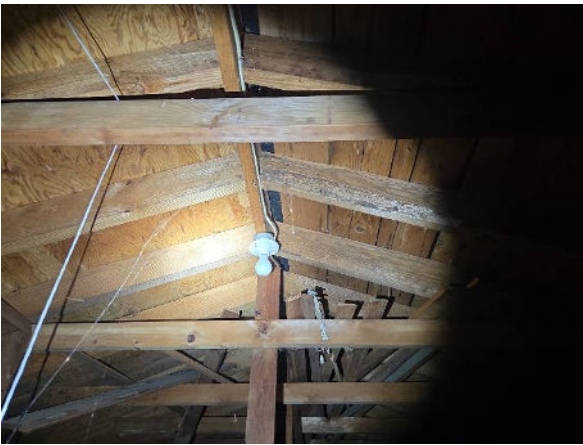
51: The attic areas were in good condition.

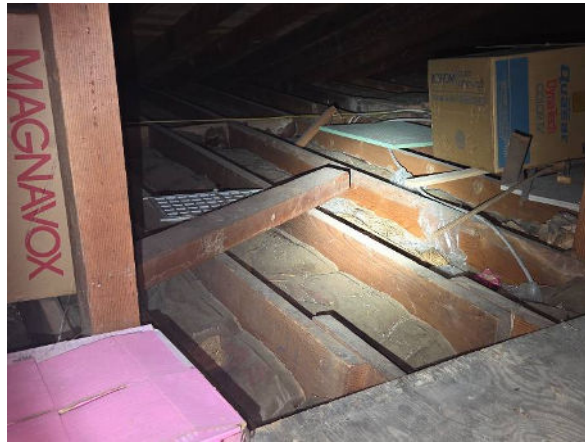
52: Insulation has settled over time. Adding insulation in the attic will help with energy efficiency of the home

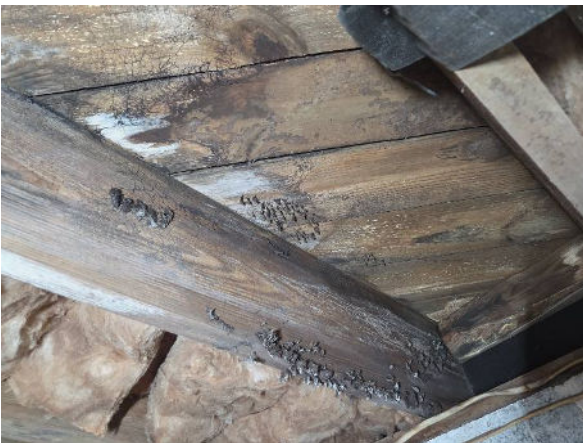
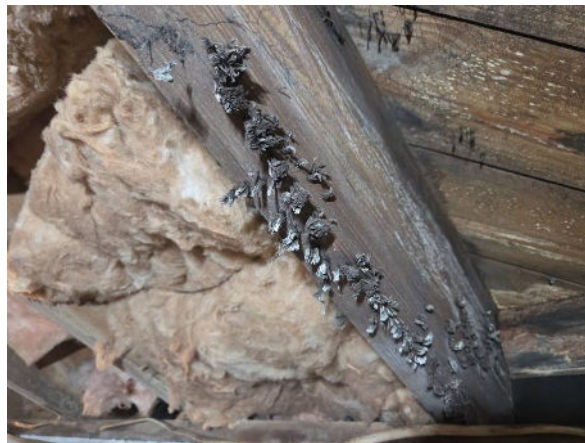
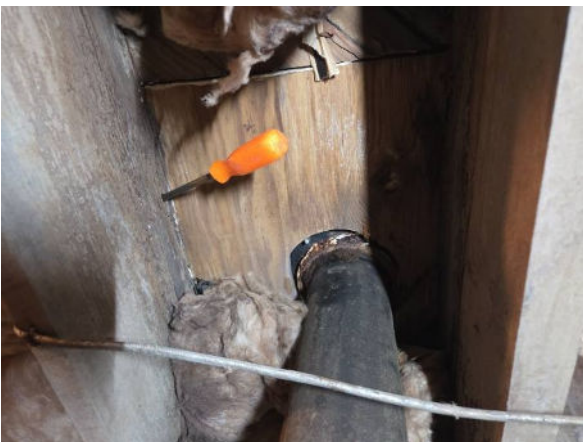
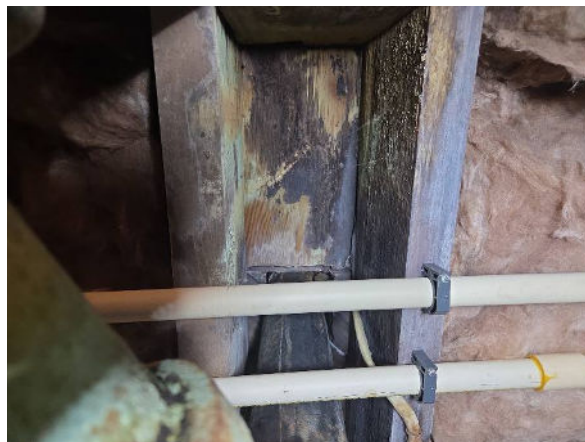
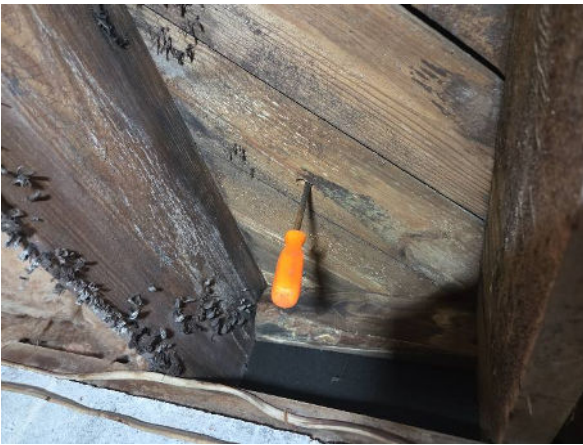
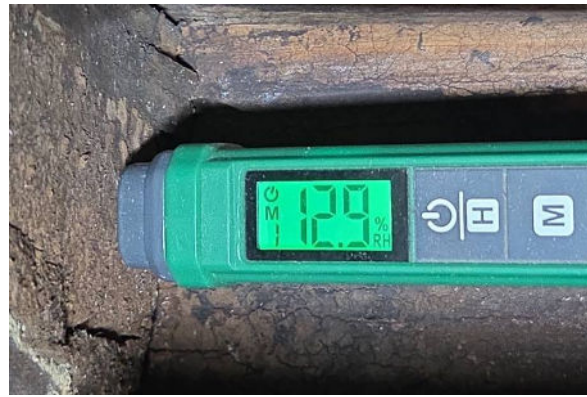
60: In the crawlspace, there appeared to be elevated levels of microbial growth on joists and insulation. Have remediated and the cause corrected. Recommend having an actual estimate given by a licensed/qualified contractor in this field.

s-60: In the crawlspace, there appeared to be elevated levels of microbial growth on joists and insulation. Have remediated and the cause corrected. Recommend having an actual estimate given by a licensed/qualified contractor in this field.

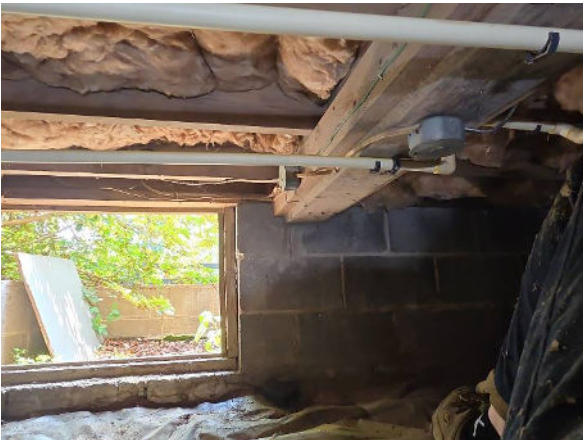
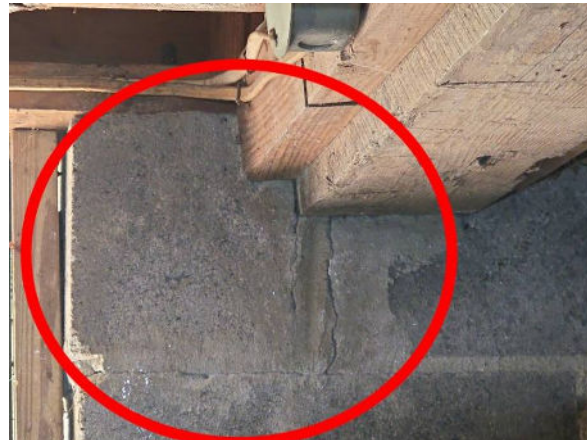
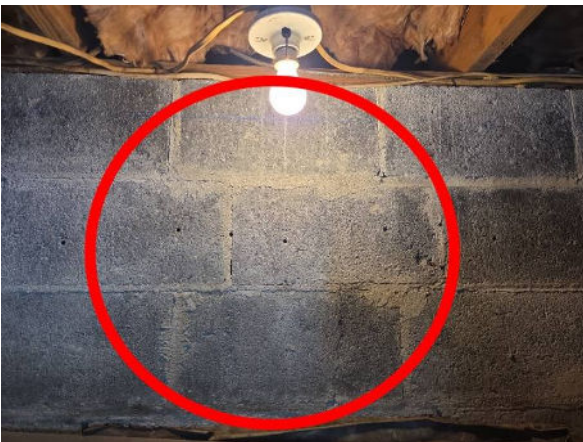
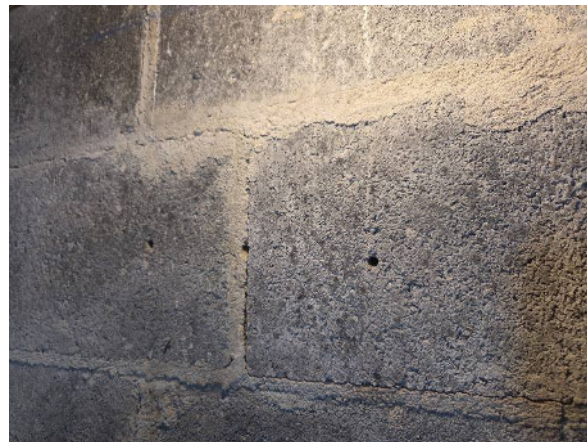
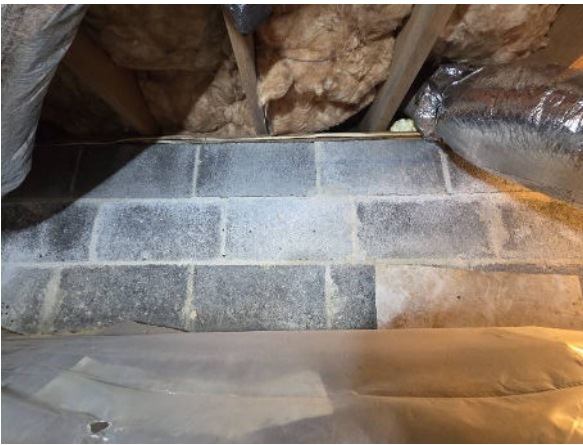
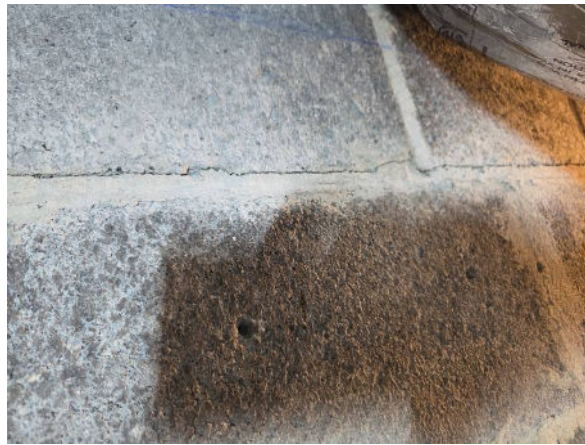
61: There were hairline cracks noted in the foundation. These appear to be from normal settlement. However, it is beyond the scope of this inspection to determine this. There was no displacement. If you have any concerns, it is recommended having them further evaluated by a licensed person in this field and corrected if needed.

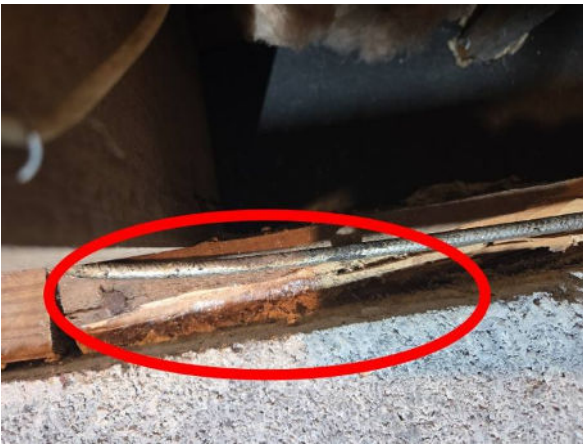
62: There were signs of termite activity in the crawlspace.
Have the home evaluated and treated for wood destroying insects.
\$150 to \$250

s-62: There were signs of termite activity in the crawlspace.
Have the home evaluated and treated for wood destroying insects.
\$150 to \$250

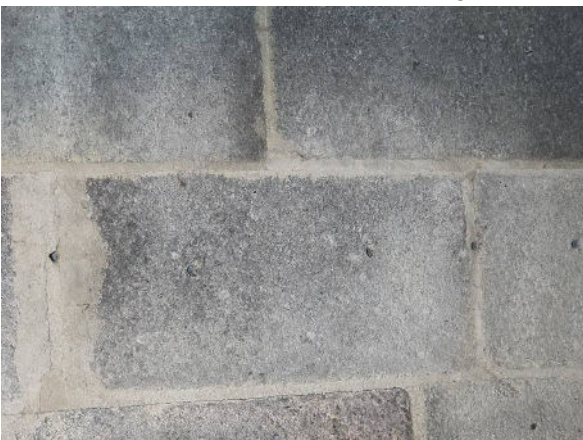
63: There were holes bored into the foundation block. These are signs of past termite treatment to the foundation. Recommend consulting with the owner for additional information.

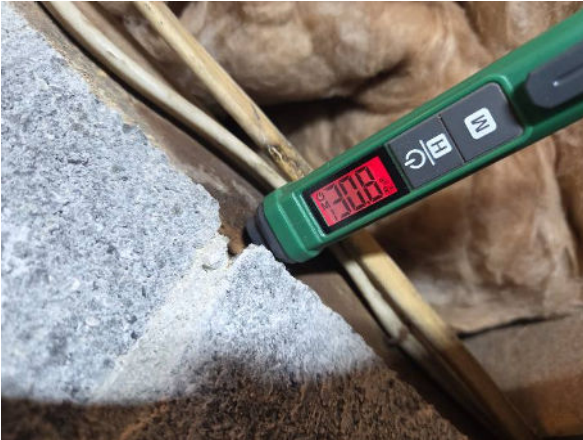
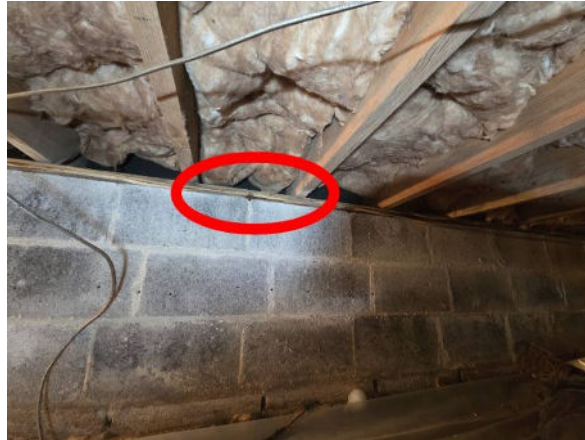
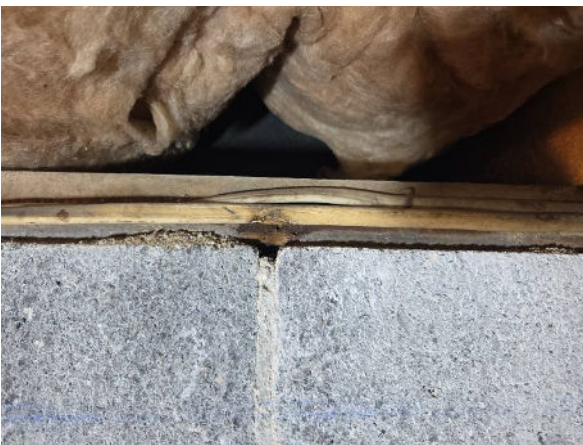
64: In the crawl space near the front porch the sill plate had high moisture. Have the underlying cause of moisture intrusion identified and an estimate submitted for repair.

s-64: In the crawl space near the front porch the sill plate had high moisture. Have the underlying cause of moisture intrusion identified and an estimate submitted for repair.

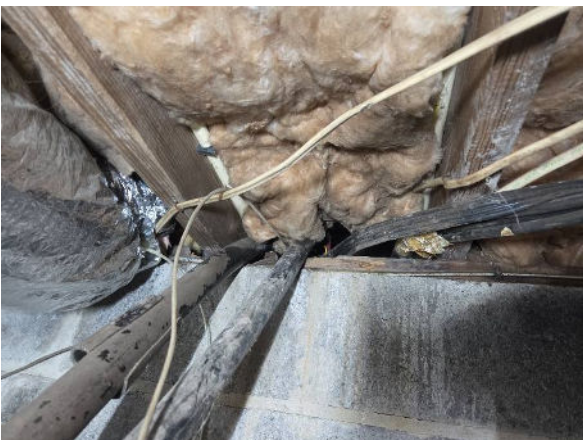
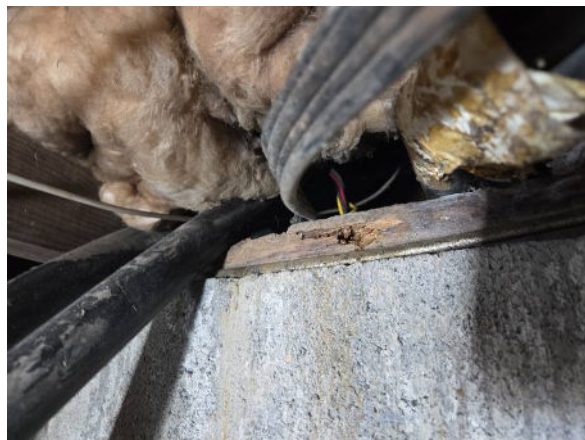
65: There was damage to the sill plate where the plumbing water lines and electrical entered the pump house.

s-65: There was damage to the sill plate where the plumbing water lines and electrical entered the pump house.
\$250 to \$350

\$250 to \$350

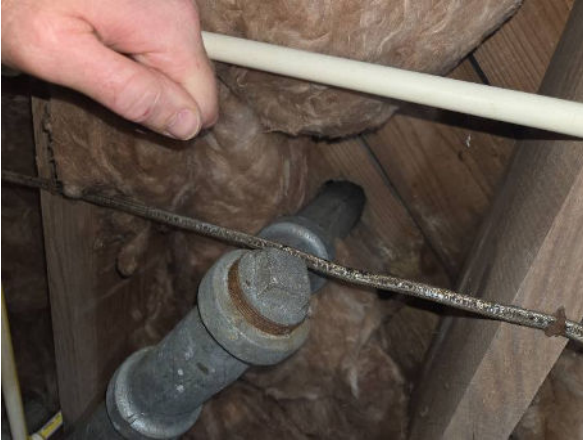
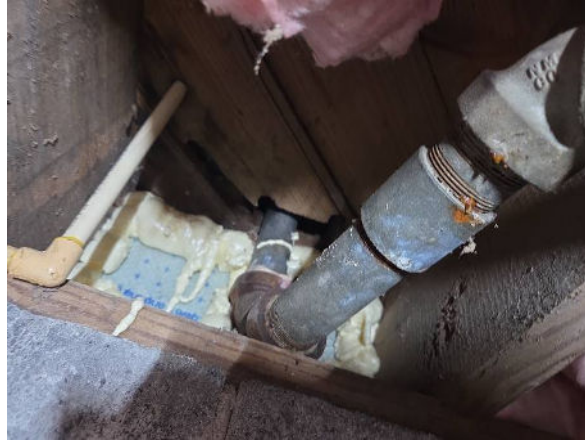
67: All subfloor/floor joists/girders/band boards could not be inspected on all sides. A general inspection of visible floor structure was conducted. Insulation was not pulled down unless it was a plumbing penetration or in areas where a stoop or deck was connected.

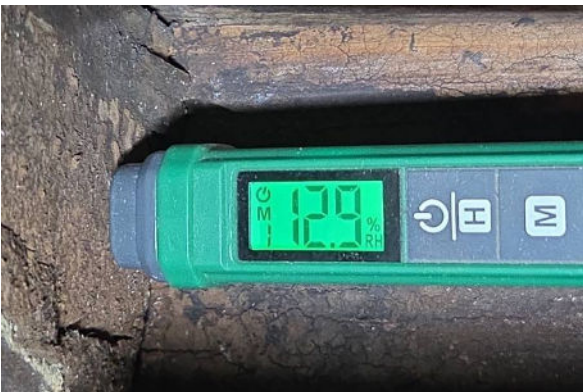
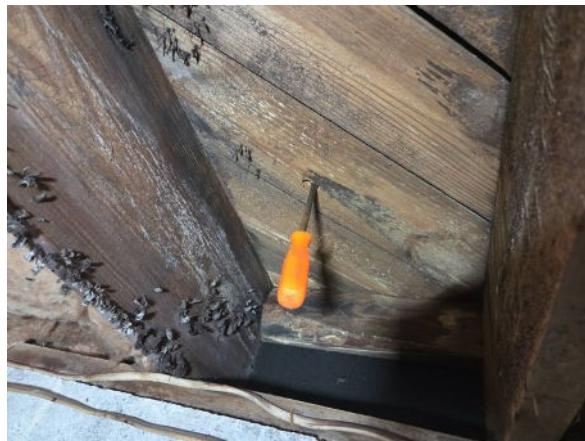
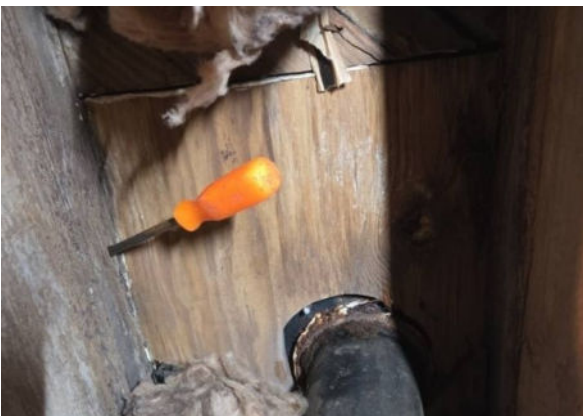
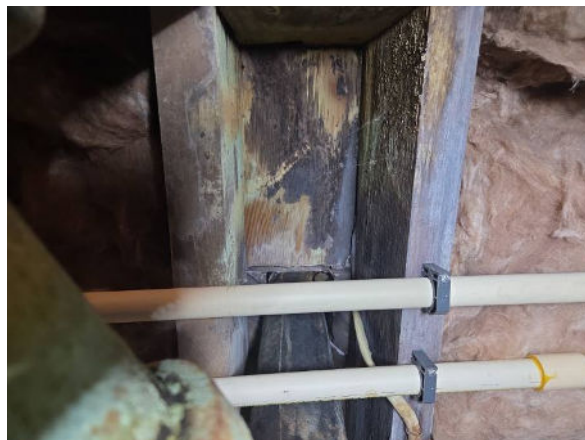
68: Some floor joist(s) and sheathing were deteriorated possibly from previous water leaks. These areas appeared too be dry at the time of inspection.

s-68: Some floor joist(s) and sheathing were deteriorated possibly from previous water leaks. These areas appeared too be dry at the time of inspection.

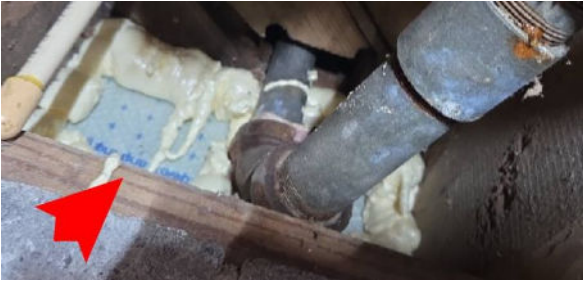
71: Foundation vents have been sealed off
