# **Inspection Report**

# **Company Name Sample Report**

1234 Main Street Central VA 12345

**Burgess Inspections, Inc**

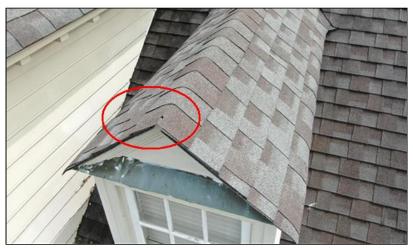
1.0 Item 4(Picture)

(4) There was a damaged ridge shingle noted over the roof dormer at Southside Insurance and over the rear gable end.

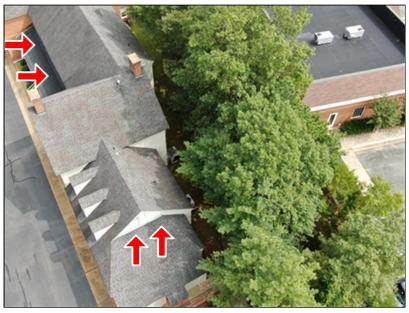
1.1 Item 3(Picture)

(2) Moisture damage and staining was noted under the gutters that terminate against the siding. Install kick out flashing to help prevent moisture from overloading the gutter and running down the exterior wall.

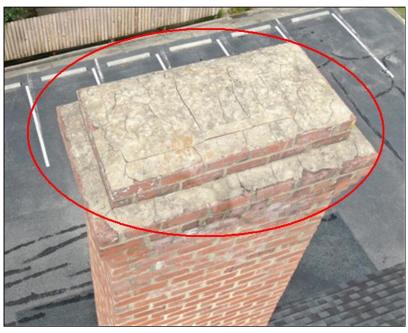
1.2 Item 1(Picture)

[2] (1) The crown on all chimney caps are deteriorated and cracked. Have a qualified mason to repair all chimney caps as needed. Refer to photos for examples.

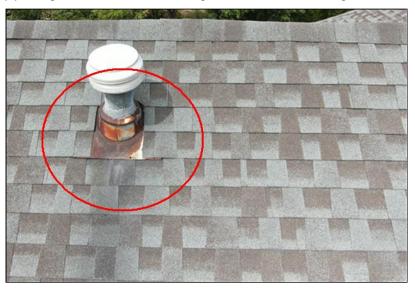
1.2 Item 3(Picture)

(2) The gas flue vents and flashings at the roof showed significant rusting. Refer to photos for examples.

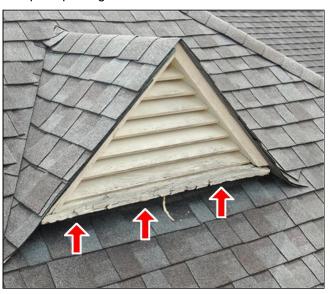
2.0 Item 4(Picture)

(3) Wood rot noted at the trim on a couple of attic ventilation dormers. The remaining dormers show bare wood in areas from paint peeling.

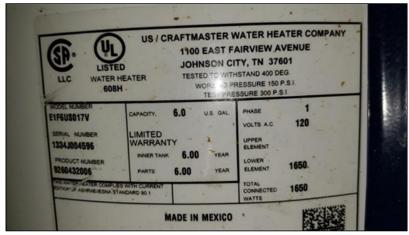
4.2 Item 2(Picture)

Missing pressure relief line. Have a qualified company install pressure relief line and terminate it at the exterior of the building (pointing downwards within 6 inches of the ground).

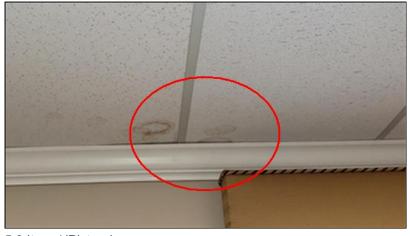
5.0 Item 1(Picture)

Ceiling tile moisture stain noted in rear right office. It appears it may be caused by bathroom exhaust duct located directly above the stain.

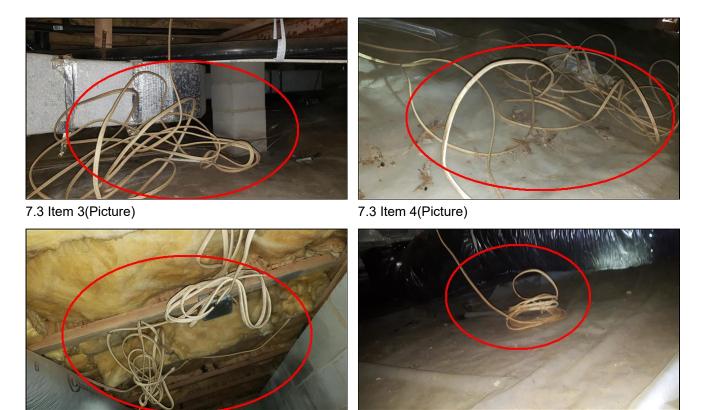
7.3 Item 5(Picture) 7.3 Item 6(Picture)

There was excess electrical wire noted throughout the crawlspace at multiple locations that was not properly terminated. Have a licensed electrical contractor remove all unused wire and properly terminate all wiring that is in use.
