## Confidential Inspection Report

Property Address:  
123 Main St  
Richmond, VA 23236

Tuesday, August 30, 2022  
John Maxwell  
123 Main St  
Richmond, VA 23236

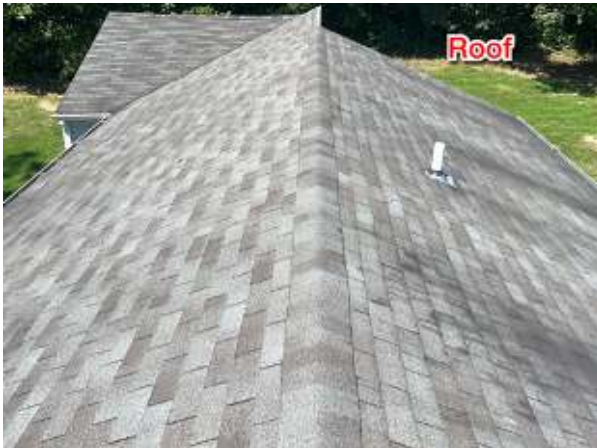
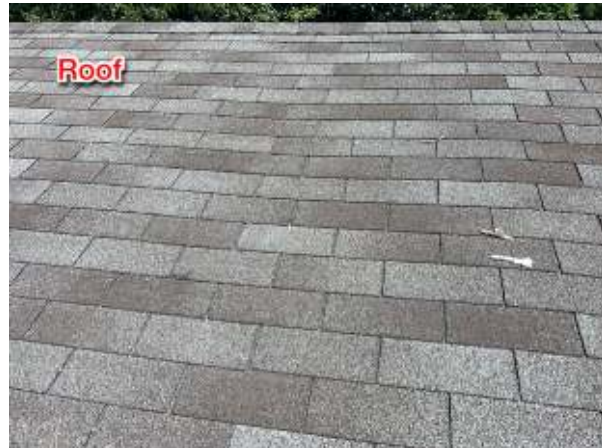
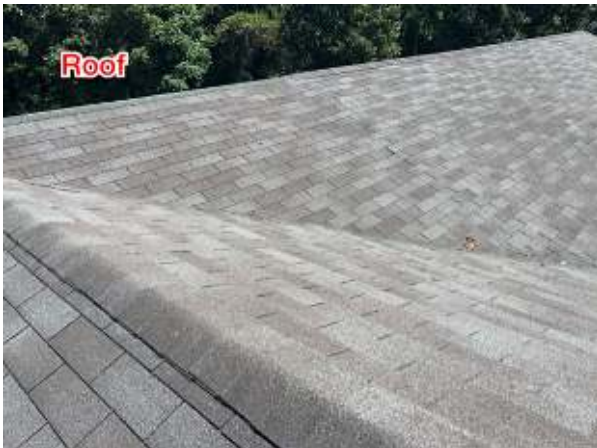
**8:** Cracked/damaged shingles at the right gable end of the roof.

**s-8:** Cracked/damaged shingles at the right gable end of the roof.

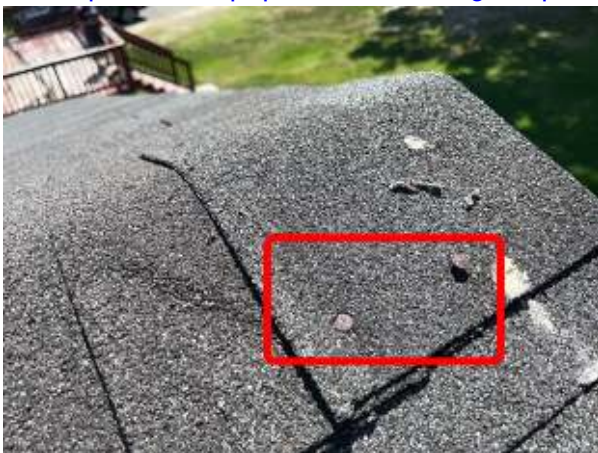
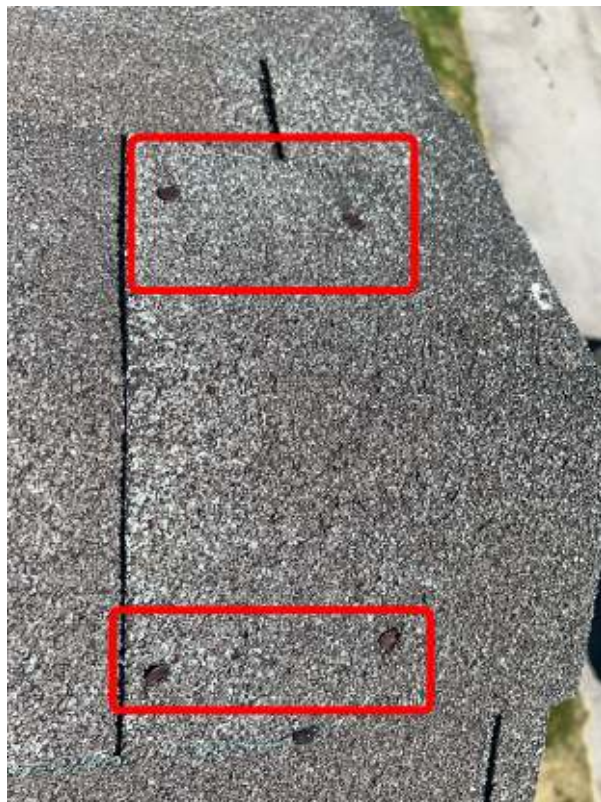
10: Exposed nail pops at several ridge caps.

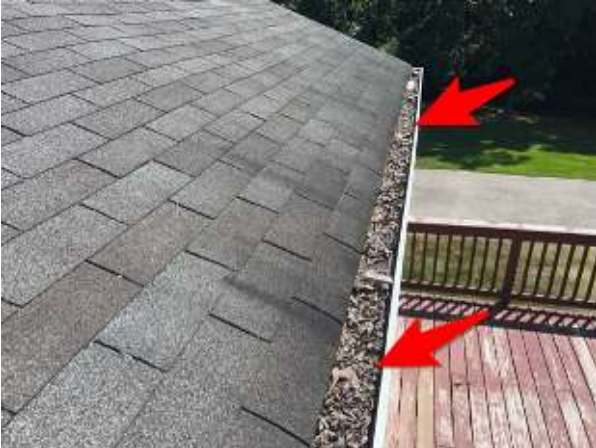
**21:** The gutters were full of debris and need to be cleaned.

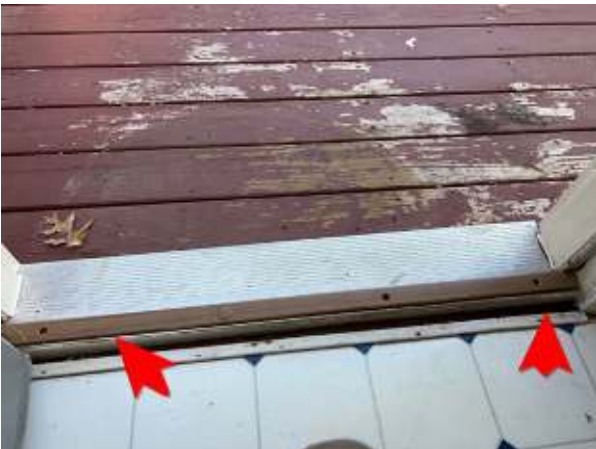
**22:** The back door threshold is loose. Also, the flooring below appeared to have minor rot.

**s-22:** The back door threshold is loose. Also, the flooring below appeared to have minor rot.

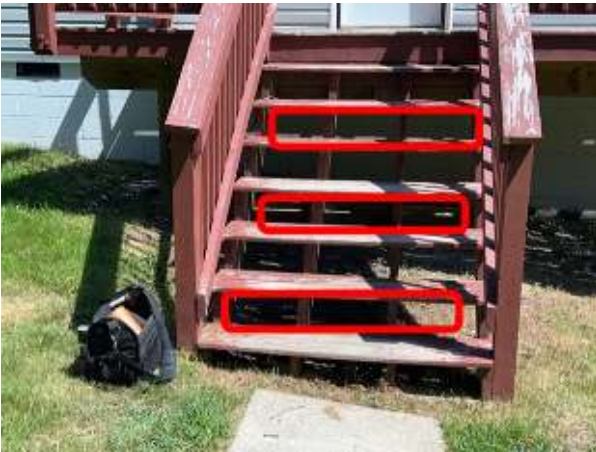
**23:** The front and rear stairs had an open riser, creating openings under each step. The openings exceeded the 4-inch space rule. The maximum space allowed will not let a 4-inch object pass through the area.

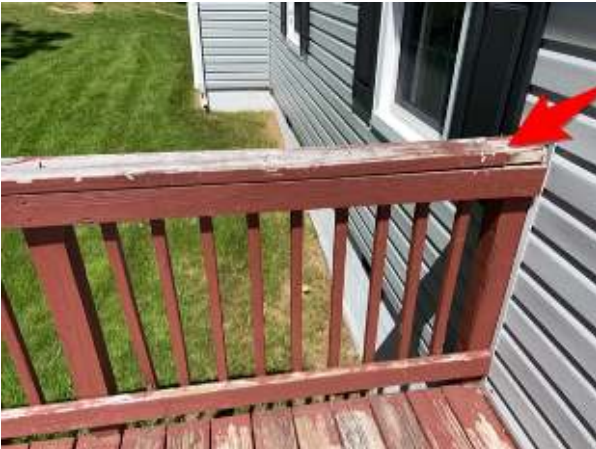
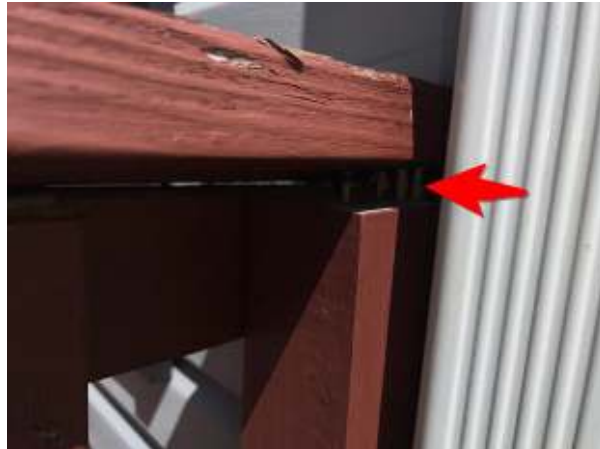
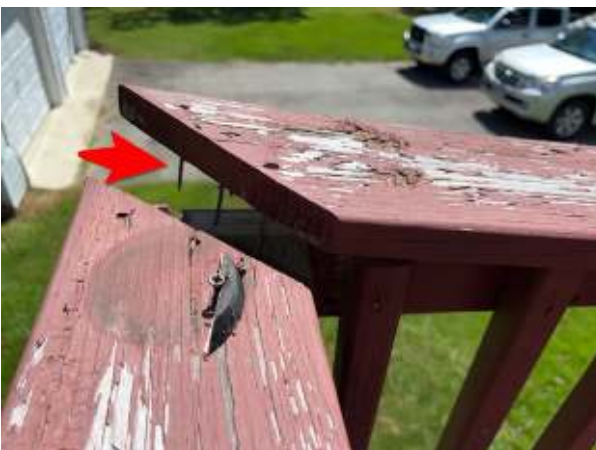
**24:** The back deck top rails were warped and loose.

**s-24:** The back deck top rails were warped and loose.

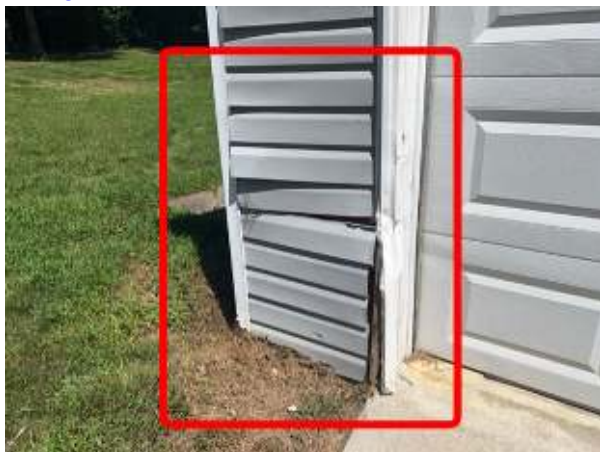
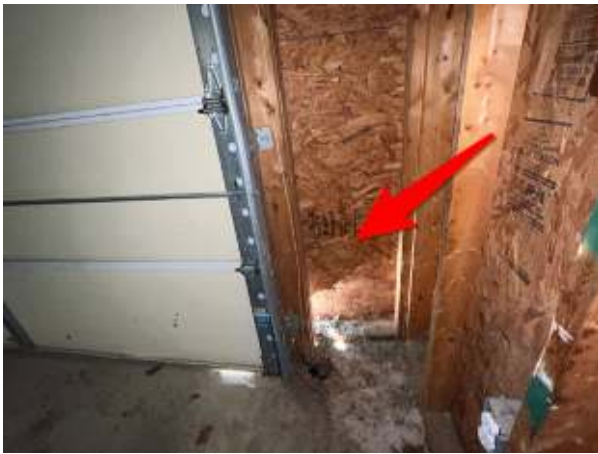
30: The front left corner of the garage has been damaged. The garage door frame has been compromised along with the front left wall.

**s-30:** The front left corner of the garage has been damaged. The garage door frame has been compromised along with the front left wall.

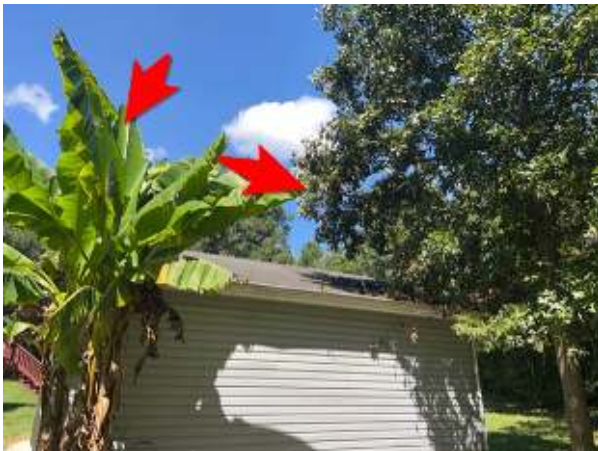
**31:** Recommend cutting back tree limbs hanging over and on the detached garage roof.

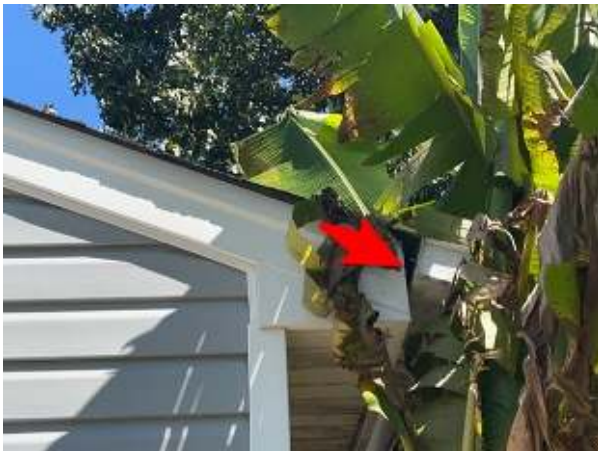
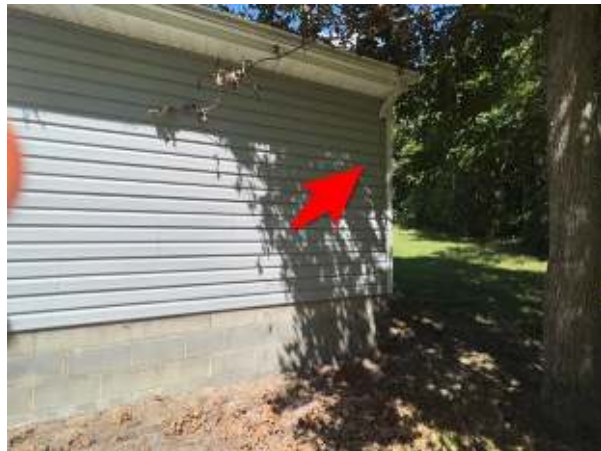
**32:** Missing downspout at the back right corner of the detached garage. Also, the gutter is pulling away from the fascia at the right front corner of the garage.

**s-32:** Missing downspout at the back right corner of the detached garage. Also, the gutter is pulling away from the fascia at the right front corner of the garage.

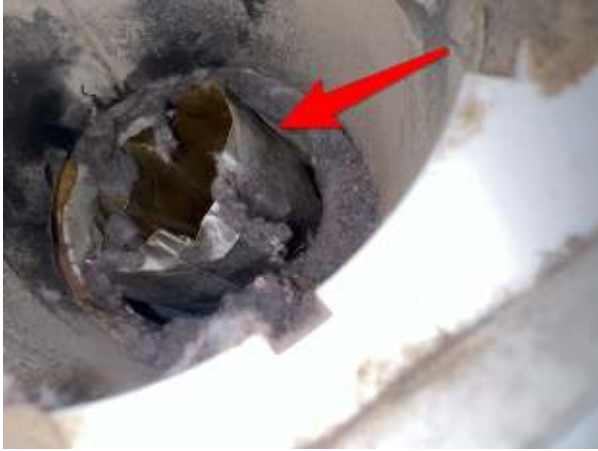
**42:** The dryer duct is terminated inside the wall cavity and needs to terminate to the exterior.

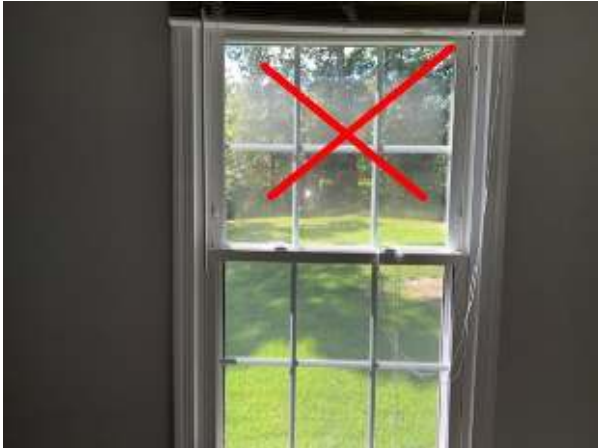
49: Failed thermal seal in the left front room window upper sash.

**s-49:** Failed thermal seal in the left front room window upper sash.

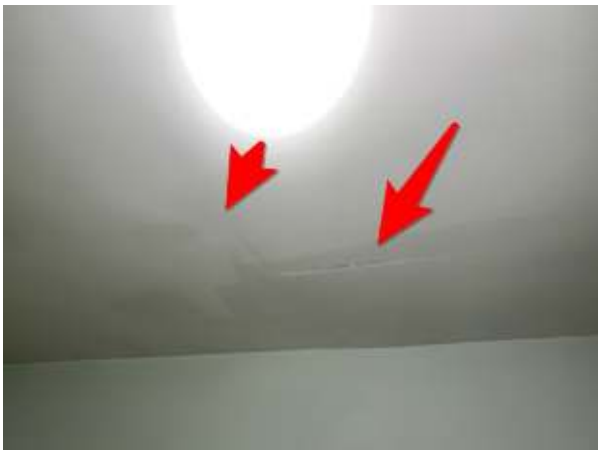
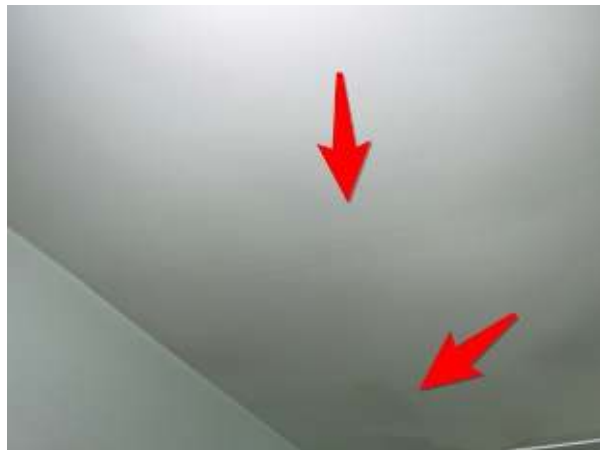
52: Water stains noted on the addition ceiling. These stains appear to be from the leaking occurring in the attic where the roof is installed improperly mentioned in the roof section.

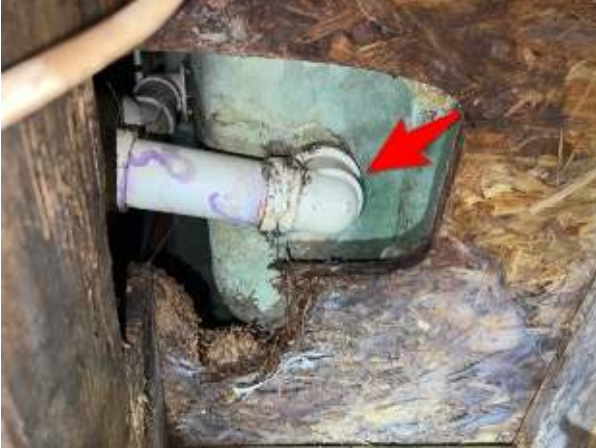
64: The hallway bathroom tub/shower drain is leaking visible in the crawl space.

**s-64:** The hallway bathroom tub/shower drain is leaking visible in the crawl space.

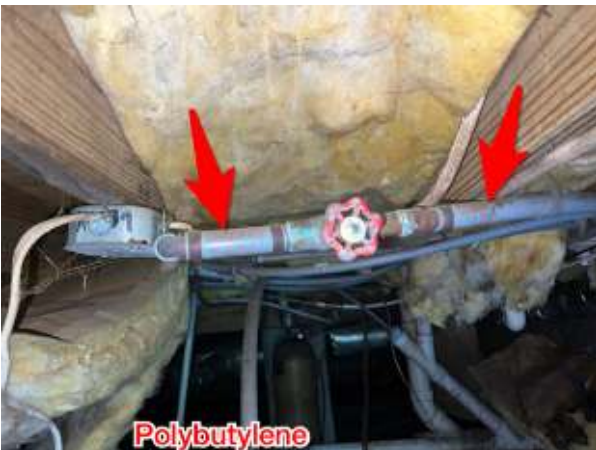
65: Most of the supply pipes for the house were plastic. It is beyond the scope of this inspection to determine what type of pipes you have. Some types have been known to prematurely fail. Polybutylene is one type that has a higher rate of failure than some others. If you have any questions or concerns about this, we recommend that you have them further evaluated by a qualified person.

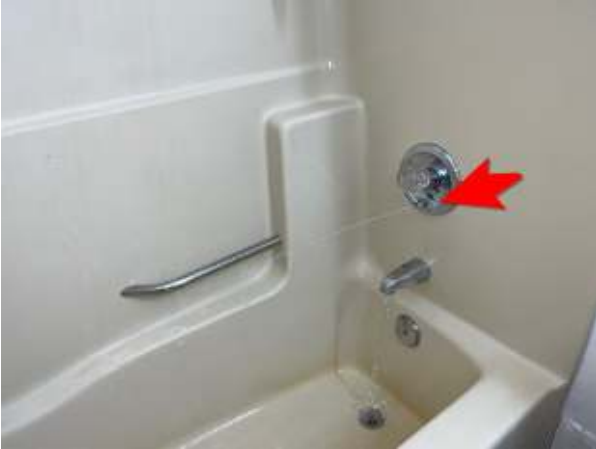
66: The hallway bathroom tub/shower diverter is leaking and needs to be replaced.

**s-66:** The hallway bathroom tub/shower diverter is leaking and needs to be replaced.

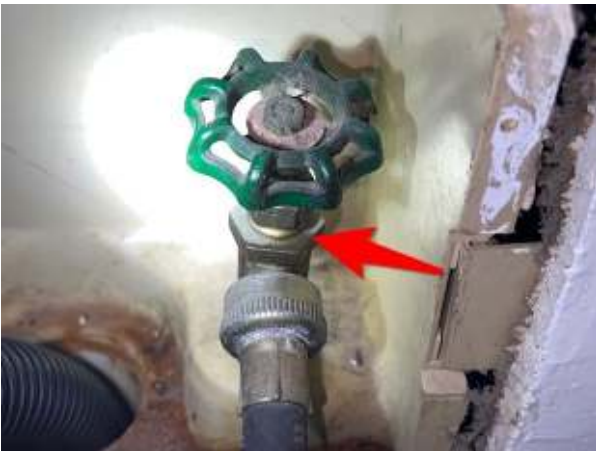
67: The cold water valve to the washing machine is leaking.

**s-67:** The cold water valve to the washing machine is leaking.

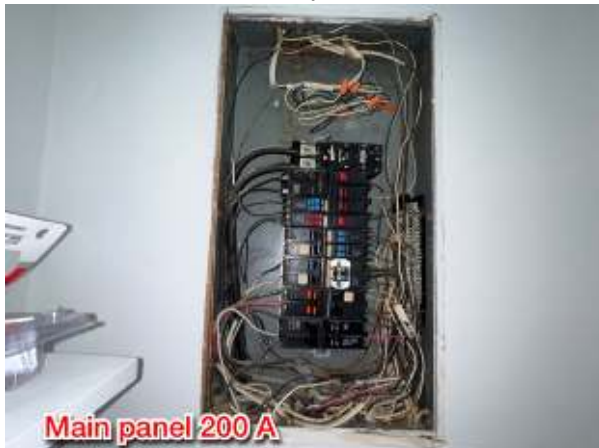
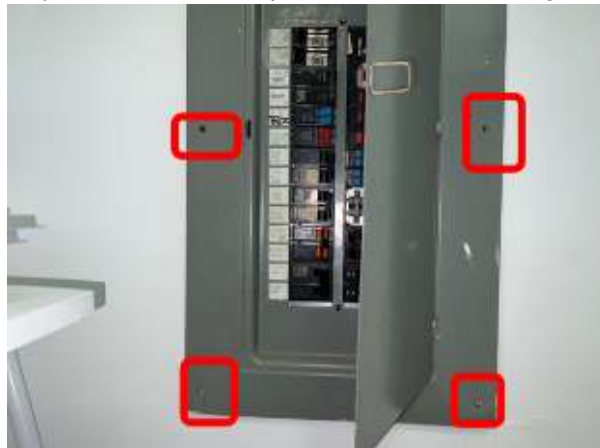
80: The main electrical panel is located in the laundry room. Also, the panel cover is missing fasteners.

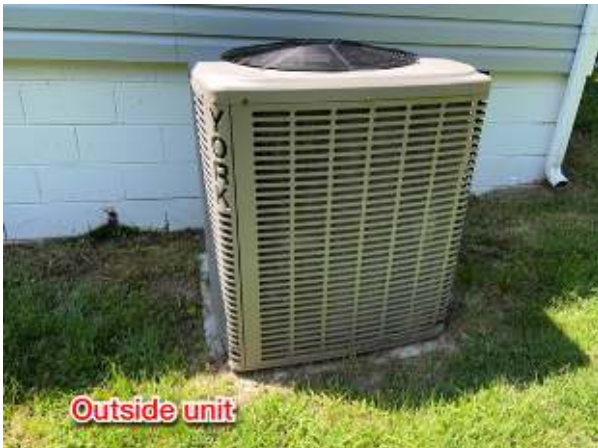
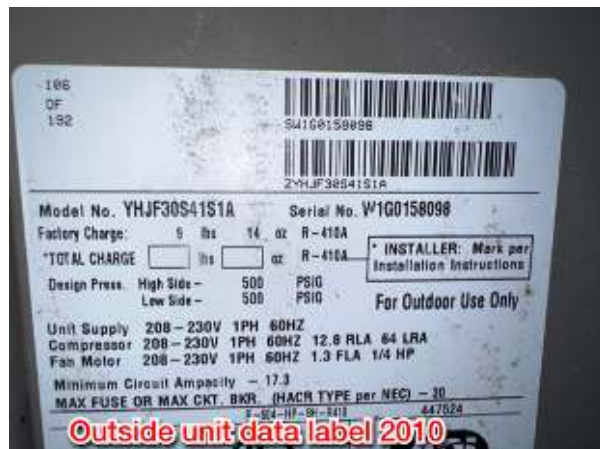
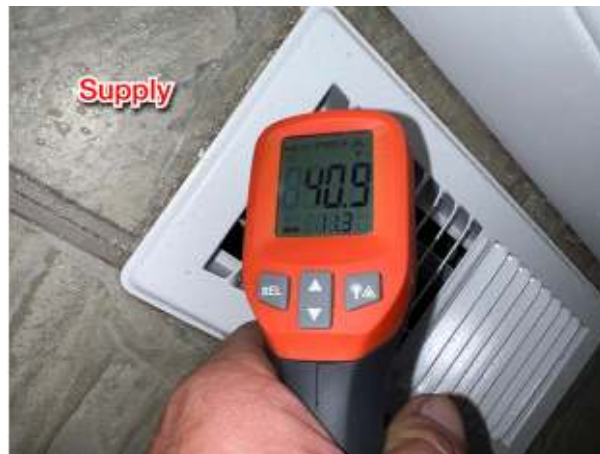
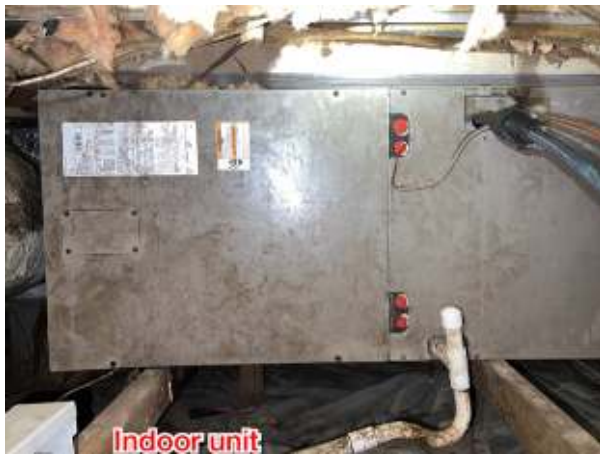
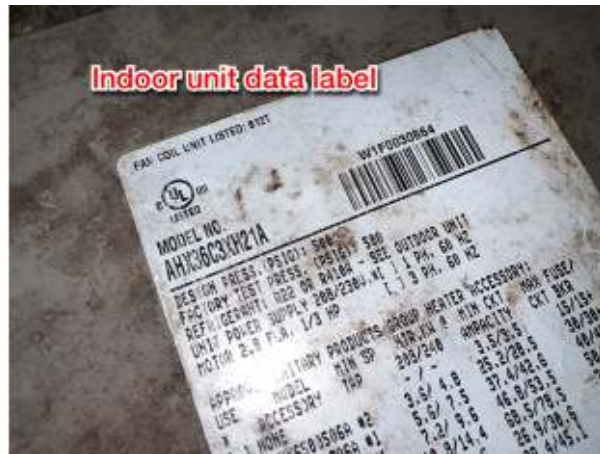
**90:** The heat pump was cooling adequately at the time of inspection. The filter was dirty and needs to be replaced.

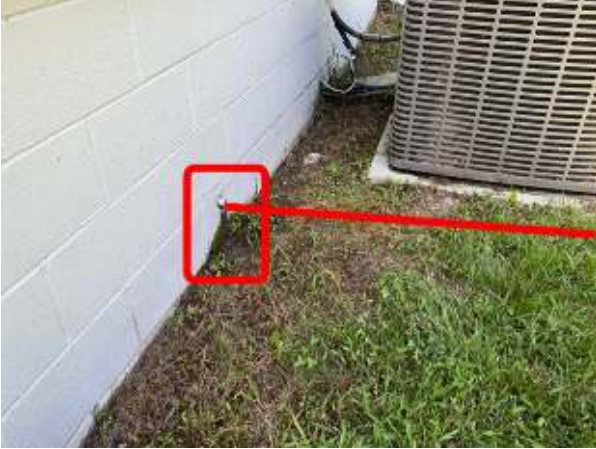
**92:** Recommend extending the condensation drain line further away from the foundation.

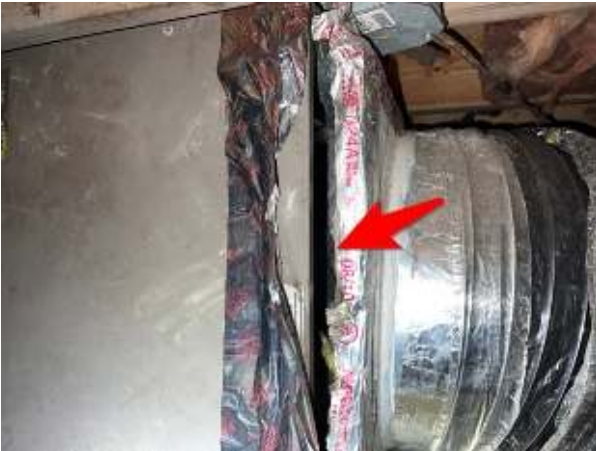
**93:** The indoor unit coils are dirty and need to be cleaned. Also, the cover to the air handler is losing air and needs to be sealed properly.

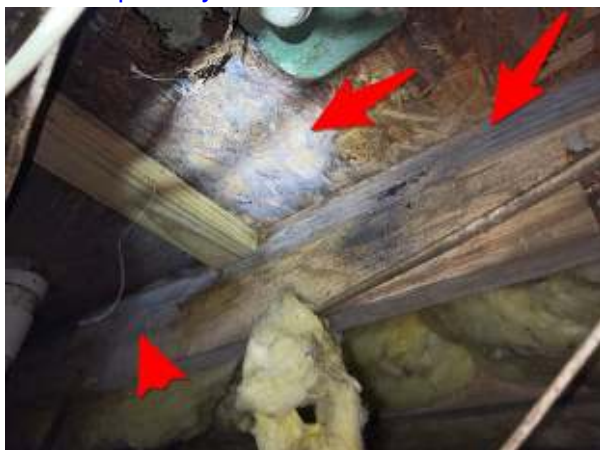
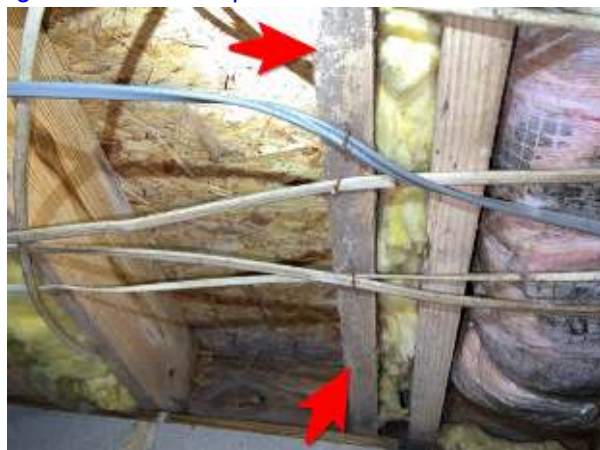
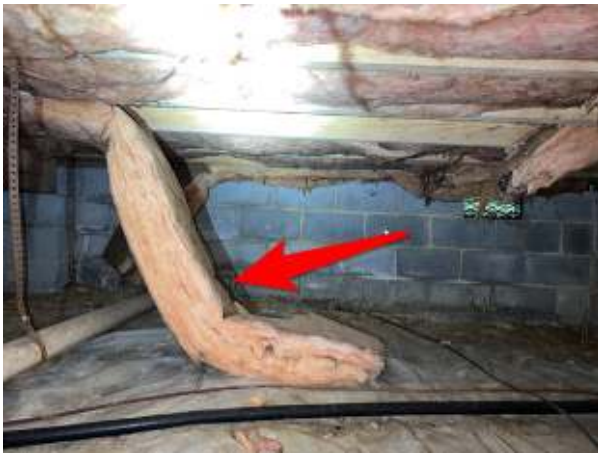
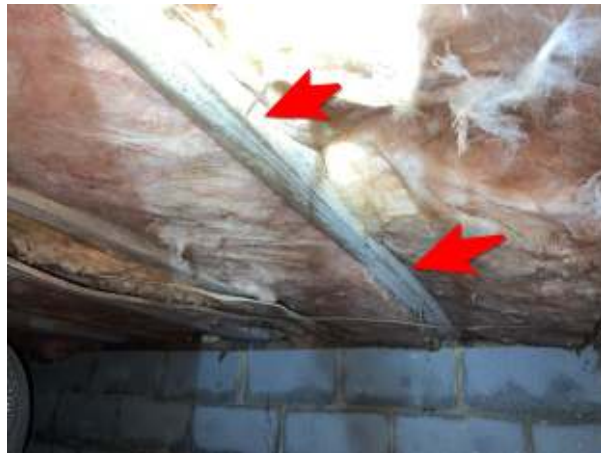
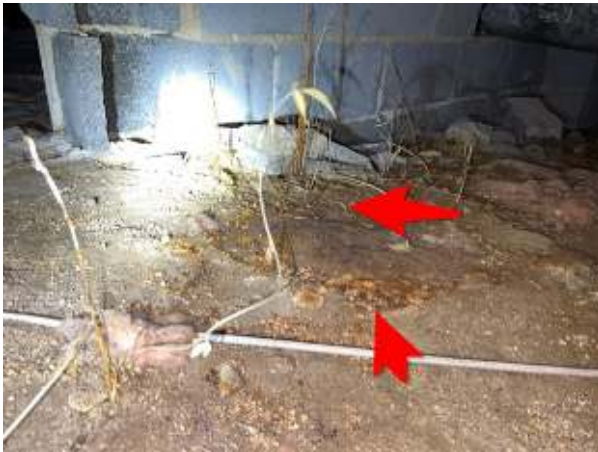
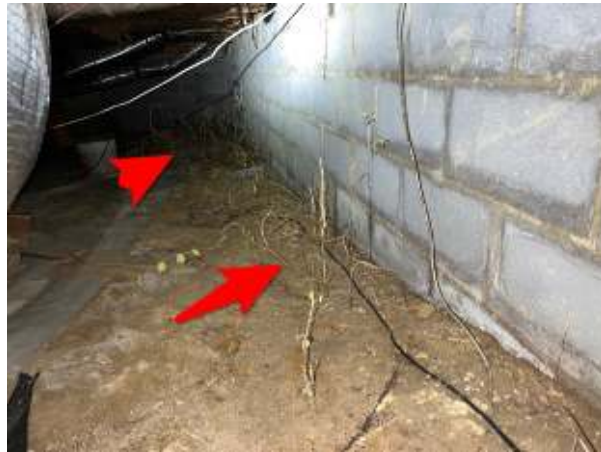
**104:** In the crawl space, there was a higher than normal level of fungi on the joists and ground. The insulation was feathered/hanging which is a sign of moisture. The vapor barrier was missing in many areas especially around the foundation walls. The ground was damp in these areas.

**s-104:** In the crawl space, there was a higher than normal level of fungi on the joists and ground. The insulation was feathered/hanging which is a sign of moisture. The vapor barrier was missing in many areas especially around the foundation walls. The ground was damp in these areas.
