## Confidential Inspection Report

Property Address:  
8484 Anystreet Rd  
Richmond, VA 23236

Inspector Dan  
State License: 3380001234 NRS 12/20/2026  
Burgess Inspections  
530-C Southlake Blvd  
N Chesterfield, VA 23236  
(804) 794-1423

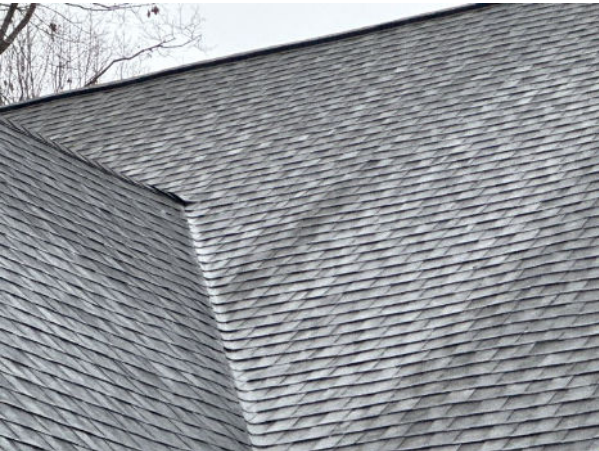
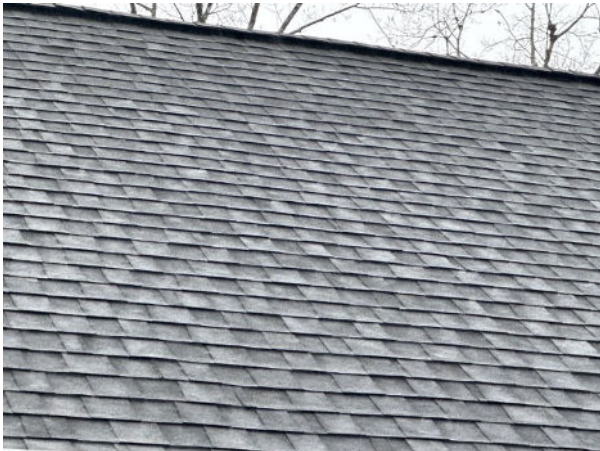
7: The roof covering was in good condition.

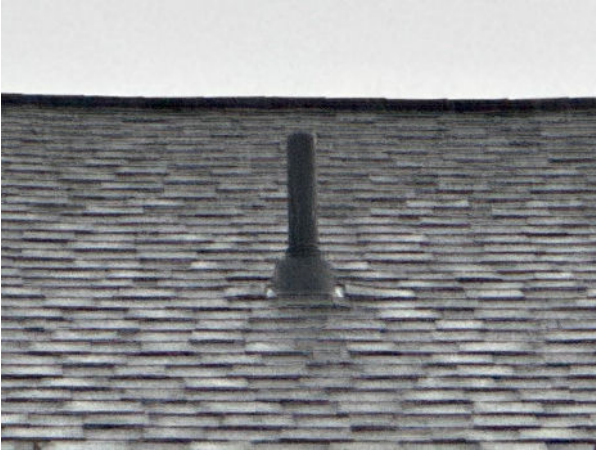
9: The plumbing vent pipe boots/seals were in good condition.

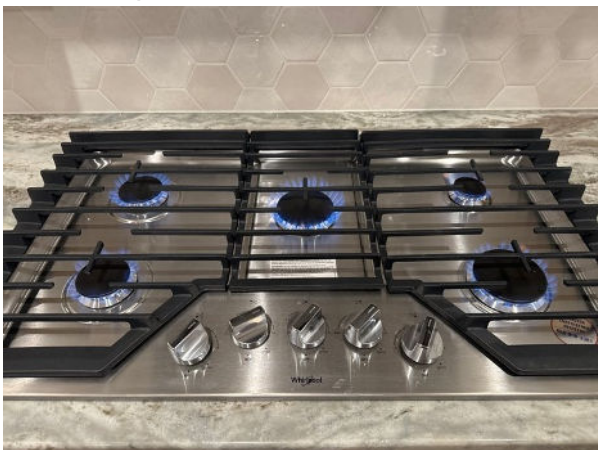
**28:** All of the burners and the oven were turned on. All ignited and adjusted correctly at the time of the inspection.

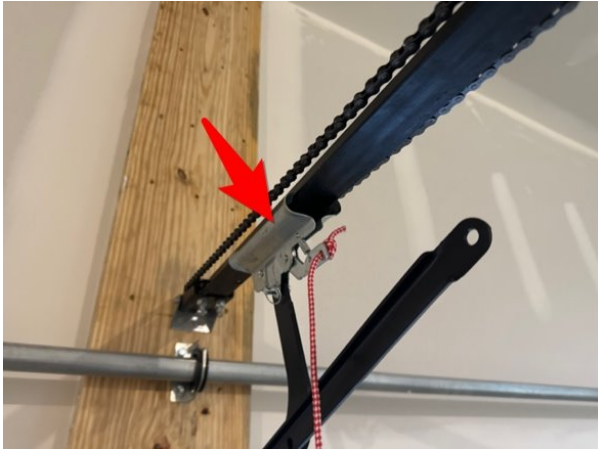
**43:** The garage door would not open when the operator was engaged. The track appeared to be bent, causing the attachment to fall off track.

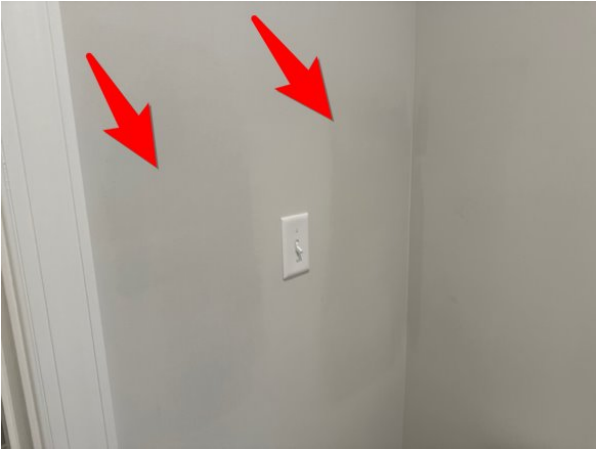
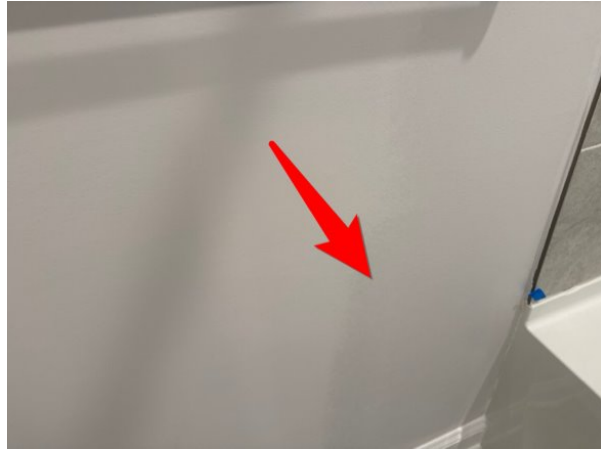
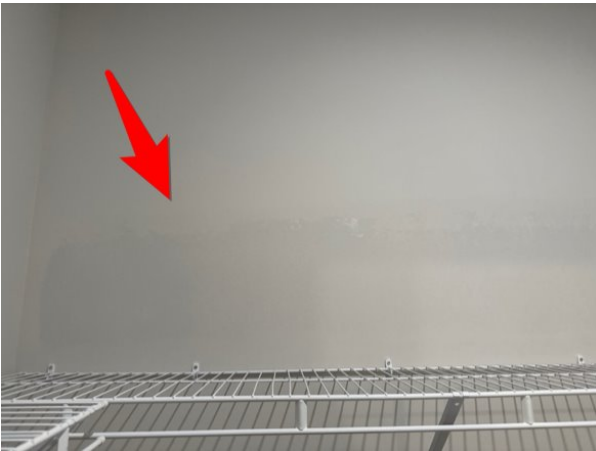
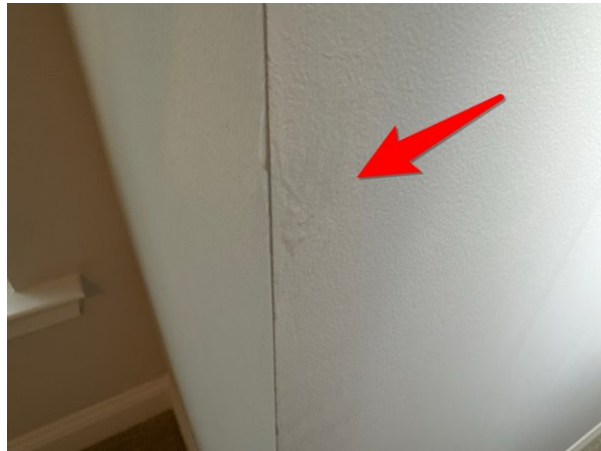
**47:** The walls in the downstairs jack and Jill bathroom and bedroom had areas where the paint was blistering and needs corrected.

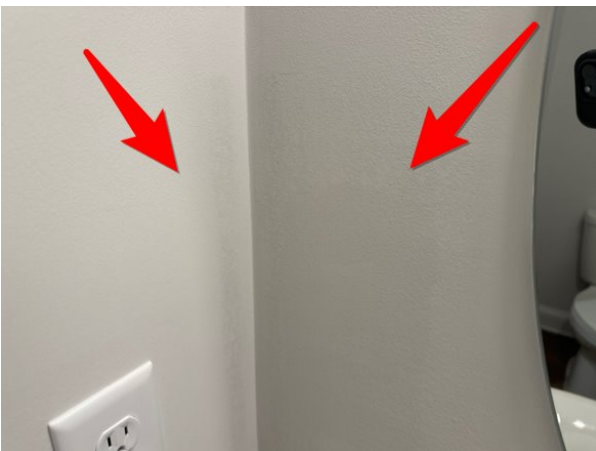
**48:** The walls in the downstairs hallway bathroom had areas that were blistering and should be corrected.

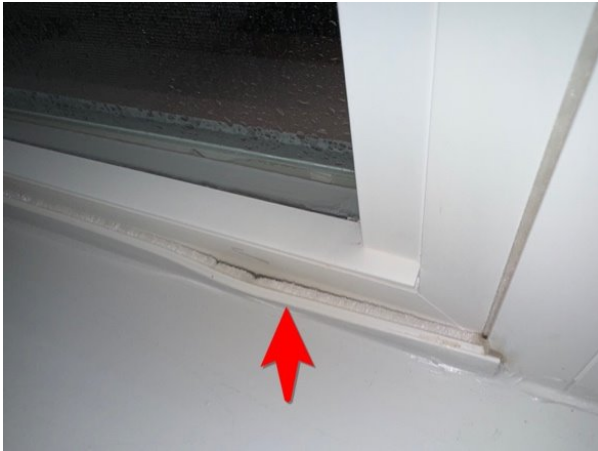
49: Damaged window rail on the interior of the sill in the downstairs front right bedroom.

**s-49:** Damaged window rail on the interior of the sill in the downstairs front right bedroom.

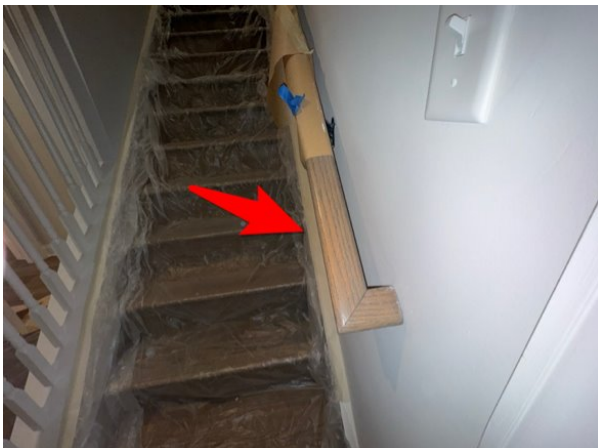
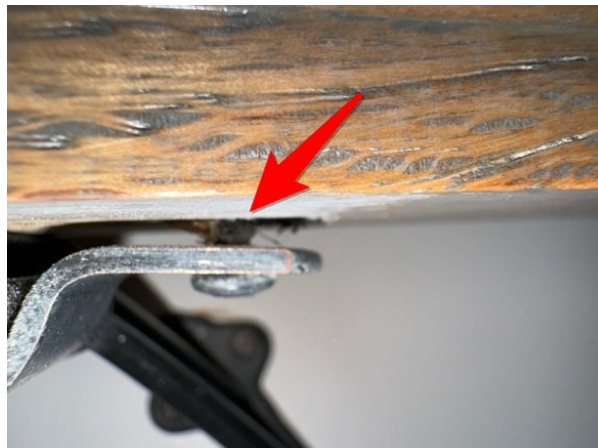
55: The stair bannister was loose.

**s-55:** The stair bannister was loose.

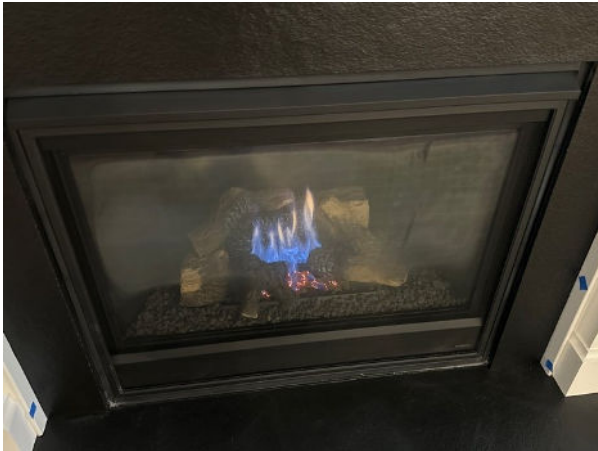
**56:** The gas log kit was operated and came on.

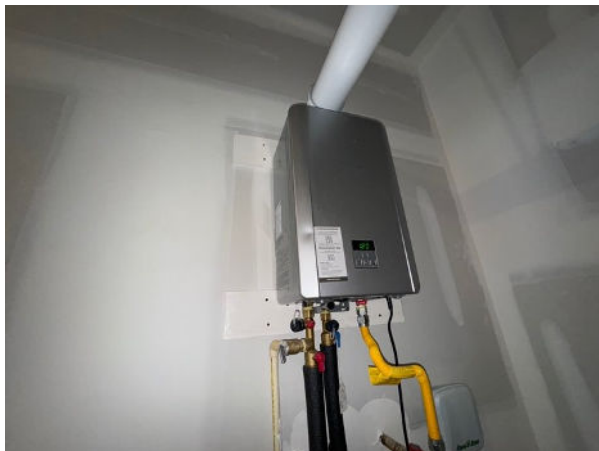
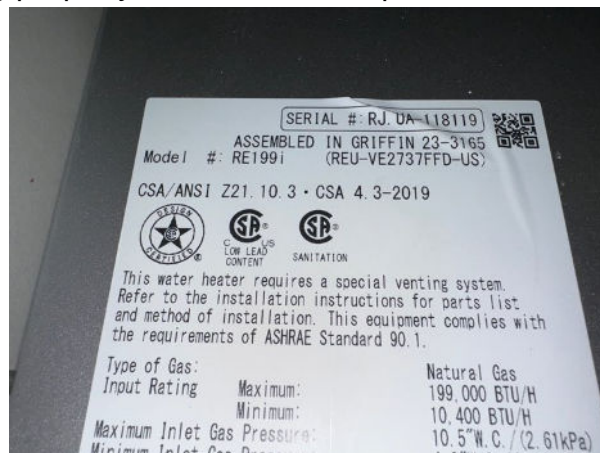
65: The tankless water heater was operating properly at the time of inspection.

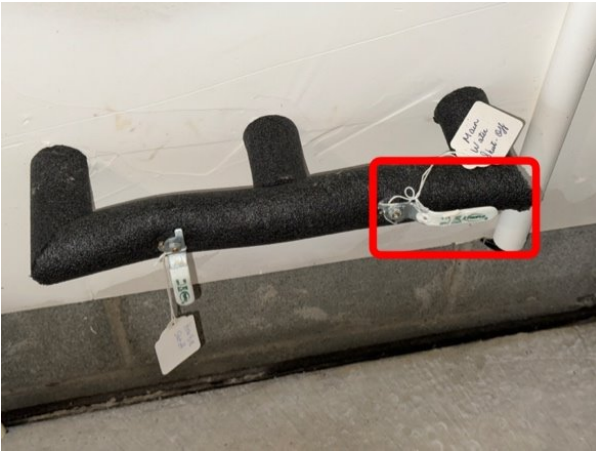
**66:** The main water shut off was located in the garage.

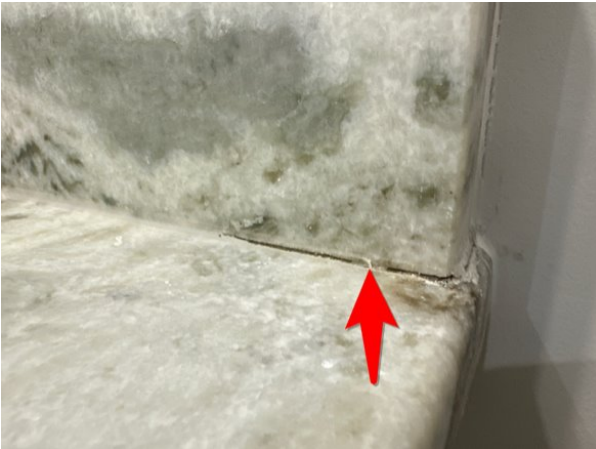
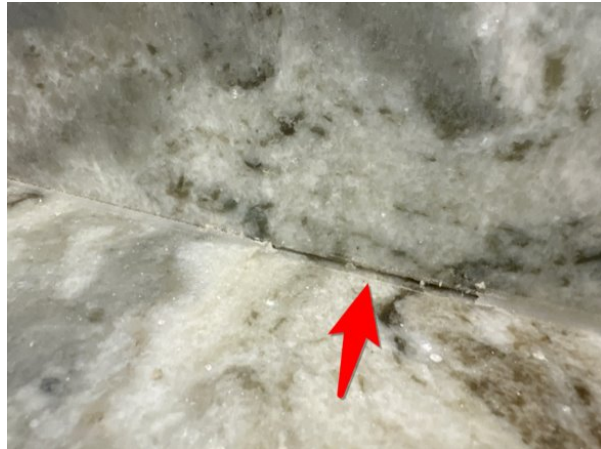
**67:** Missing sealant around the master bathroom sink countertop.

**s-67:** Missing sealant around the master bathroom sink countertop.

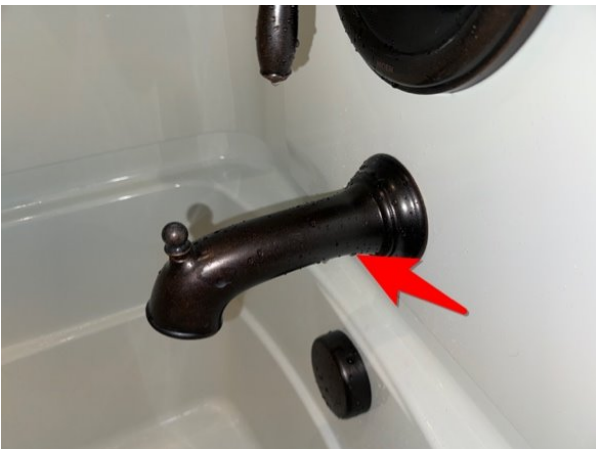
**68:** The upstairs bathroom tub faucet was loose.

**s-68:** The upstairs bathroom tub faucet was loose.

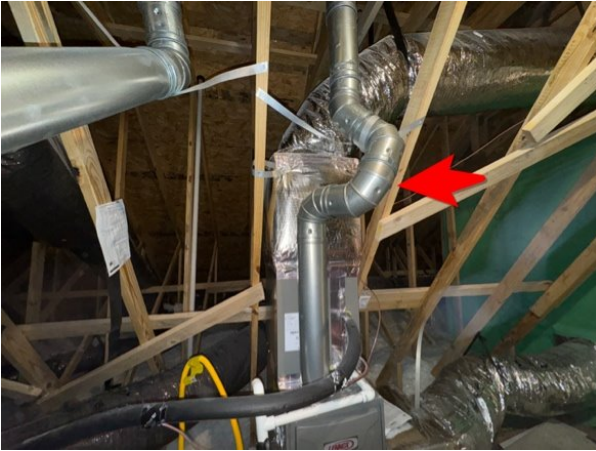
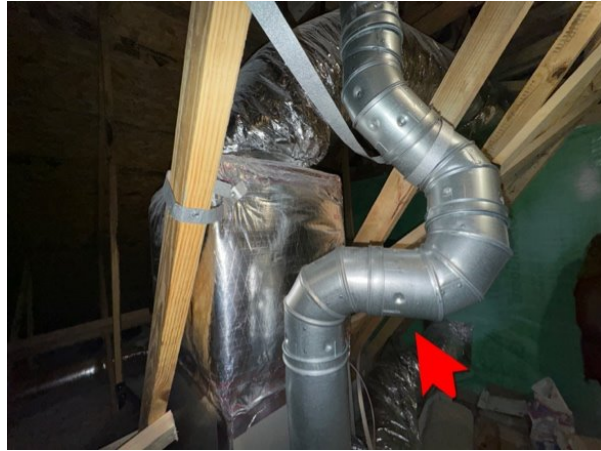
69: The second floor gas furnace vent pipe had a negative grade that needs to be corrected to slope 1/4 inch per foot.

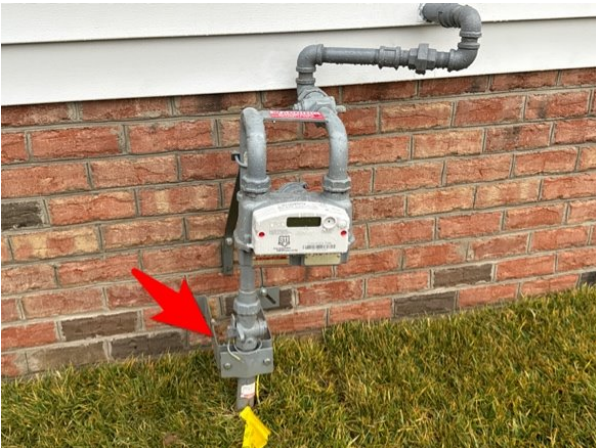
70: The main fuel shut off is located at the gas meter.

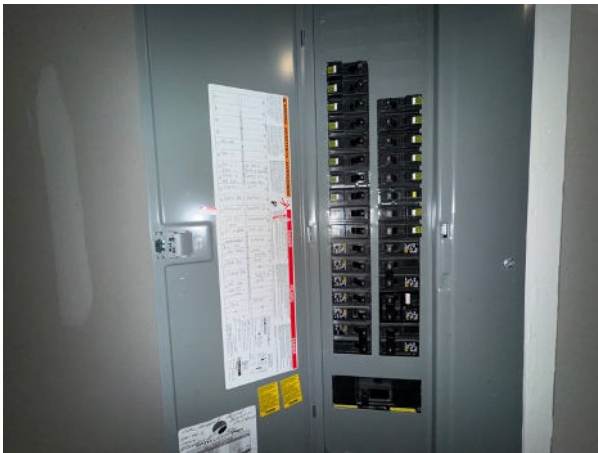
**81:** The main electrical panel was located in the garage.

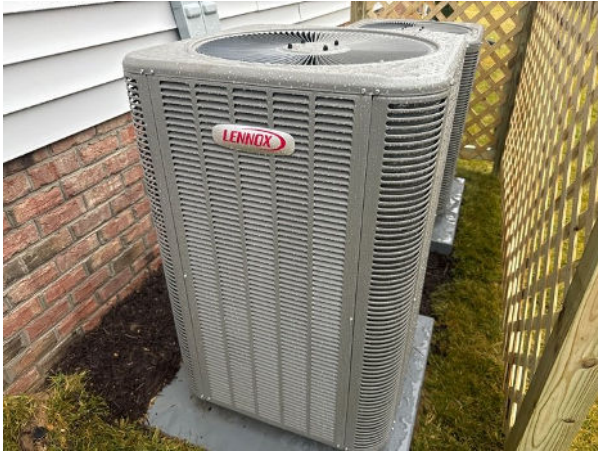
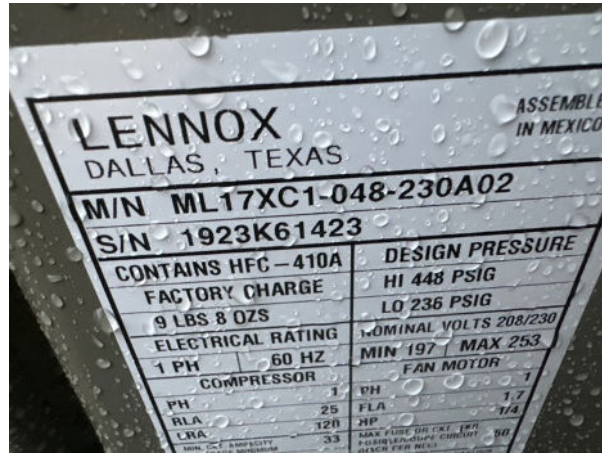
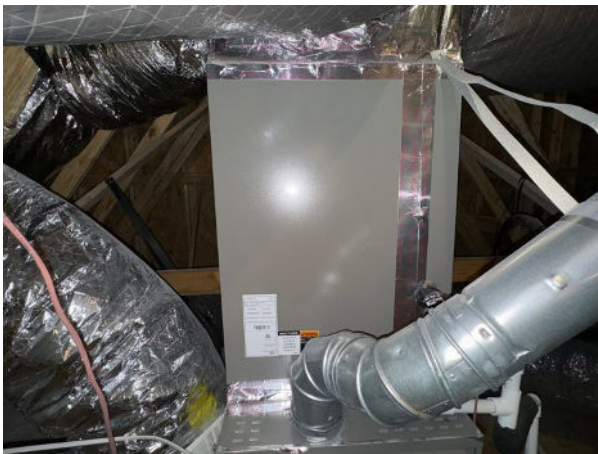
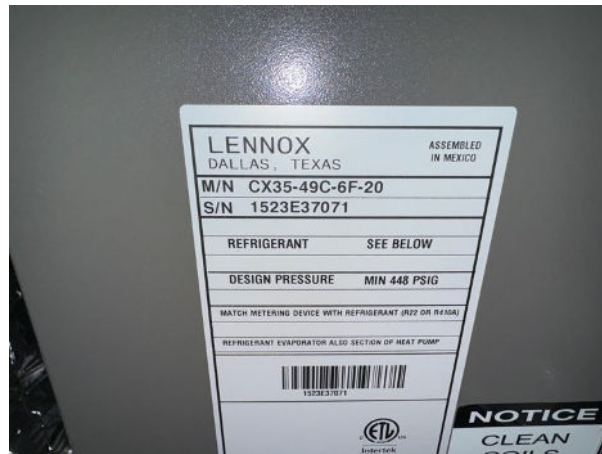
**86:** The temperature was too cool to test the first floor AC. There was a chance that the compressor could be damaged operating the AC unit.

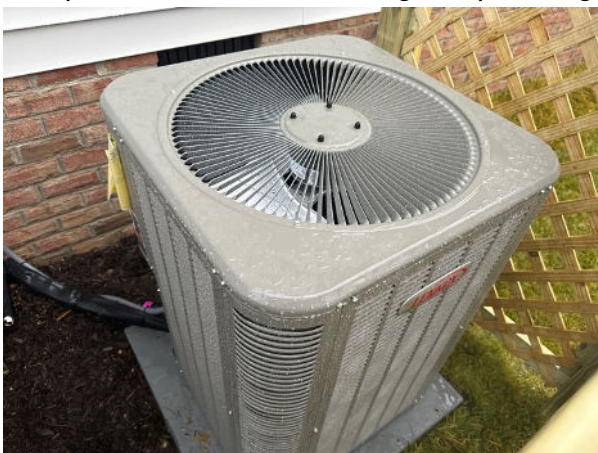
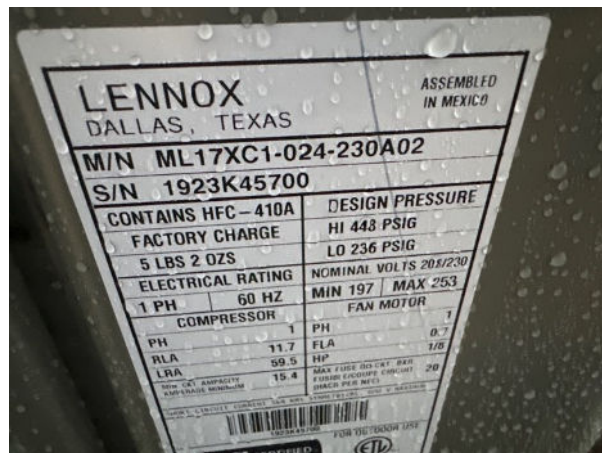
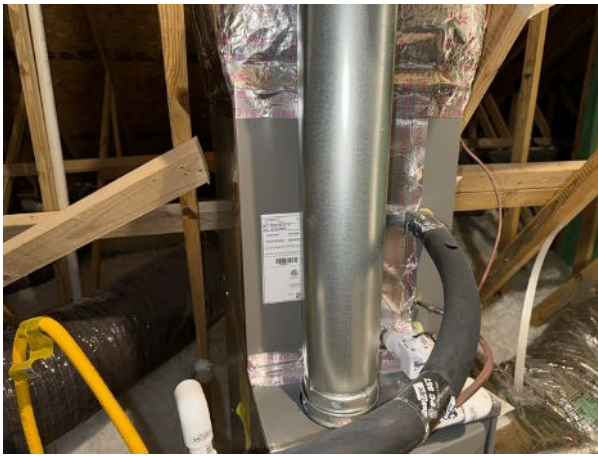
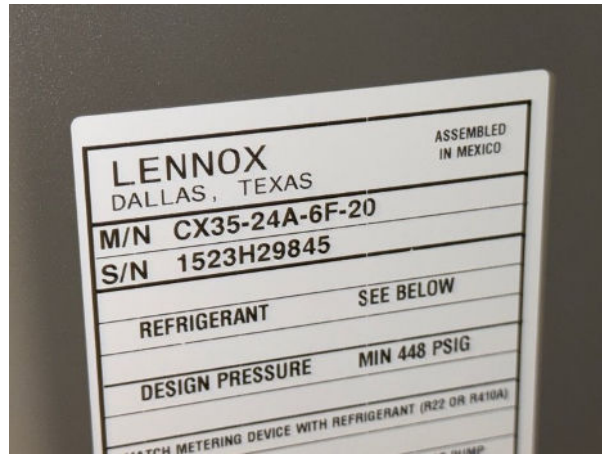
**87:** The temperature was too cool to test the second floor AC. There was a chance that the compressor could be damaged operating the AC unit.

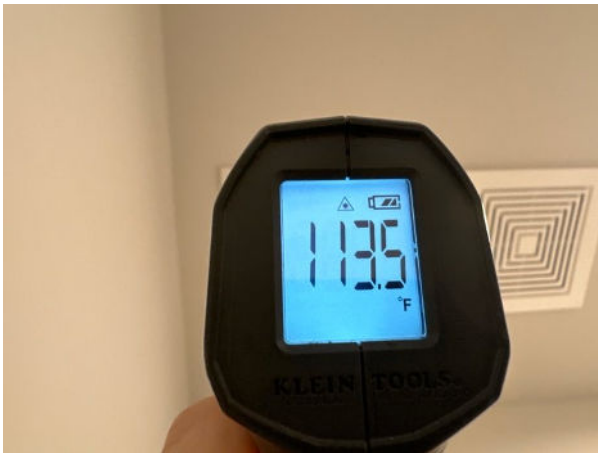
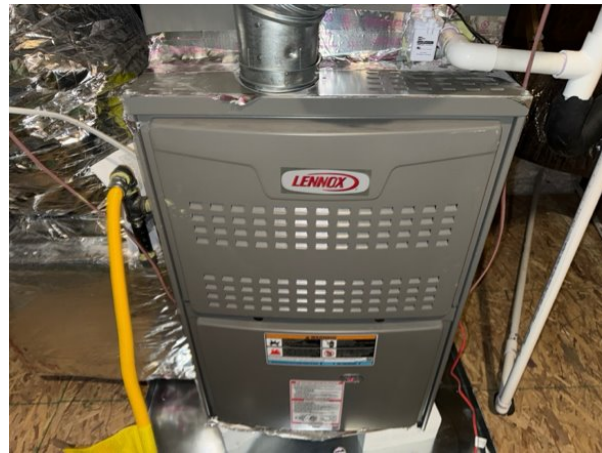
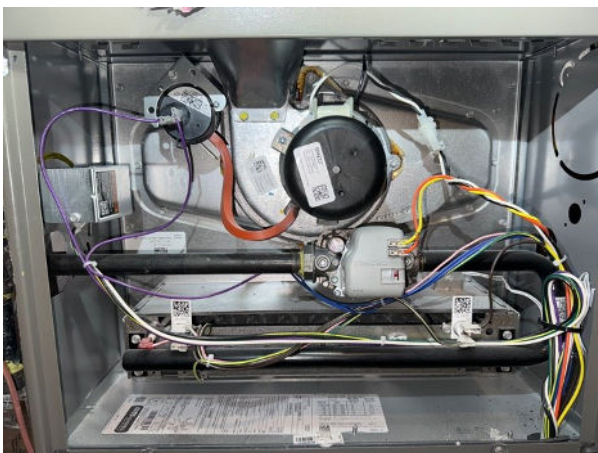
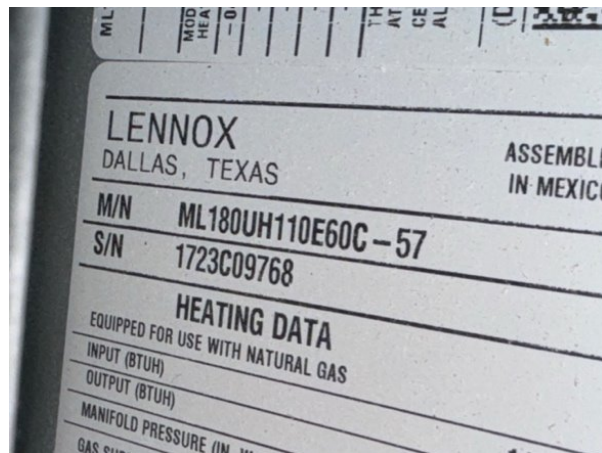
88: The first floor gas furnace was heating adequately at the time of inspection.

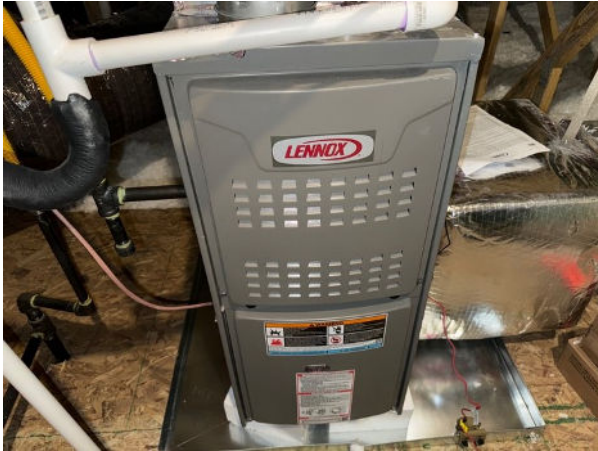
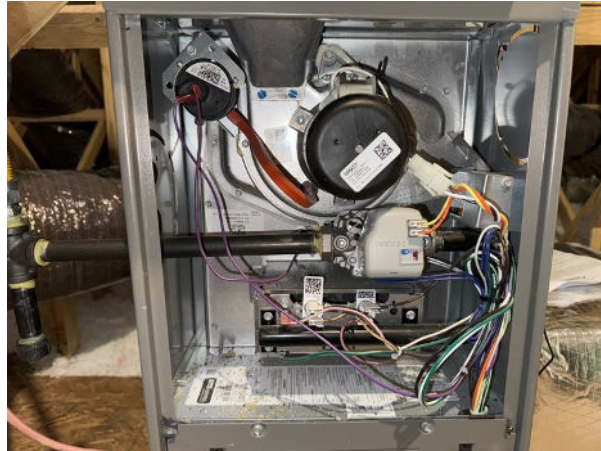
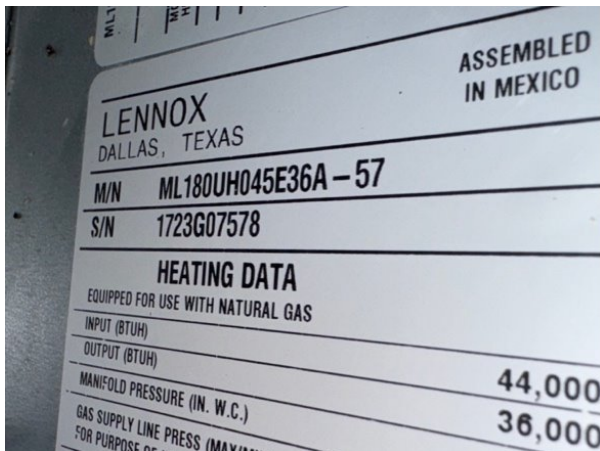
**89:** The second floor gas furnace was heating adequately at the time of inspection.
