# Pre-Drywall Inspection Report

Property Address:  
9876 Richmond St  
Midlothian, VA 23113

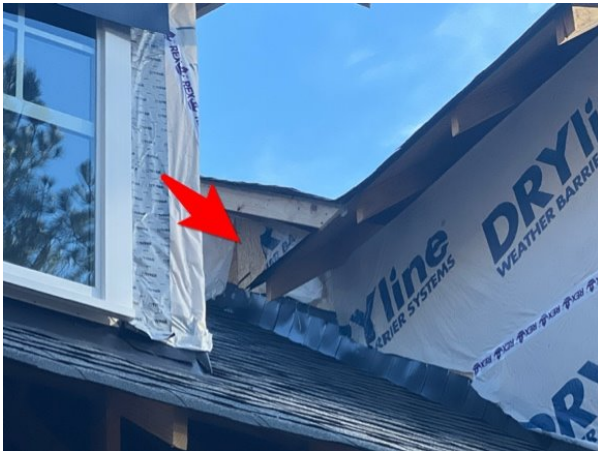
5: Moisture barrier needed at the upper left side of the house.

**s-5:** Moisture barrier needed at the upper left side of the house.

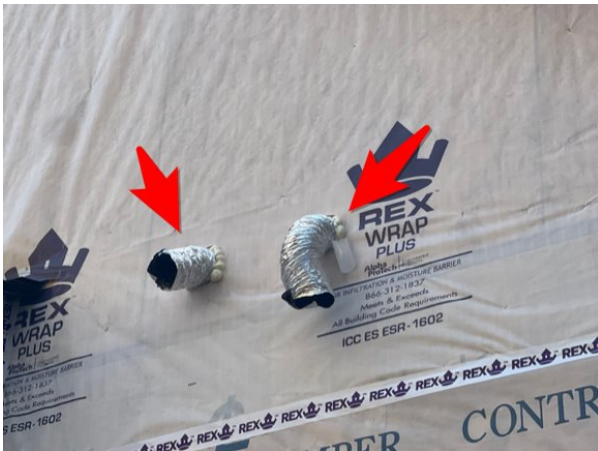
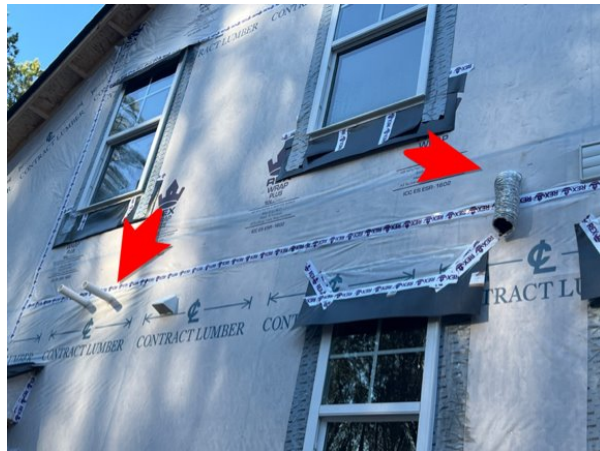
6: Flashing covers needed around exhaust ducts before siding is installed.

**s-6:** Flashing covers needed around exhaust ducts before siding is installed.

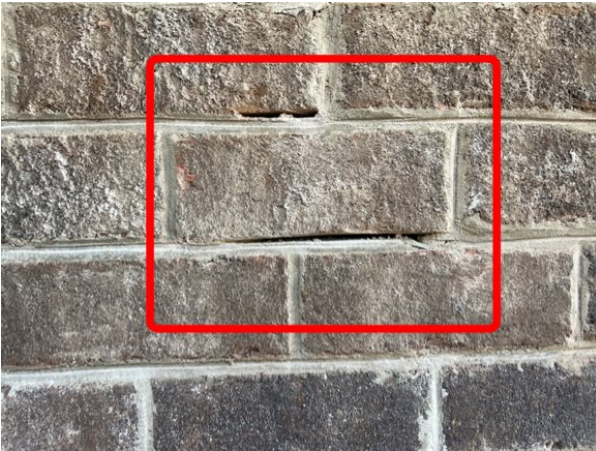
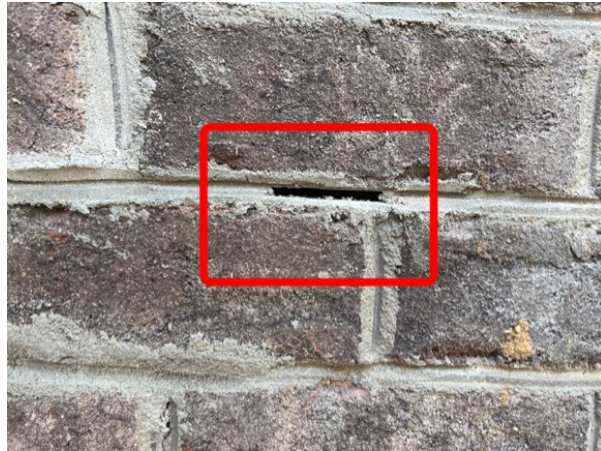
7: Missing mortar noted at the back side of the house near the crawl space opening that needs re-pointed.

**s-7:** Missing mortar noted at the back side of the house near the crawl space opening that needs re-pointed.

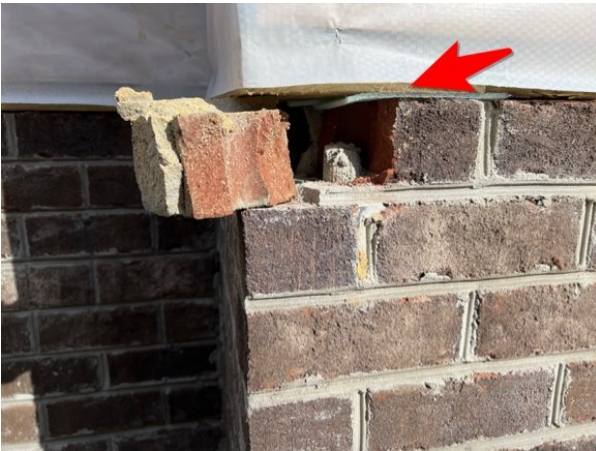
8: Loose/damaged brick at the front side of the house.

**s-8:** Loose/damaged brick at the front side of the house.

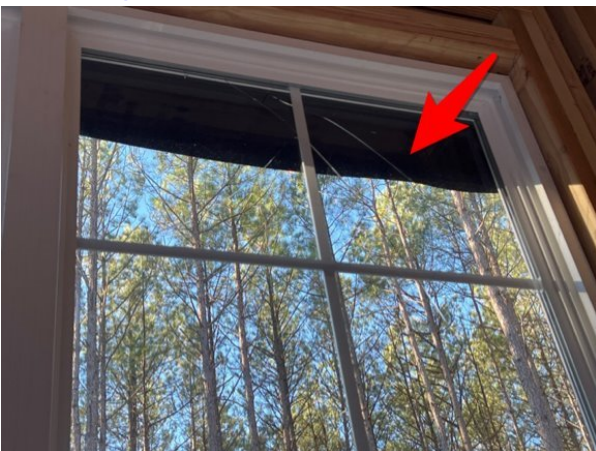
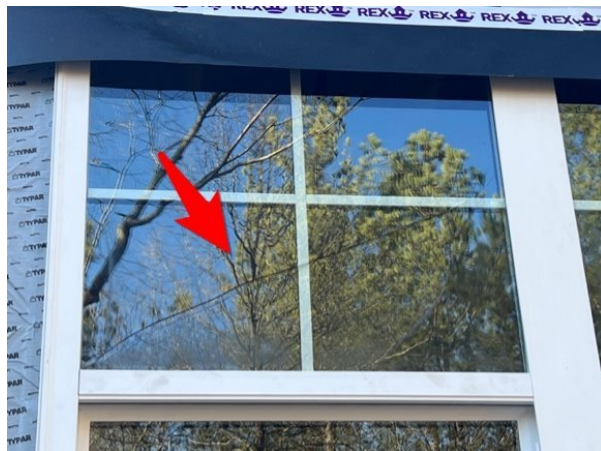
9: A couple cracked windows at the front and rear of the home.

**s-9:** A couple cracked windows at the front and rear of the home.

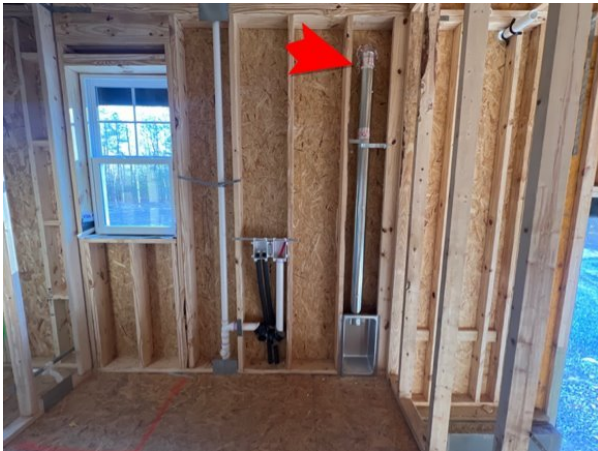
**10:** The dryer duct has been routed up near the top of the wall and out to the exterior. Unable to determine why the duct was not run floor level and out to the exterior.

**s-10:** The dryer duct has been routed up near the top of the wall and out to the exterior. Unable to determine why the duct was not run floor level and out to the exterior.

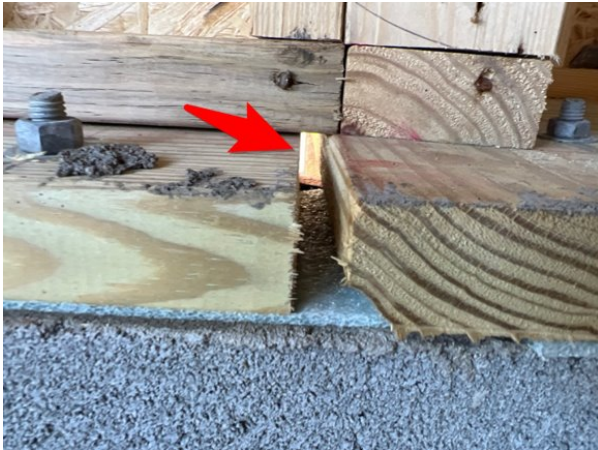
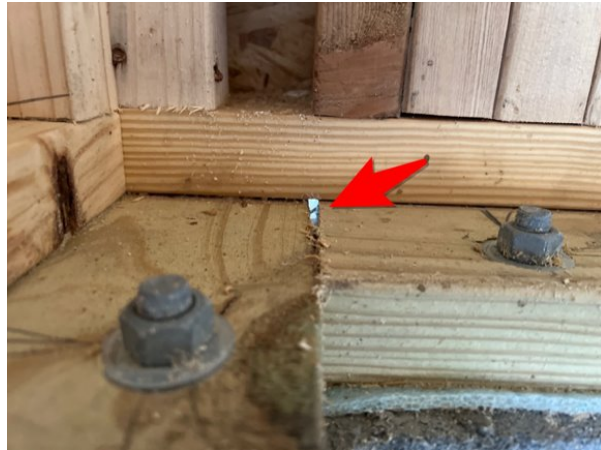
11: There were gaps noted at the front wall in the garage that need to be sealed.

**s-11:** There were gaps noted at the front wall in the garage that need to be sealed.

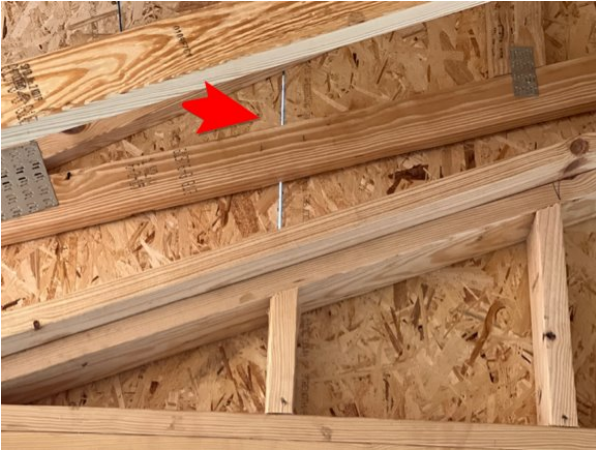
**12:** Areas on the wall in the sunroom that need to be sealed.

**s-12:** Areas on the wall in the sunroom that need to be sealed.

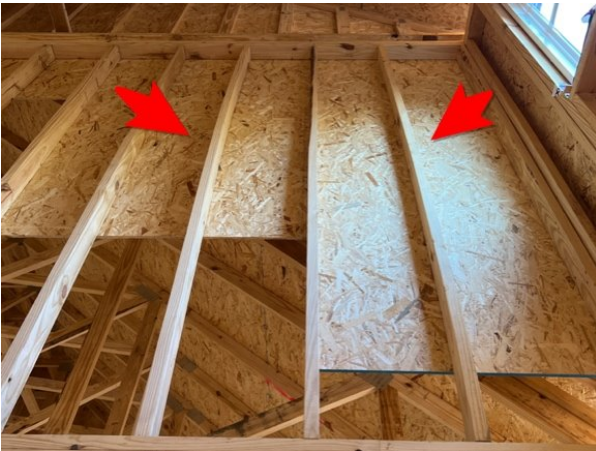
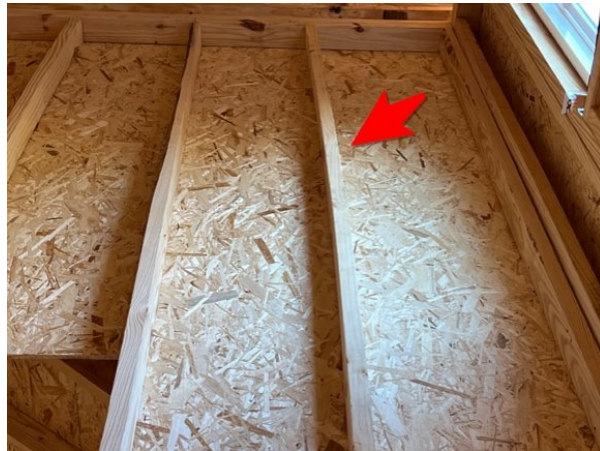
**13:** The upper interior wall adjacent to the attic had bowed studs.

**s-13:** The upper interior wall adjacent to the attic had bowed studs.

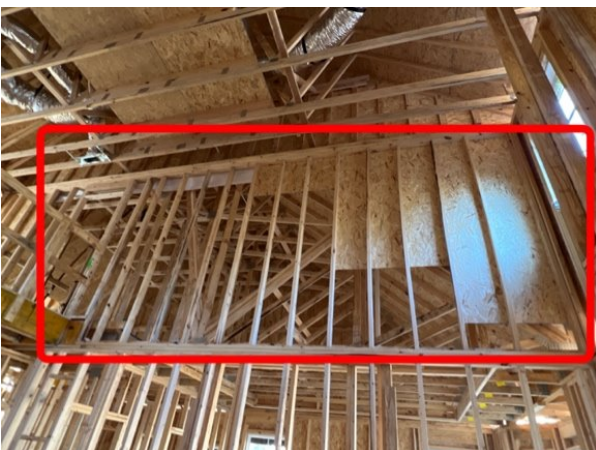
**14:** The upper interior wall adjacent to the attic should be sheathed to properly insulate this wall in the attic.

**s-14:** The upper interior wall adjacent to the attic should be sheathed to properly insulate this wall in the attic.

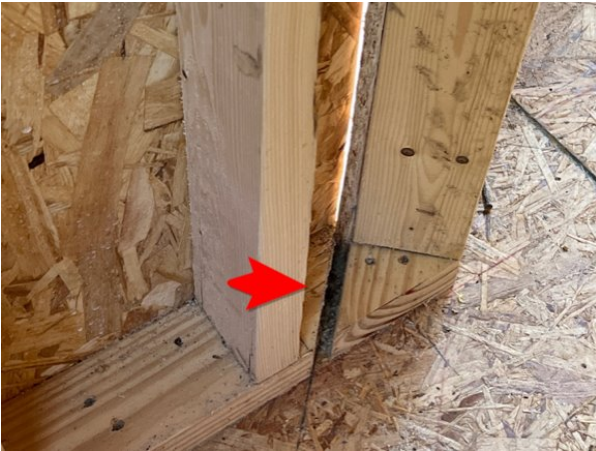
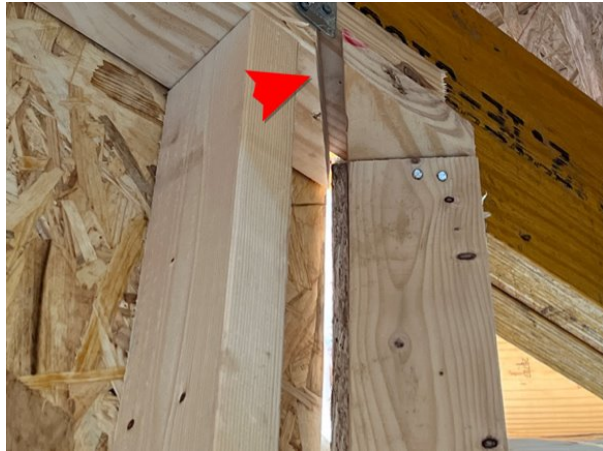
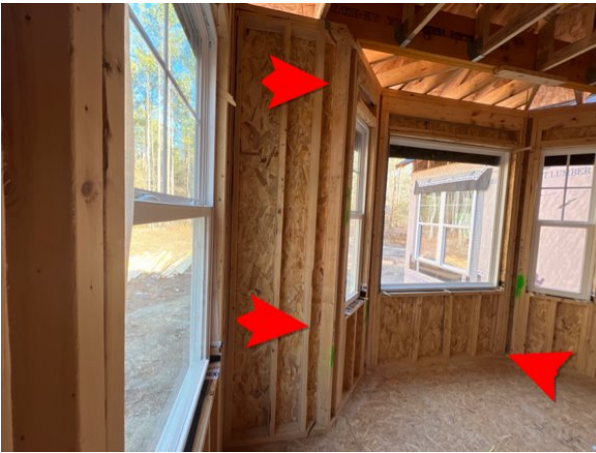
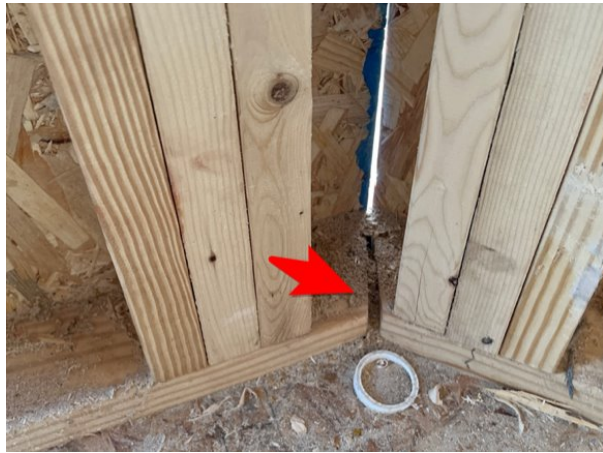
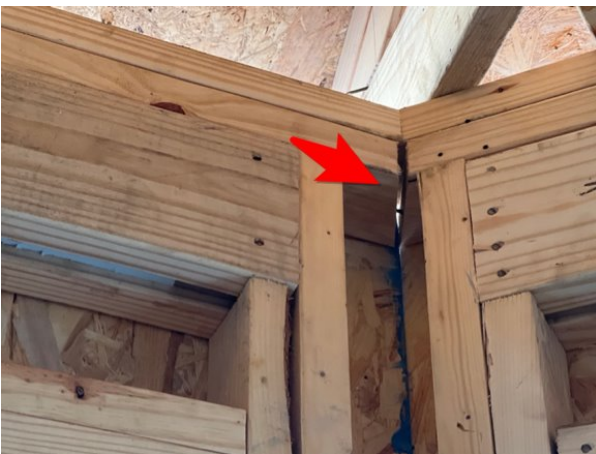
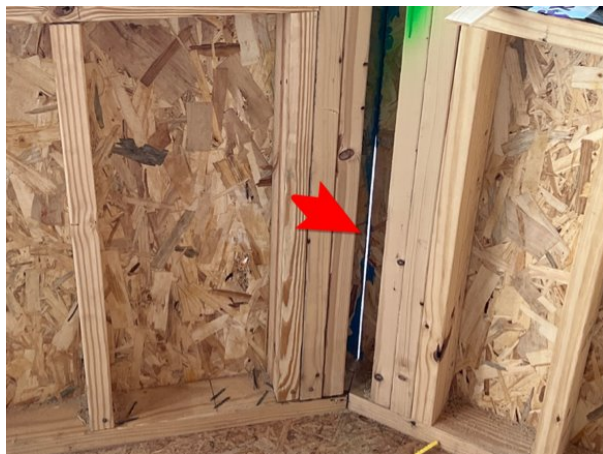
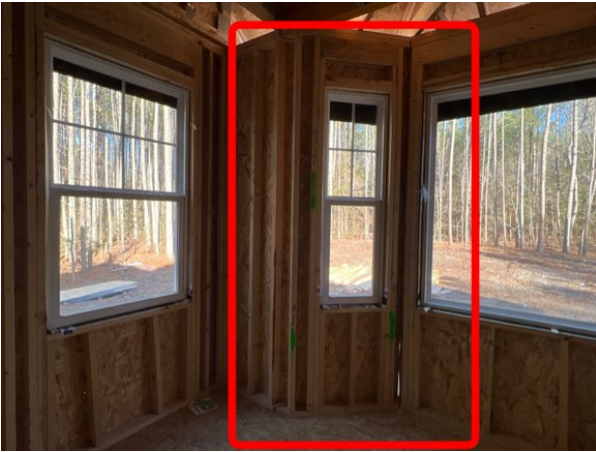
**15:** It appears the bump out rear wall in the master bedroom has not been framed improperly. The walls have not been secured properly with noticeable offset gaps. Have this evaluated.

**s-15:** It appears the bump out rear wall in the master bedroom has not been framed improperly. The walls have not been secured properly with noticeable offset gaps. Have this evaluated.

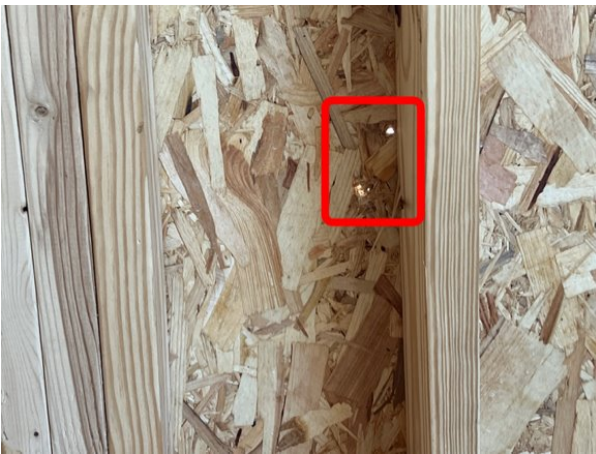
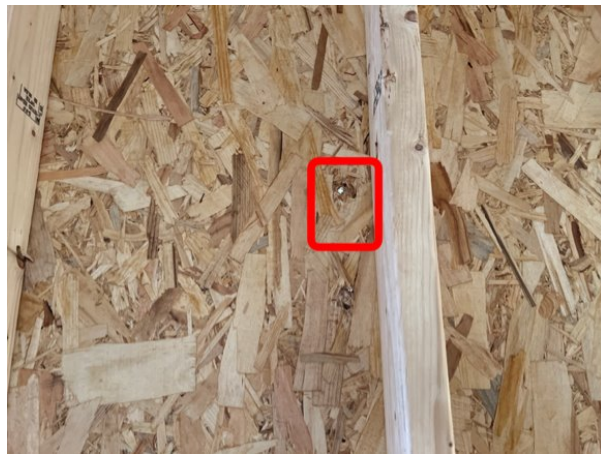
**16:** Missed nails noted in several areas on the exterior walls that need to be sealed.

**s-16:** Missed nails noted in several areas on the exterior walls that need to be sealed.

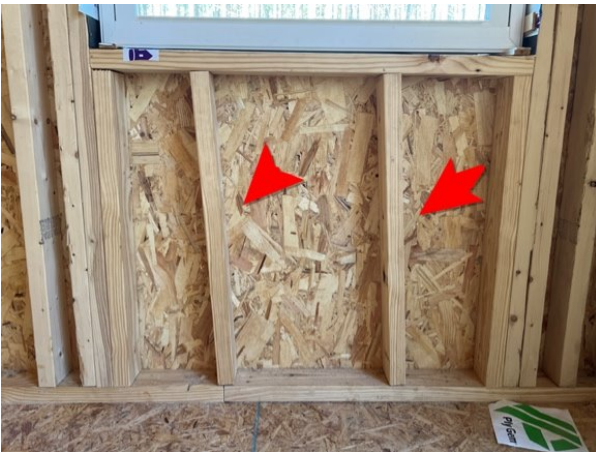
**17:** Leaning cripple studs under a window in an upstairs bedroom.

**s-17:** Leaning cripple studs under a window in an upstairs bedroom.

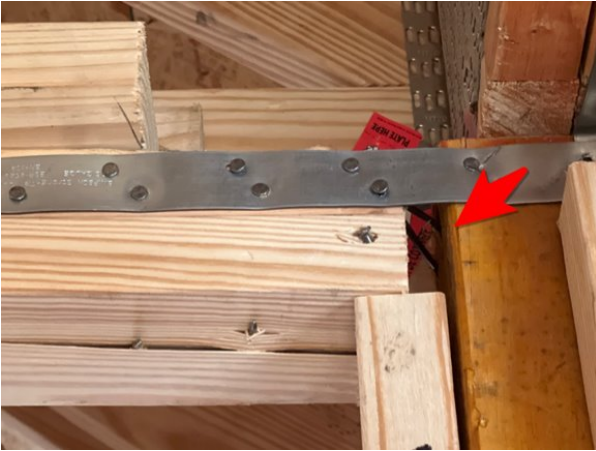
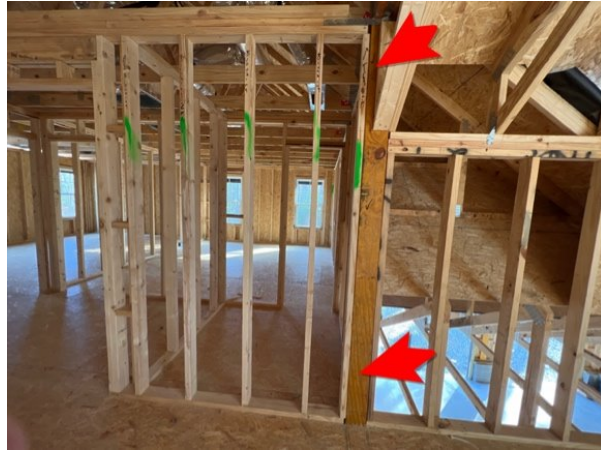
**18:** Interior top wall plate was cut too short and improperly nailed in the upstairs loft.

**s-18:** Interior top wall plate was cut too short and improperly nailed in the upstairs loft.

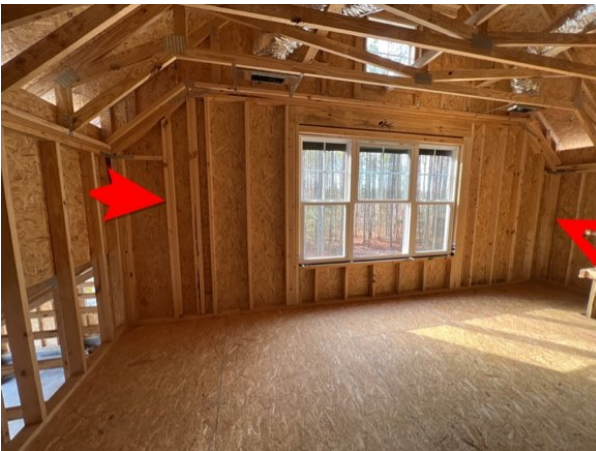
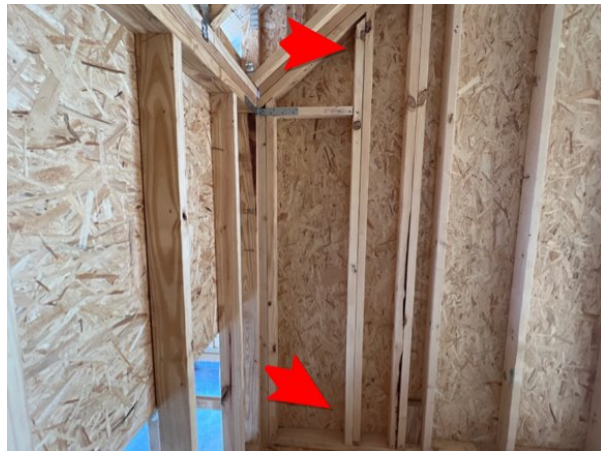
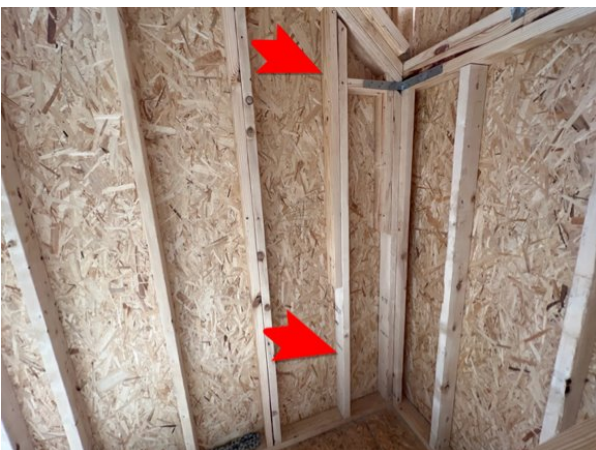
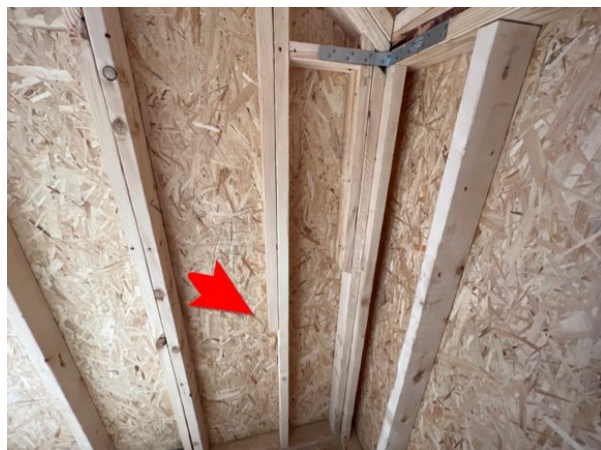
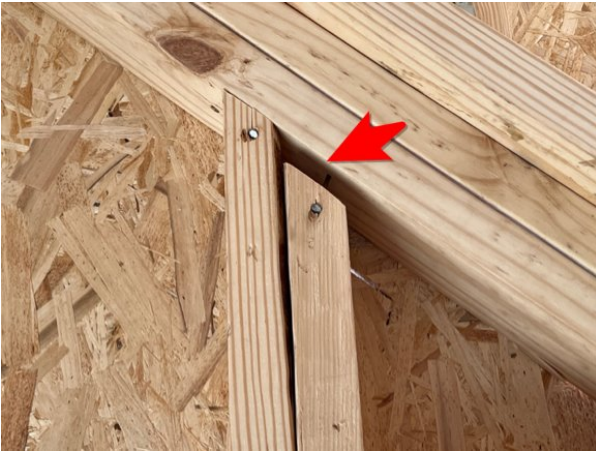
**19:** The front wall studs in the upstairs loft have been cut too short at both ends of the wall. The studs have been nailed in to one another and metal braces added in the corners. It appears these studs are improperly secured.

**s-19:** The front wall studs in the upstairs loft have been cut too short at both ends of the wall. The studs have been nailed in to one another and metal braces added in the corners. It appears these studs are improperly secured.

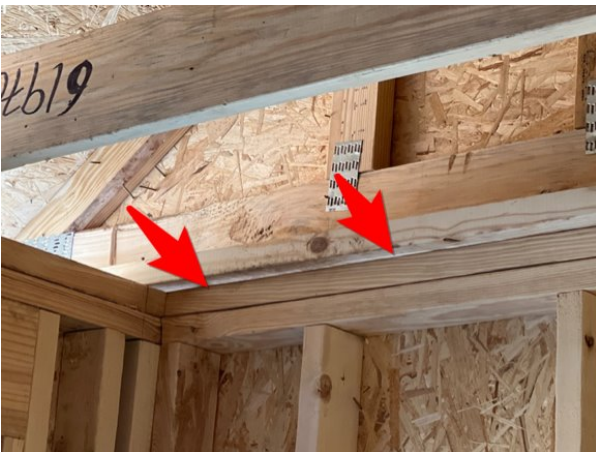
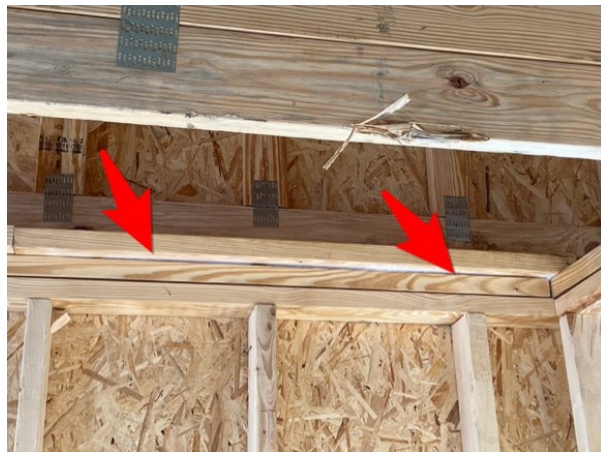
**20:** The exterior walls at the top plate need to be sealed in areas.

**s-20:** The exterior walls at the top plate need to be sealed in areas.

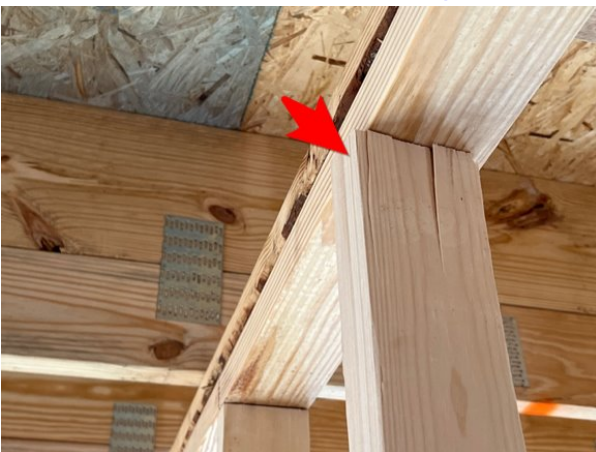
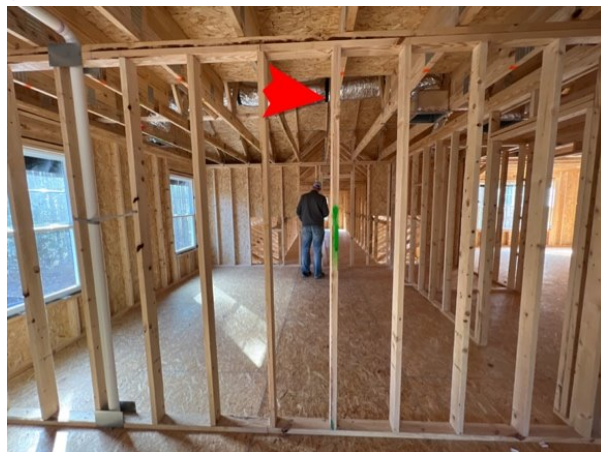
**21:** Twisted/loose stud in the upstairs back right bedroom.

**s-21:** Twisted/loose stud in the upstairs back right bedroom.

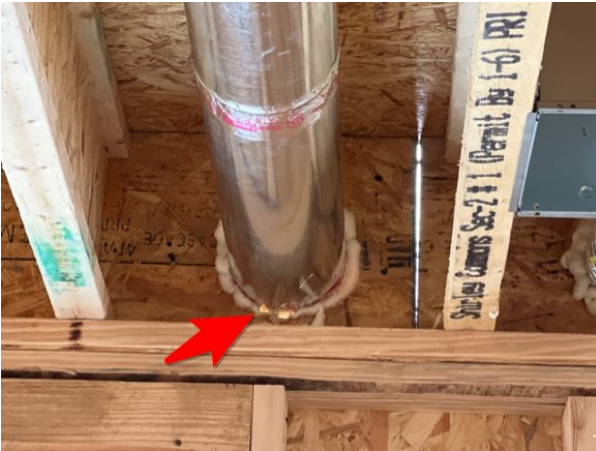
**22:** The exhaust duct terminating at the right side of the house has open gaps around the spray foam. Also, the exterior wall in this area needs to be sealed.

**s-22:** The exhaust duct terminating at the right side of the house has open gaps around the spray foam. Also, the exterior wall in this area needs to be sealed.

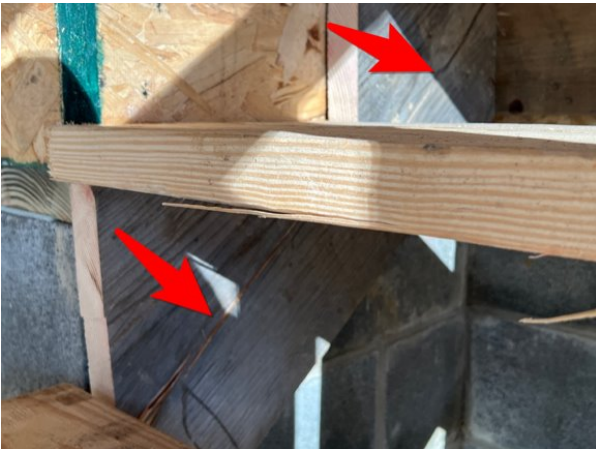
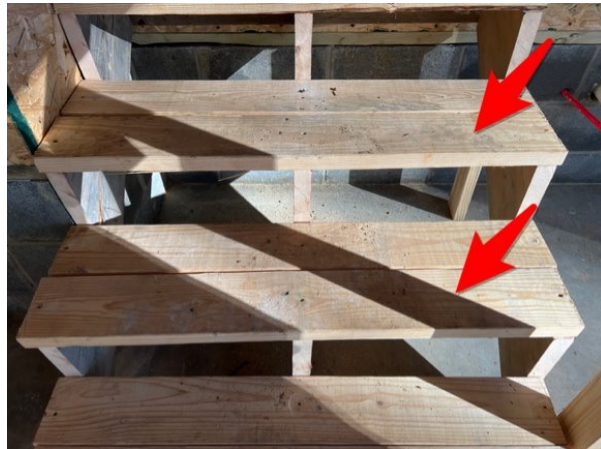
**23:** The stairs in the garage had loose treads and a split stringer.

**s-23:** The stairs in the garage had loose treads and a split stringer.

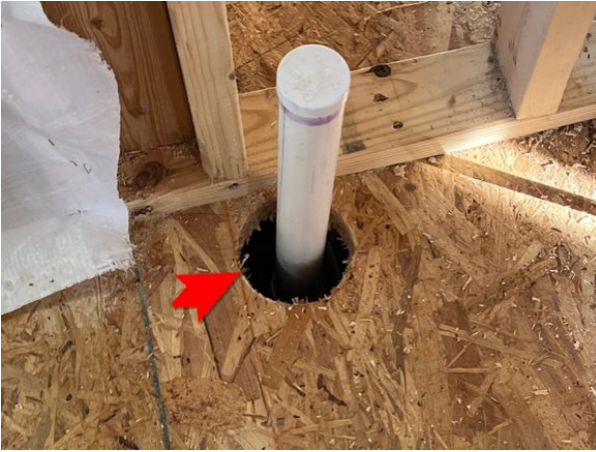
**24:** The cut out for the master bathroom tub drain appears to be too large of a gap compared to the size of the pipe.

**s-24:** The cut out for the master bathroom tub drain appears to be too large of a gap compared to the size of the pipe.

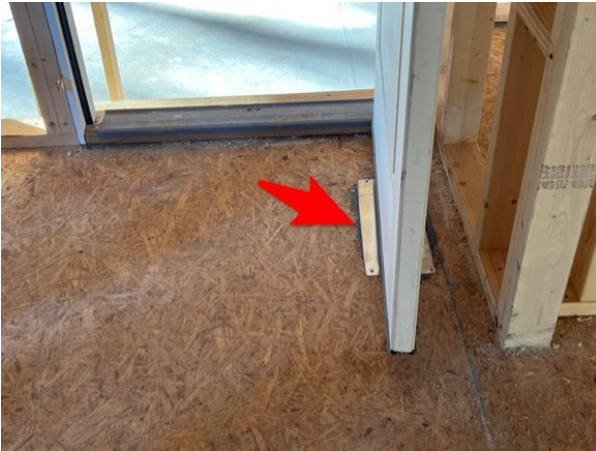
25: The duct was installed directly under the garage door when opened.

**s-25:** The duct was installed directly under the garage door when opened.

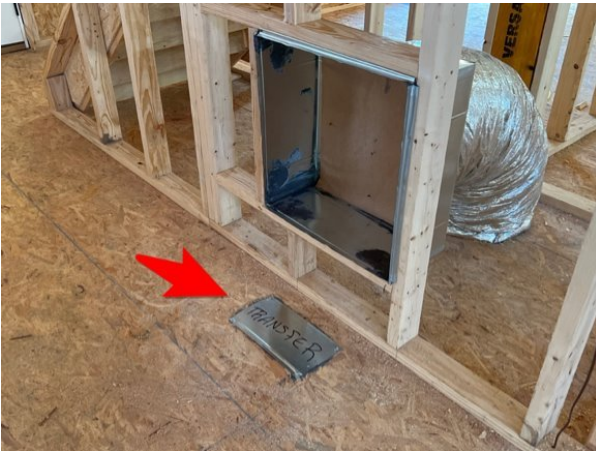
26: There was a duct installed directly under the downstairs hallway return.

**s-26:** There was a duct installed directly under the downstairs hallway return.

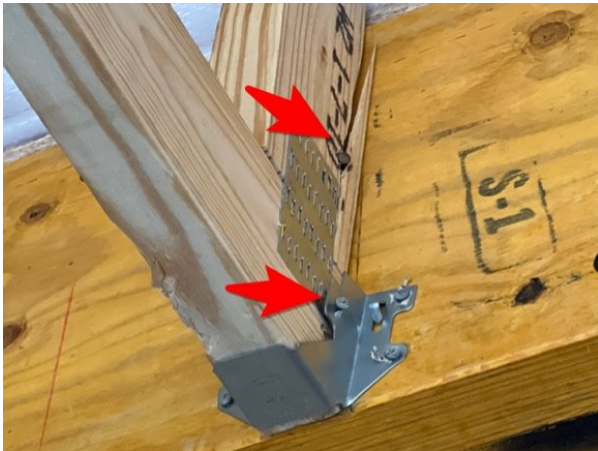
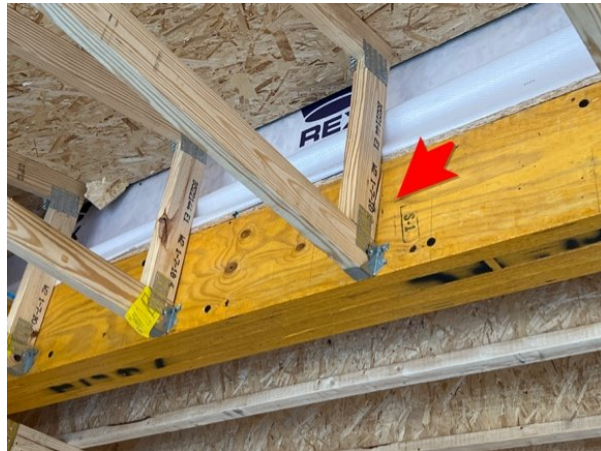
**27:** The rafters in the rear of the family room had loose nails in the hangers and a split rafter from being improperly nailed.

**s-27:** The rafters in the rear of the family room had loose nails in the hangers and a split rafter from being improperly nailed.

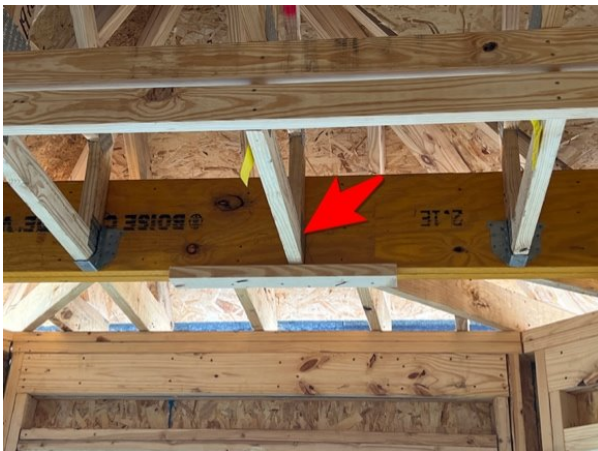
**28:** Missing ceiling joist hanger in the master bedroom above a window.

**s-28:** Missing ceiling joist hanger in the master bedroom above a window.

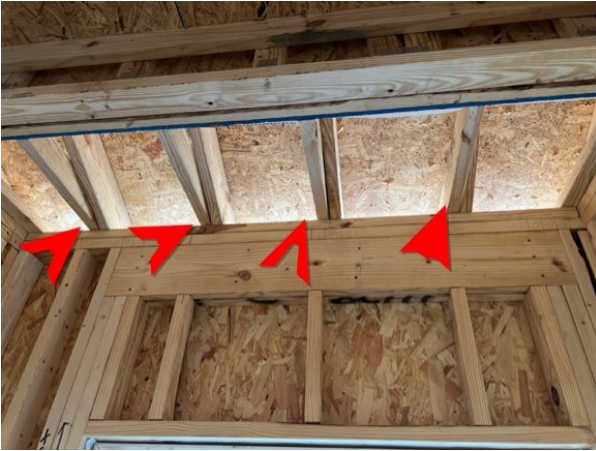
**29:** Missing truss hangers at the master bathroom outer wall.

**s-29:** Missing truss hangers at the master bathroom outer wall.

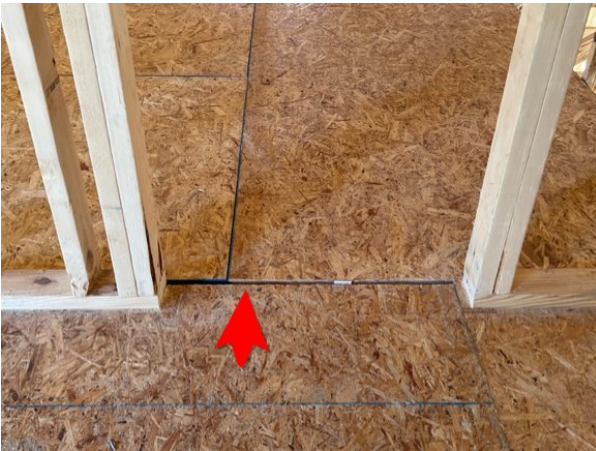
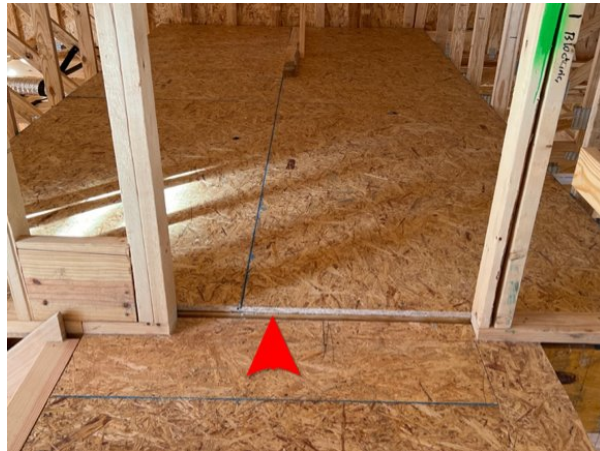
**30:** There were two unfinished attic areas upstairs. The flooring was level at one and the other had a raised floor.

**s-30:** There were two unfinished attic areas upstairs. The flooring was level at one and the other had a raised floor.

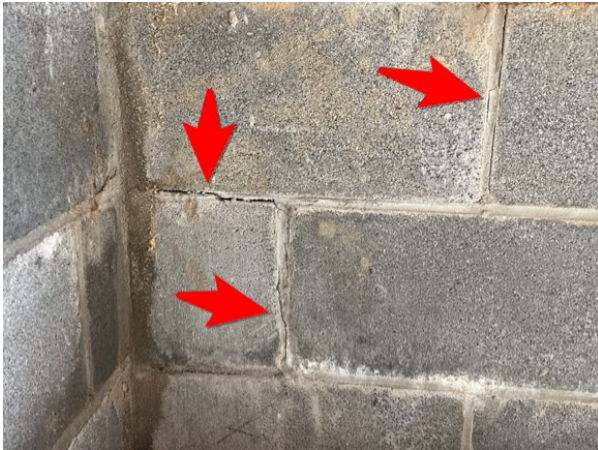
**31:** [Missing/cracked mortar on the masonry block wall in the garage that needs to be re-pointed.](#)

**s-31:** Missing/cracked mortar on the masonry block wall in the garage that needs to be re-pointed.
