## Sewer Scope Inspection Report

LOCATED AT:  
123 Main Street  
Richmond, VA 23220

INSPECTED ON:  
Tuesday, March 22, 2022

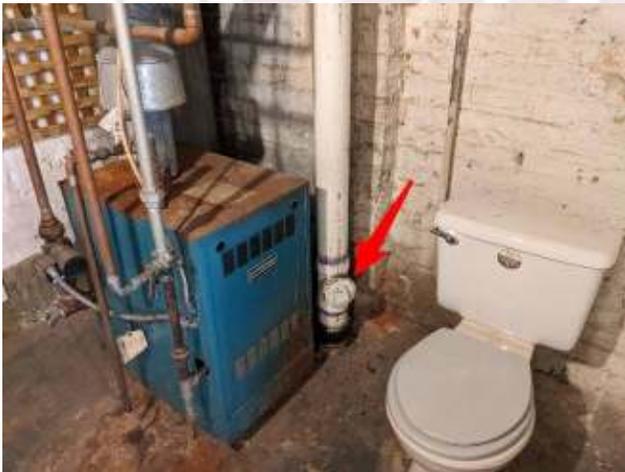
5: The cleanout was located in the basement near the toilet.

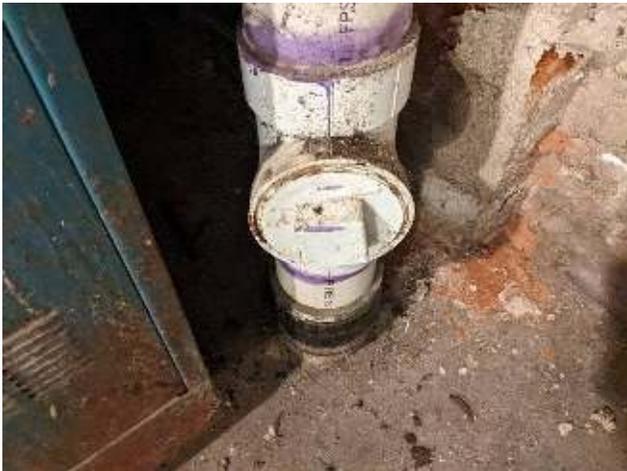
6: The clean out access was in good condition.

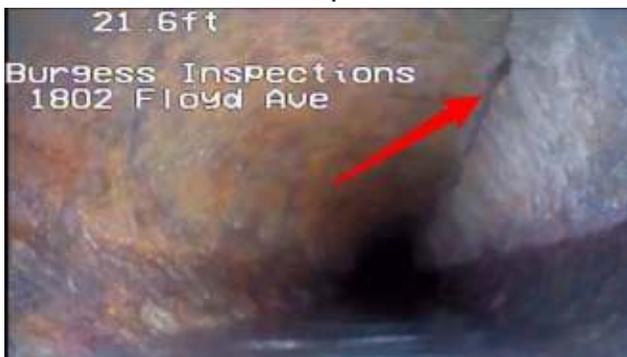
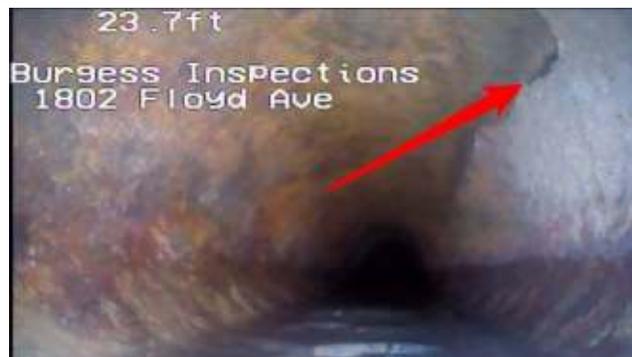
10: There appeared to be a crack visible in the main sewer line/pipe at approximately 22 feet from the access point.

There appears to be a crack in the cast iron pipe.

A licensed plumber should be consulted to determine the severity of the crack and the blockage and to repair or replace as needed and then re-inspect with a camera.

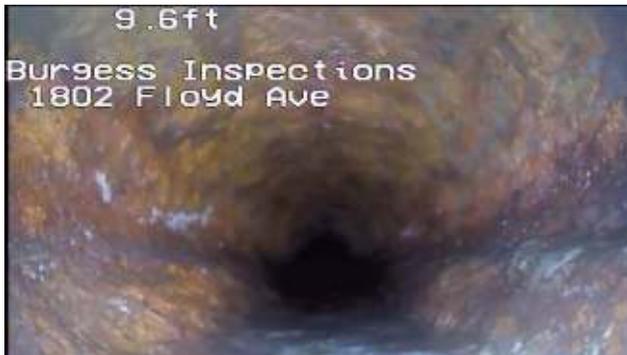
**11:** Heavy rust / scale was visible in the cast iron portion of the main sewer line/pipe.

Cast Iron is rusted and corroded.

**14:** Cast iron rusts from the inside out and it is beyond the scope of this inspection to determine how deep the rust goes.

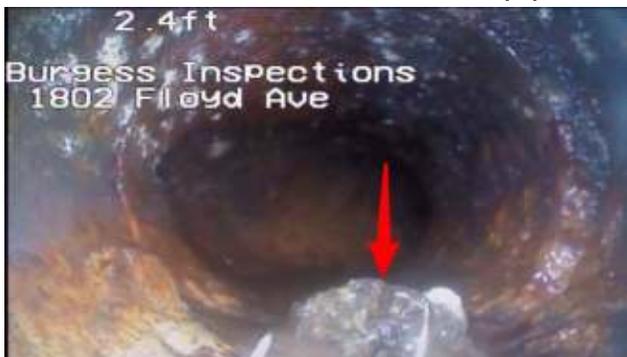
**12:** There was debris inside the pipe at various points.

Debris in the pipe at approximately 2.4 ft from the access point

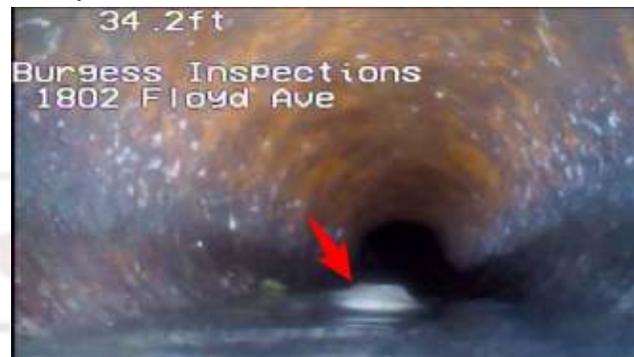
Debris in the pipe at approximately 34.5 ft from the access point

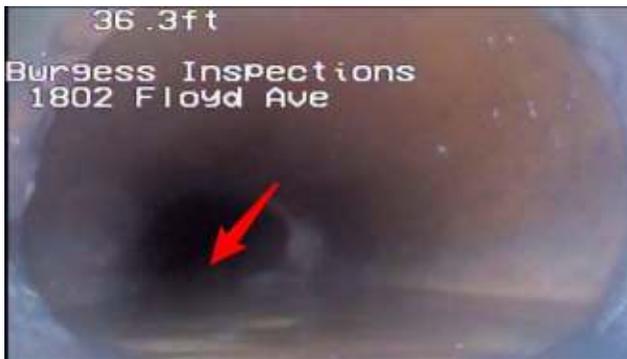
Picture show the blockage at the pipe transitions to clay.

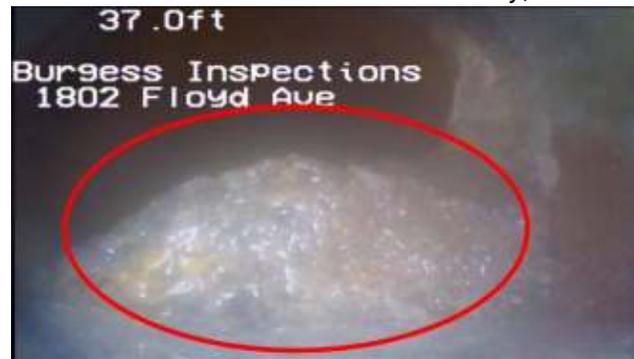
Site of the blockage

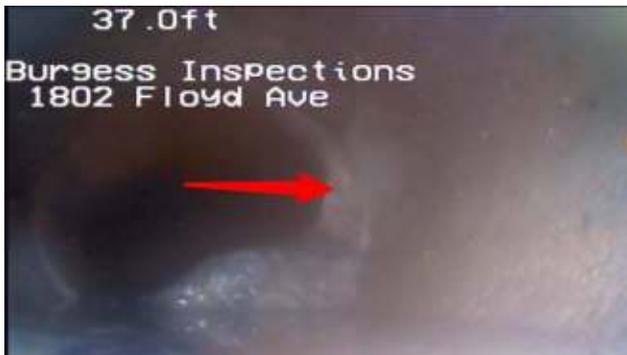
Another shot of the blockage. This shows the potential offset of the pipe at the arrow.
