Confidential Inspection Report

Property Address:
313 Main Street
Virginia Beach, VA 23451

5: Completed thermal imaging scan of the interior and exterior walls upon the request from the homeowner. The building has had the exterior siding removed with the intent to re-install new siding. Foam and green board sheathing has been installed but no siding. The foam and green board sheathing have been out in the elements for over a year. Per the client, he has concerns of moisture intrusion in the walls inside the condo.

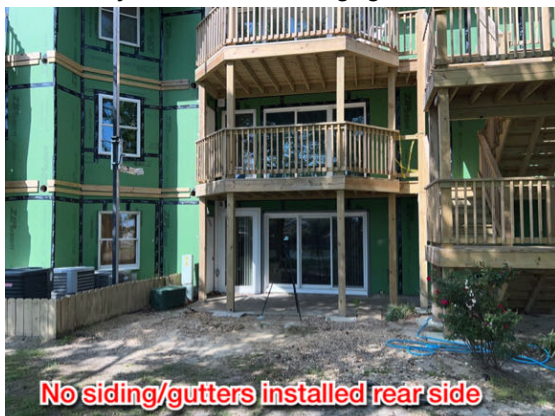
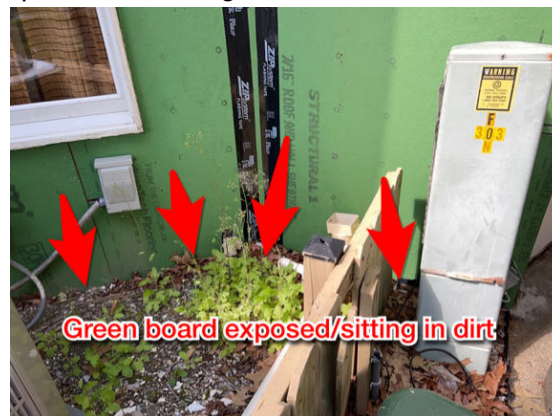
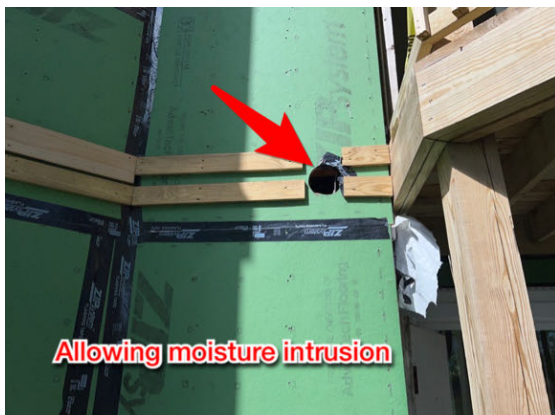
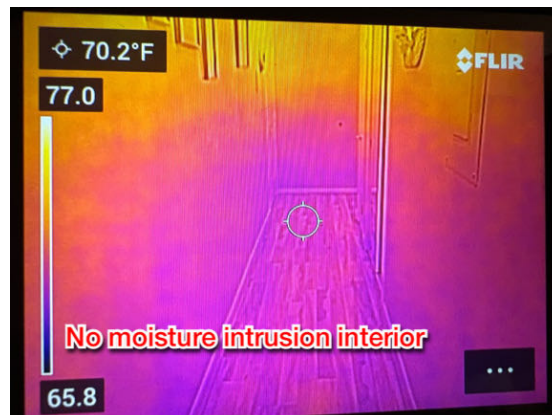
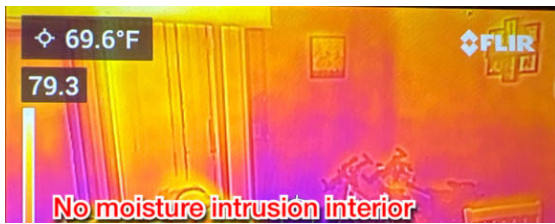
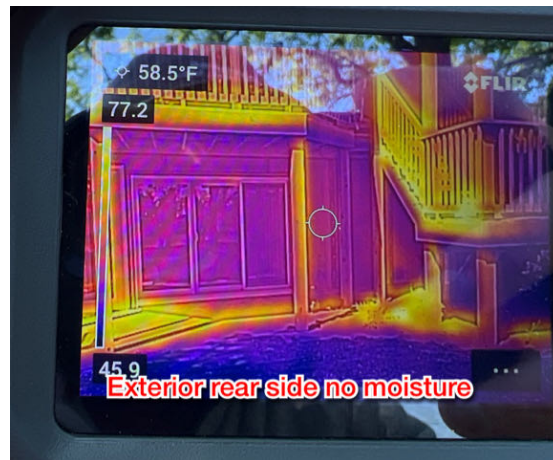
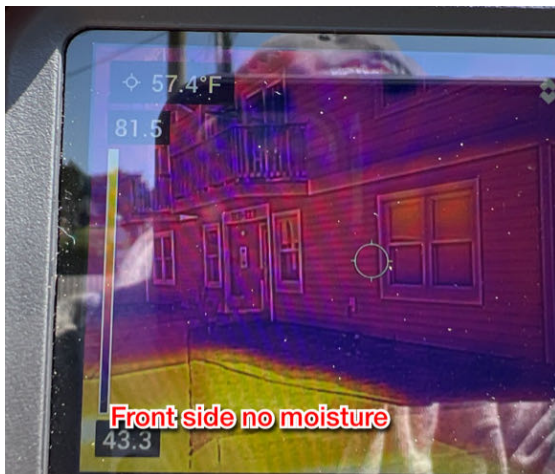
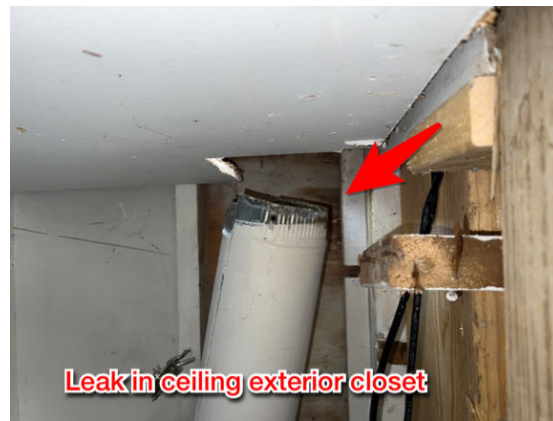
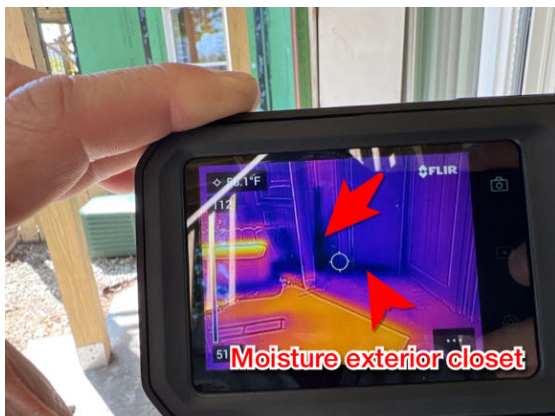
The thermal imaging photos were taken from inside of the 72 degree home. The exterior temperature was approximately 55 degrees at the time of inspection.

After a thermal imaging scan of the entire interior of the condo there were NO findings of unwanted moisture intrusion found in the walls.

However, the rear exterior wall of the building is exposed to the elements. The green board sheathing is touching dirt and soaking up moisture. There are no gutters installed which is allowing water to sit at the foundation. There are visible holes where exhaust ducts should terminate that are allowing moisture intrusion. An exterior closet at the back patio of the condo has moisture intrusion occurring which has rotted the door casing and exterior wall. It appears the deck above this unit is not flashed properly allowing water intrusion into the ceiling of the exterior closet.

These issues appear they could be remedied by installing gutters back on the building and properly siding the rear of the building along with flashing the deck properly.

It is recommended that all green board sheathing at ground level be replaced before siding is installed to avoid any future mold/fungi growth from any exposed sheathing to moisture.
