# Inspection Report

## Customer Name Sample Report

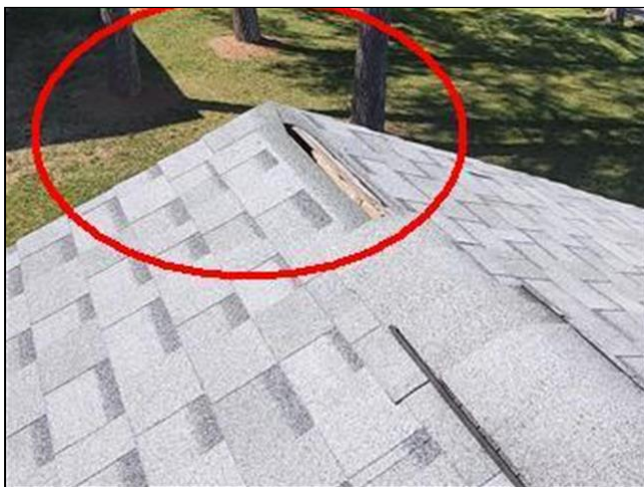
(1) There were multiple missing roof shingles noted at the right roof ridge. Correct all as needed. See photos for examples. \$150-\$200 +/-

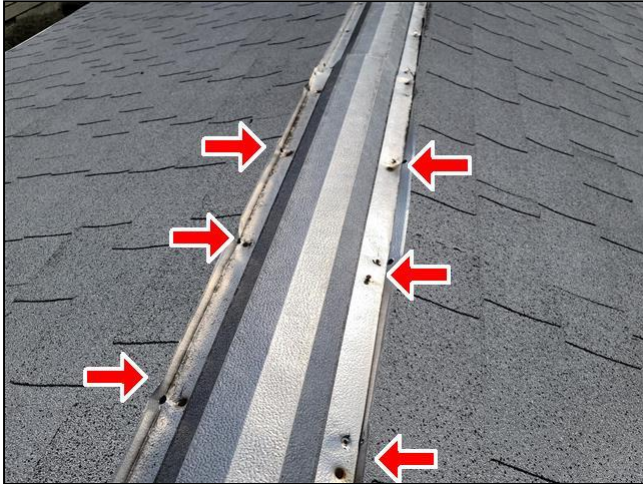
🏠 (3) There were exposed metal fasteners noted at carport ridge vent . The fastener heads should be sealed to prevent moisture intrusion into the home. Correct all as needed. See photos for examples. \$100-\$150 +/-

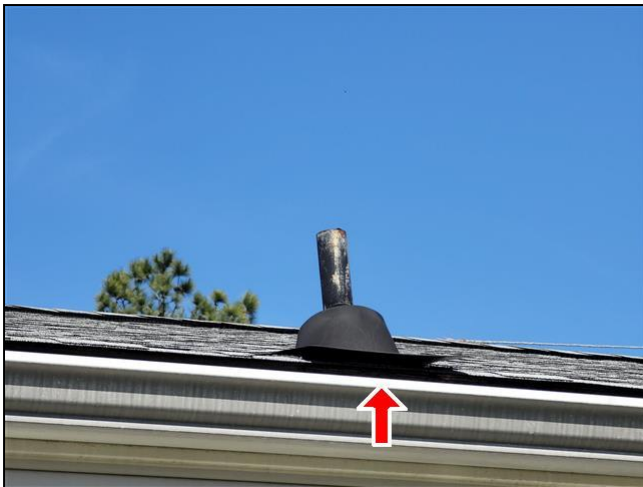
🏠 The roof penetration flashing is lifting at the front edge of the flashing. \$100-\$125 +/-

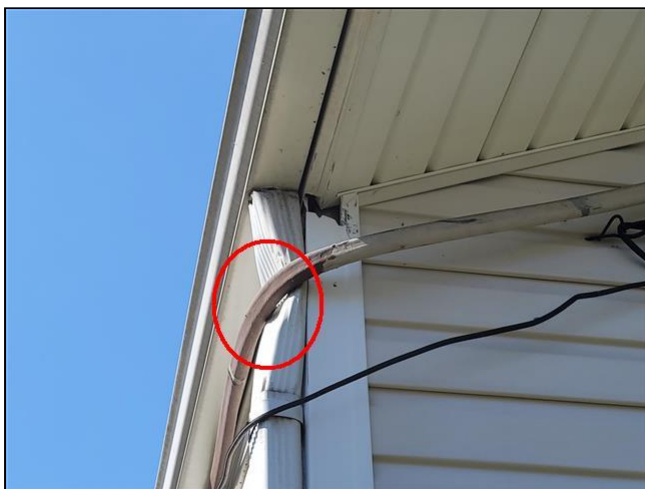
(1) Right rear corner of home downspout is crushed at the top. \$100-\$125 +/-

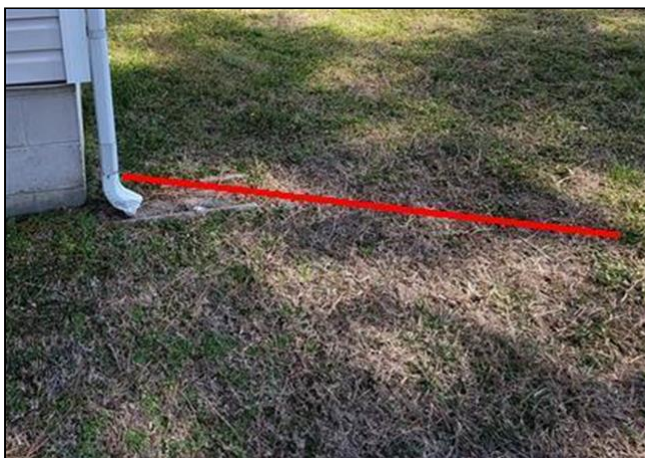
- (2) As regular maintenance keep gutters and downspouts clear to allow water to flow away from the home.
- (3) Recommend draining gutters 4 - 5 feet from the foundation.

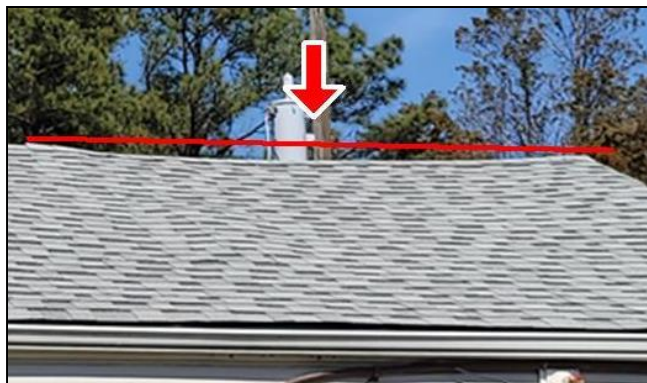
After engineer evaluates, have a qualified company quote repairs & costs.

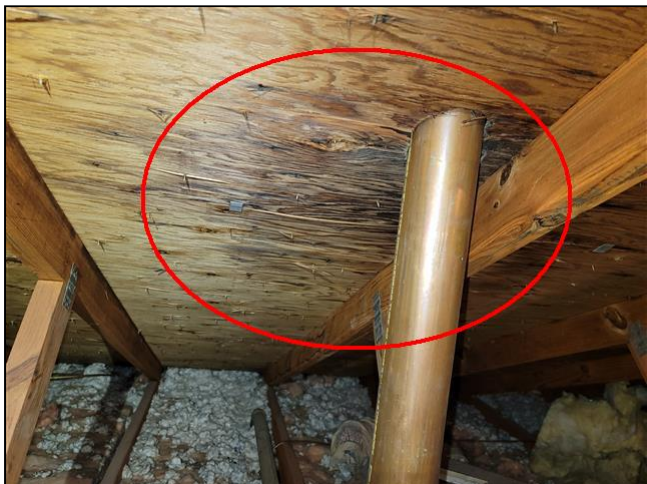
(2) Water stains were noted in the attic. There was no moisture at this time and they appeared to be old, however it is beyond the scope of this inspection to determine this or if they will leak in the future. If you have any concerns I would recommend having them further examined by a licensed roofer and repair if needed.

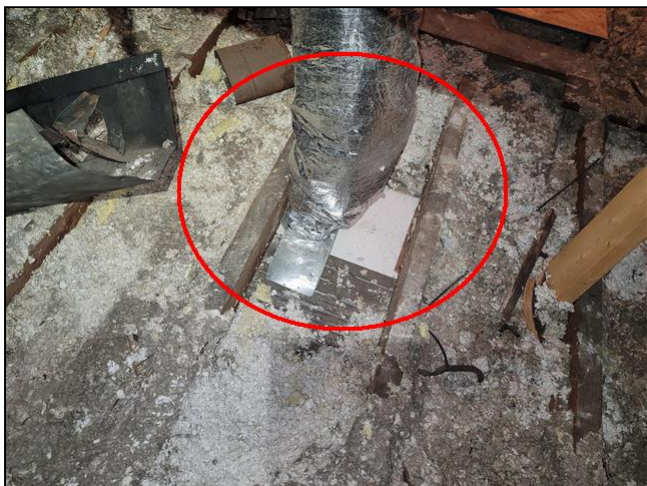
(1) There were areas of missing insulation in the attic. Correct all as needed. \$100- \$150 +/-

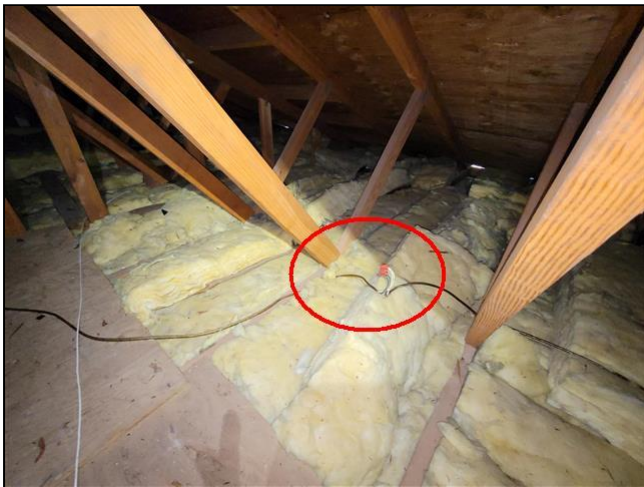
There are a couple of improper wire connections noted in the left attic space at the rear. These connections should be made in junction boxes and properly secured. \$100- \$150 +/-

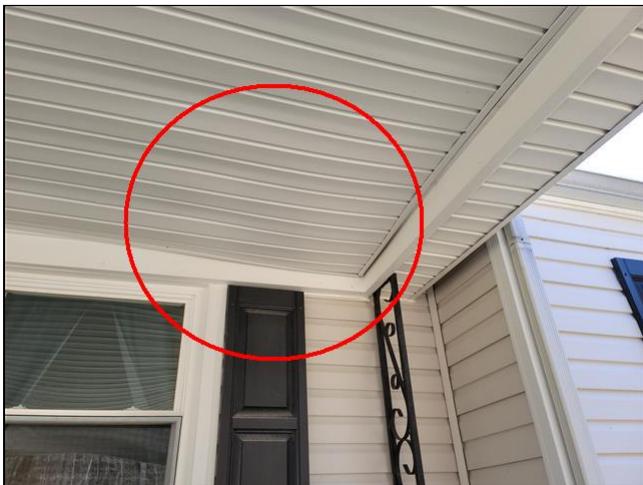
- 🏠 (1) The corner of the carport soffit is dropping down in the right rear corner and also at the front corners where the posts pass through. There is a bee hive noted at the front left corner. \$150-\$200 +/-

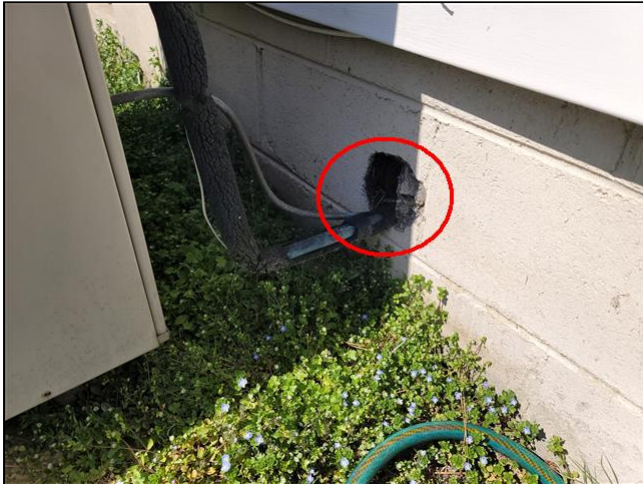
🏠 (2) There are openings in the foundation at the rear of the house where pipes/wires pass through. These should be closed off with sealant or liquid foam to prevent water intrusion into the home. Correct all as needed. See photos for examples. \$100- \$125 +/-

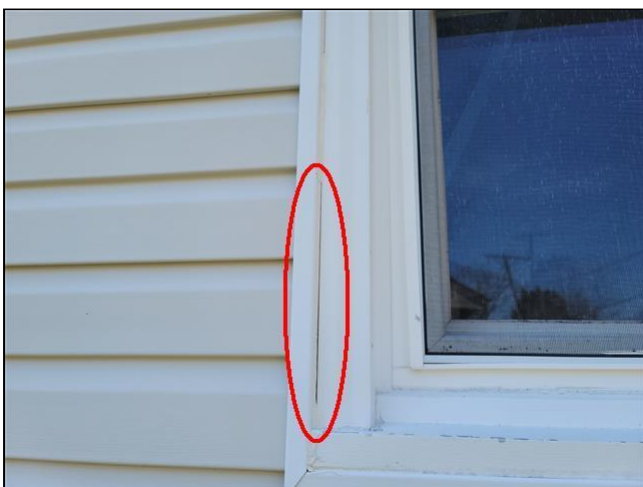
🏠 (3) The sealant is missing and/or deteriorated at window and door trim noted at multiple locations. Correct all as needed. See photos for examples. \$150- \$200 +/-

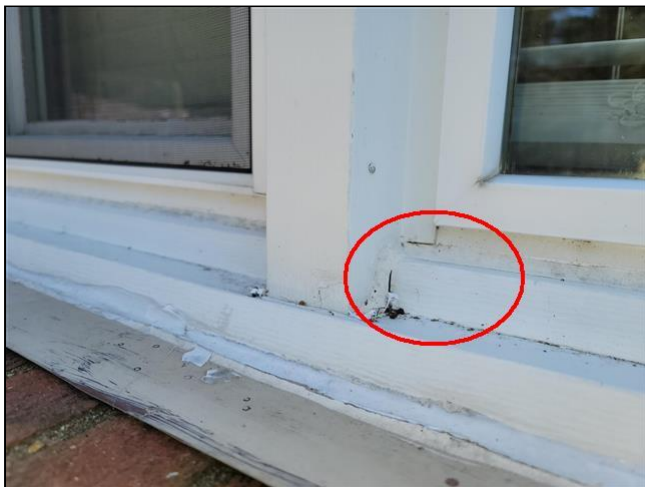
2.0 Item 12(Picture)

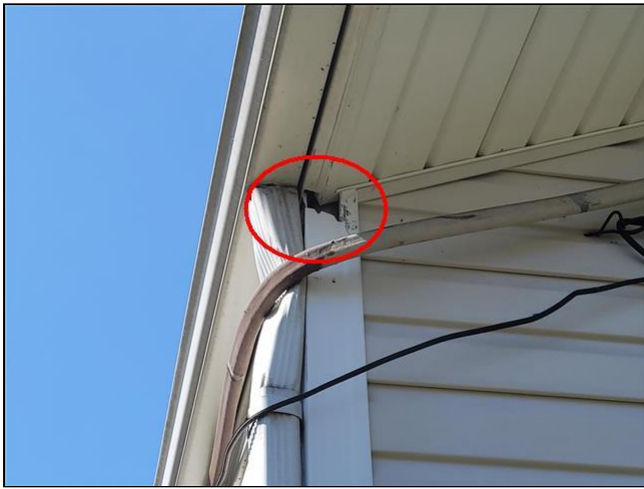
2.0 Item 13(Picture)

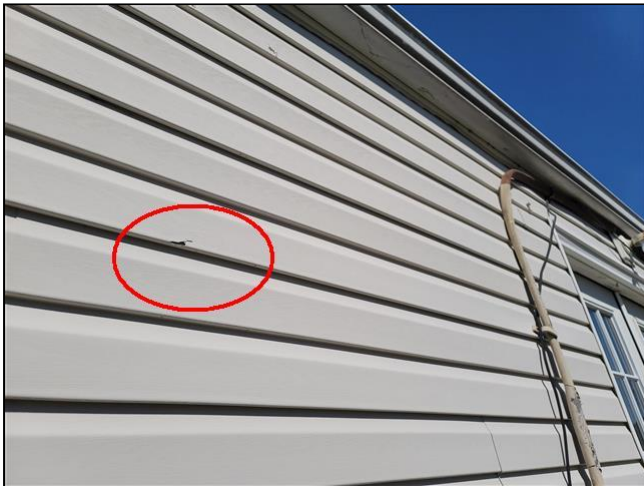
2.0 Item 14(Picture)

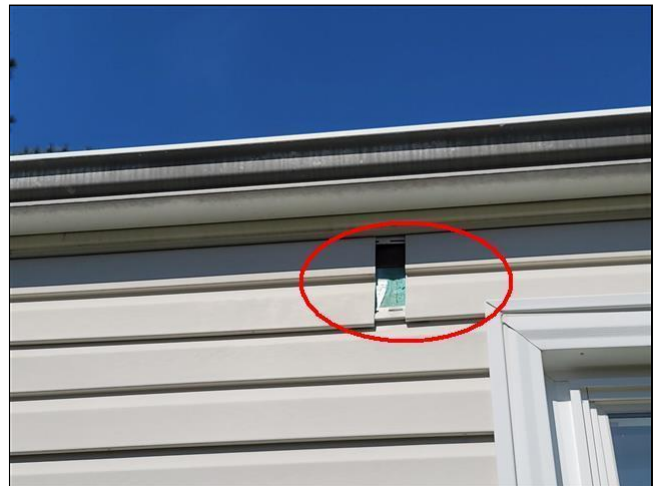
2.0 Item 17(Picture)

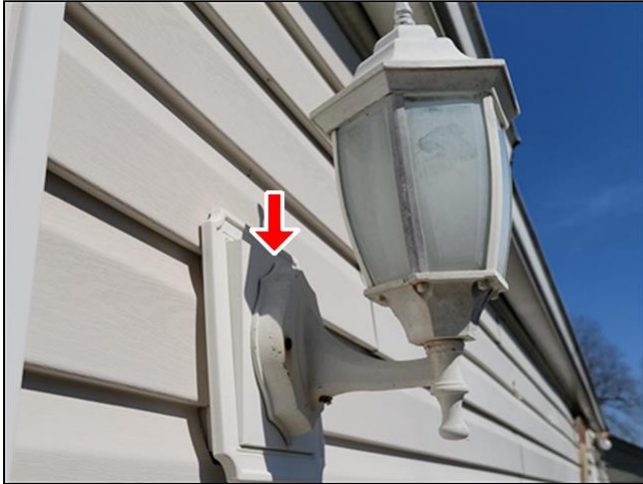
2.0 Item 18(Picture)

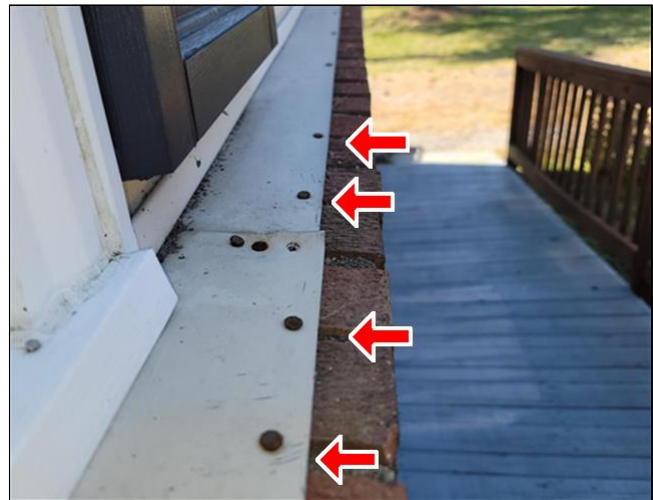
2.0 Item 20(Picture)

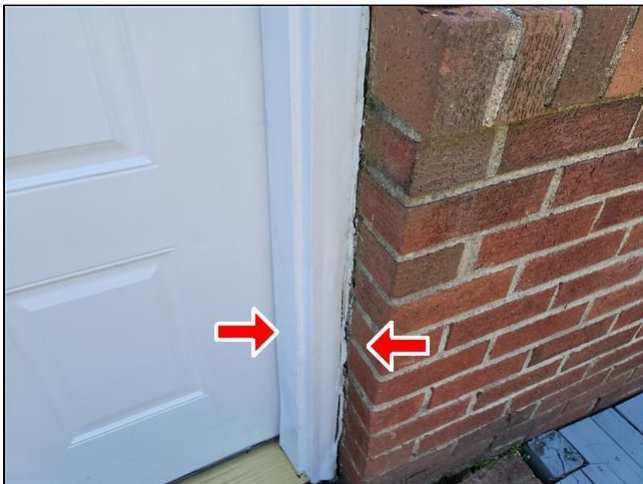
2.0 Item 21(Picture)

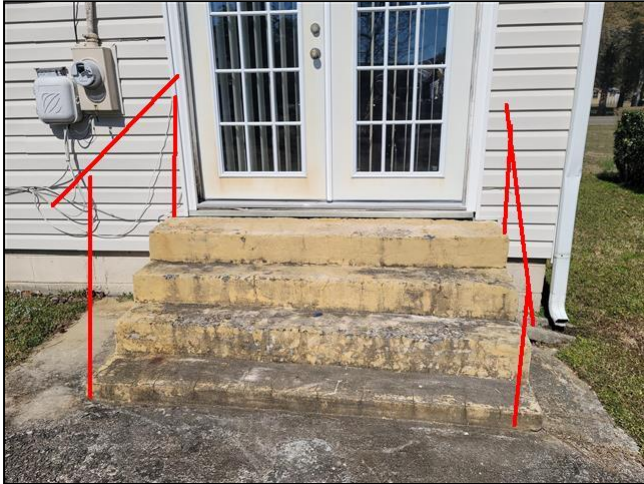
🏠 (2) The steps pictured (front and rear steps) are missing a railing system. Have a licensed contractor to properly install a railing for the stairs. Estimated cost \$300-\$400 +/-

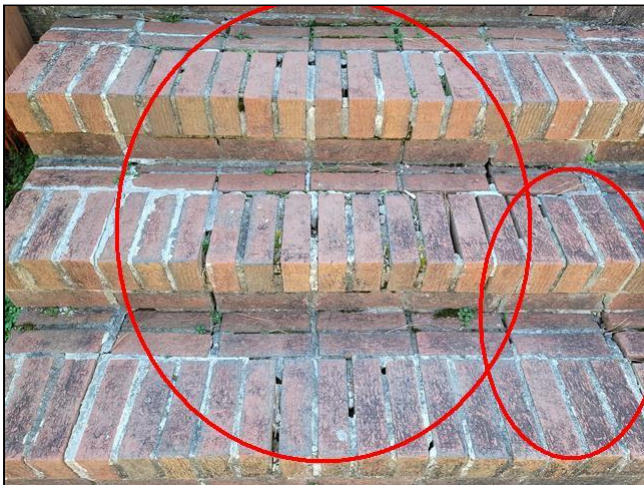
🏠 (4) There are areas of missing brick mortar at the front steps. Also, there are some areas on the the right side lower steps that have settled slightly. Have a licensed mason to repair all areas as needed. \$275 - \$375+/-

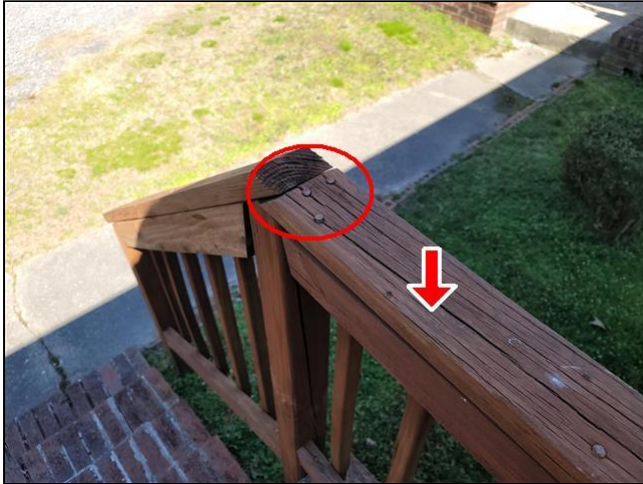
- (5) The top rail at the front steps and ramp is split and damaged and nails are withdrawing at multiple locations. Refer to photos for examples. Correct all damaged rails as needed. \$225- \$275 +/-

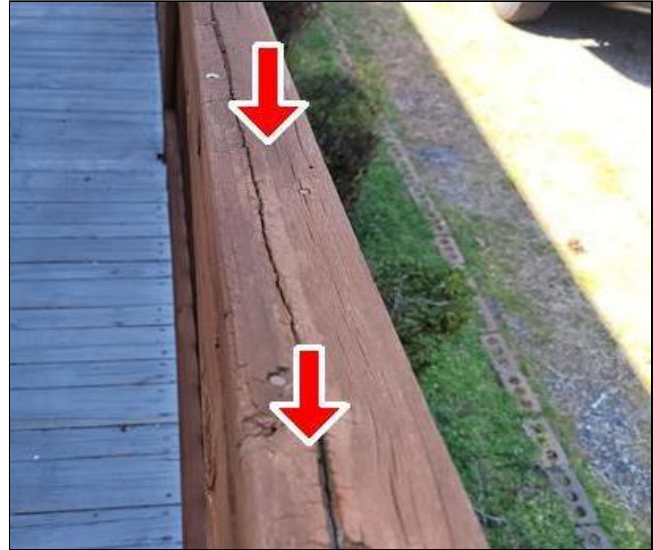
2.3 Item 10(Picture)

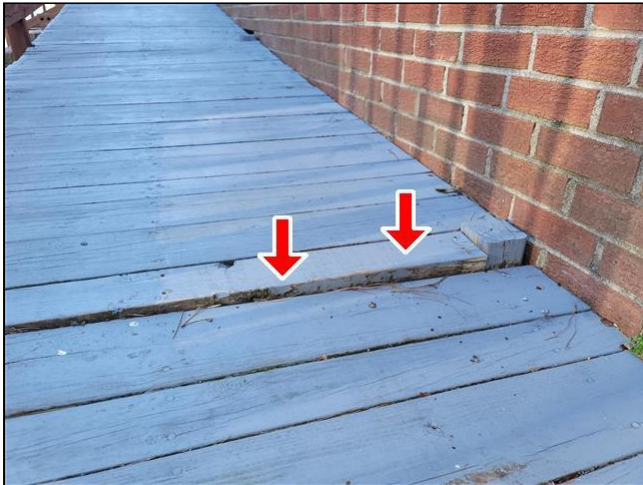
2.3 Item 11(Picture)

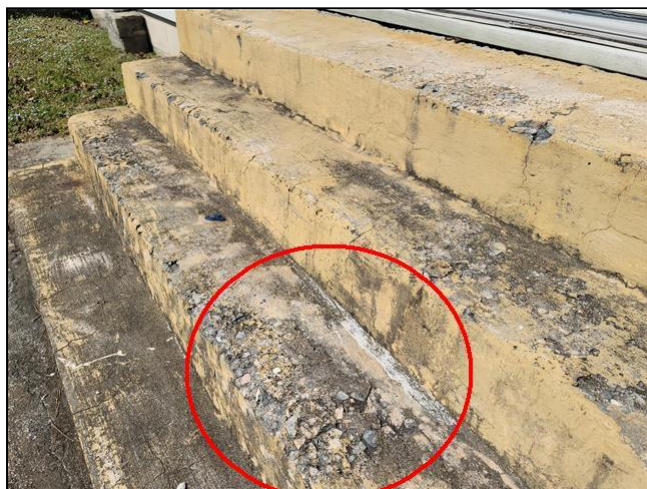
2.3 Item 12(Picture)

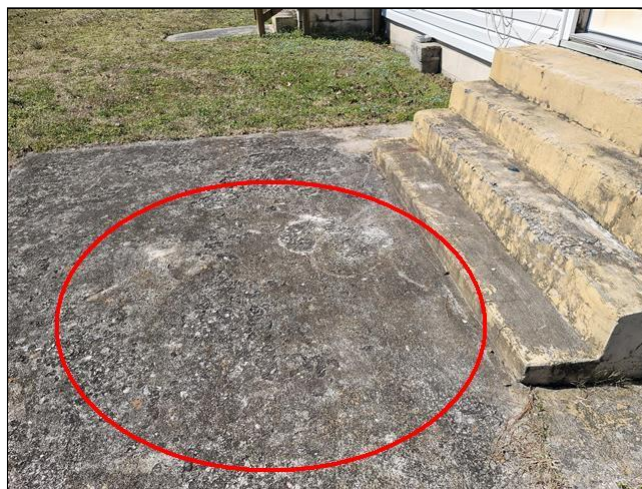
2.3 Item 13(Picture)

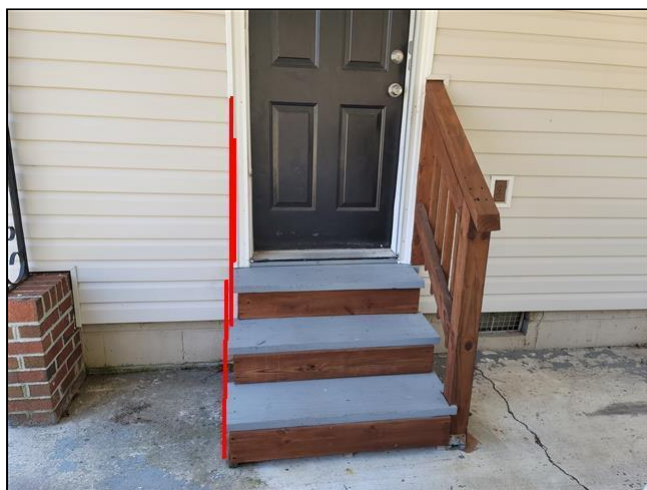
2.3 Item 14(Picture)

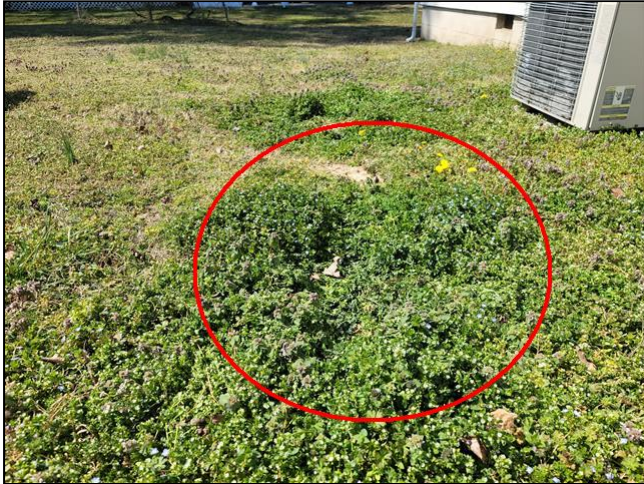
- 🏠 (1) There are some depressions on the property (mainly at the rear) that should be filled in to prevent possible injuries. \$100-\$150+/-

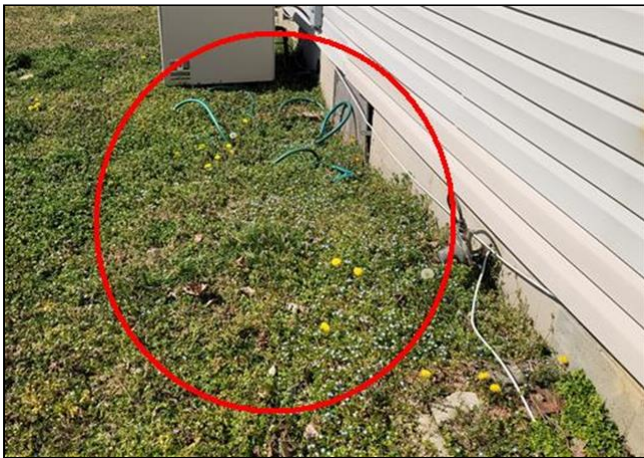
- (2) There are some low grade areas around the home. The grading should be so water drains away from the foundation about 4 - 5 feet.

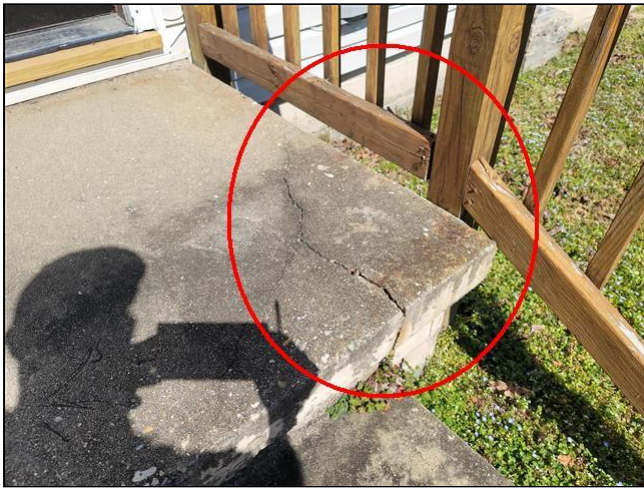
(4) Rear entry door stoop is cracked at the corner but it appears to be stable.

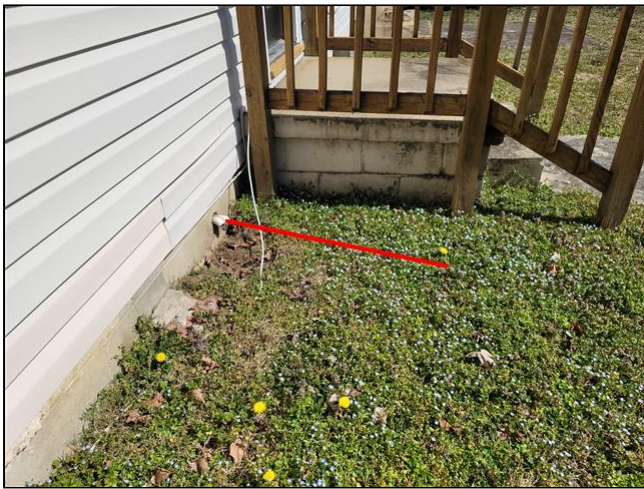
Recommend to extend HVAC condensate lines four to five feet from the edge of the foundation.

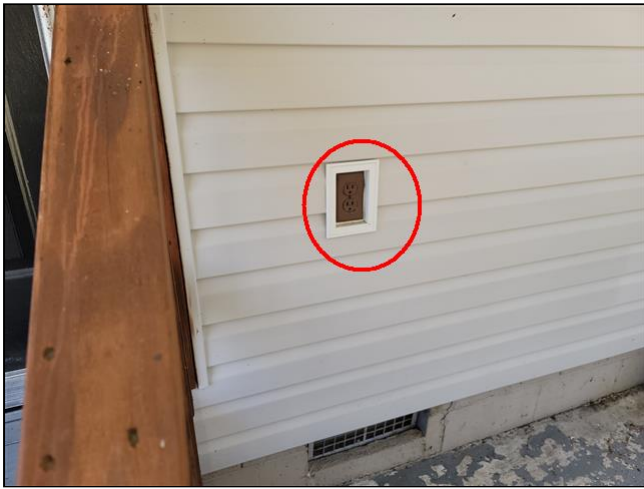
⚡ (1) The outlet at the carport should have a weather resistant cover. \$75 - \$125

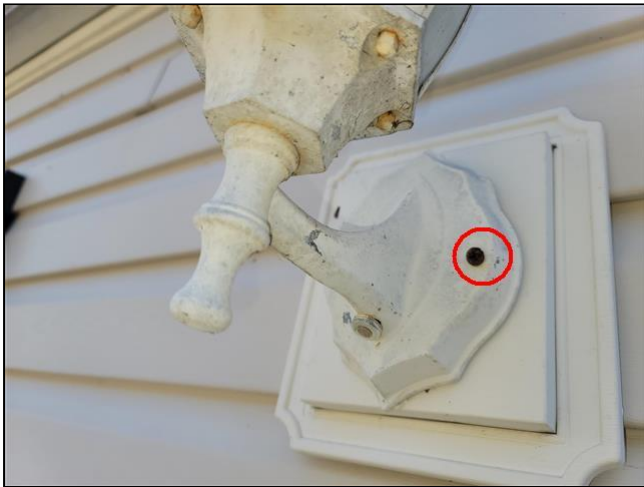
⚡ (2) The front entry exterior light has been installed with drywall screws. These should be replaced with corrosion resistant fasteners and the fixture should be secured. \$75- \$100 +/-

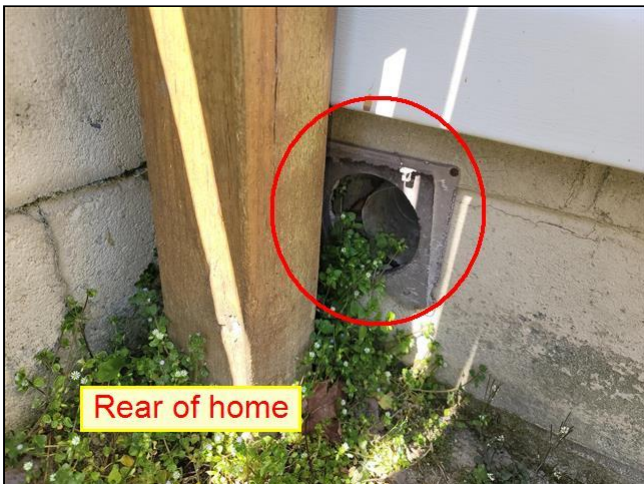
🏠 The exterior dryer vent kit is damaged and needs to be replaced by a licensed contractor. \$75 - \$125

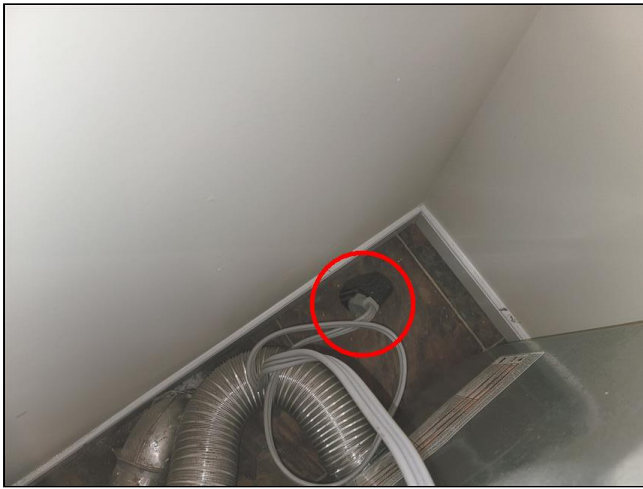
⚡ The dryer receptacle is not secured to the wall or floor. \$100 to \$150 +/-

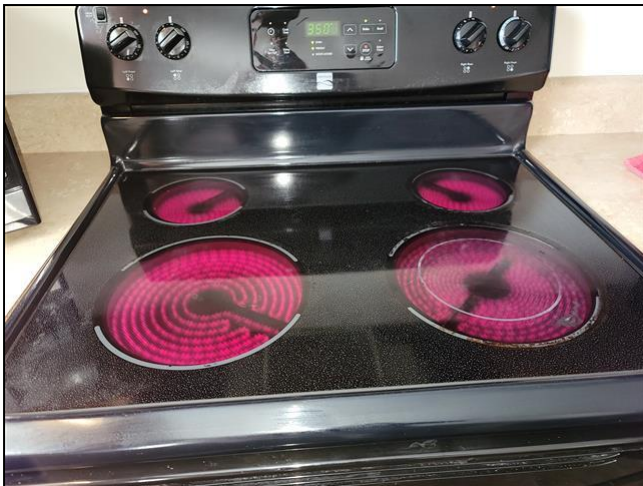
(2) I turned on all of the heat elements and the oven element. All of the elements and lights worked at the time of inspection. The ratings of the actual oven temperatures were not tested to verify the actual temperatures represented by the settings.

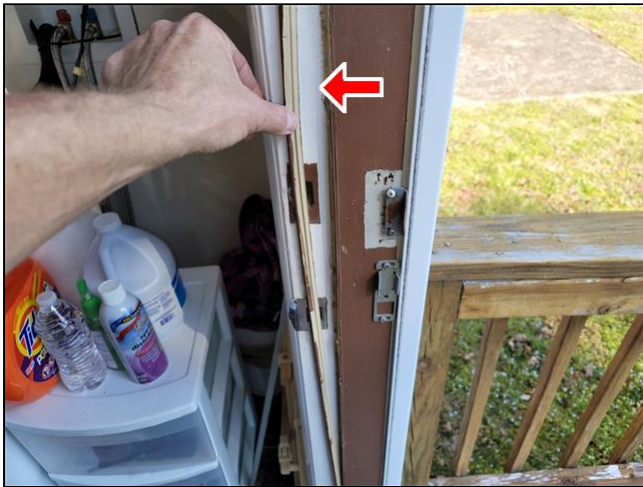
🏠 (3) The weather stripping is damaged at the rear exterior door.

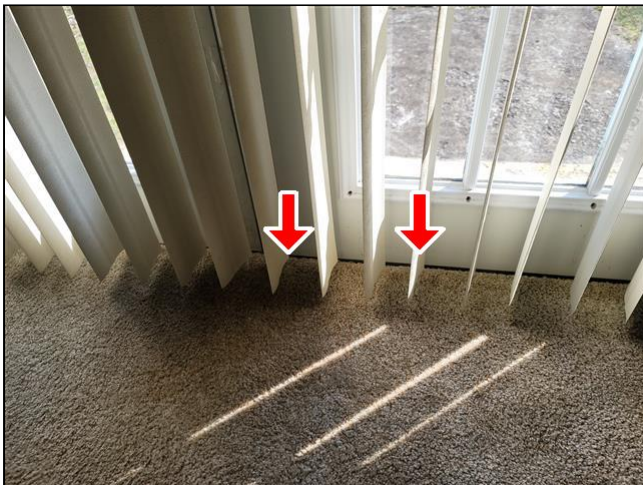
🏠 (4) **Rear exterior double doors located off of the living:** I was unable to operate the doors. They have improper type of weather stripping noted at the openable door and the door would not open over the carpeting. Have qualified company evaluate doors and correct as needed.

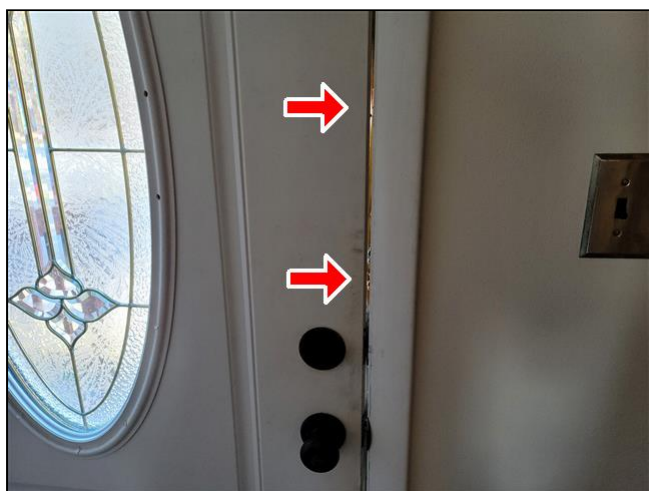
🏠 (6) Front entry door needs to have the weather stripping corrected I can see daylight through the edges of the door.

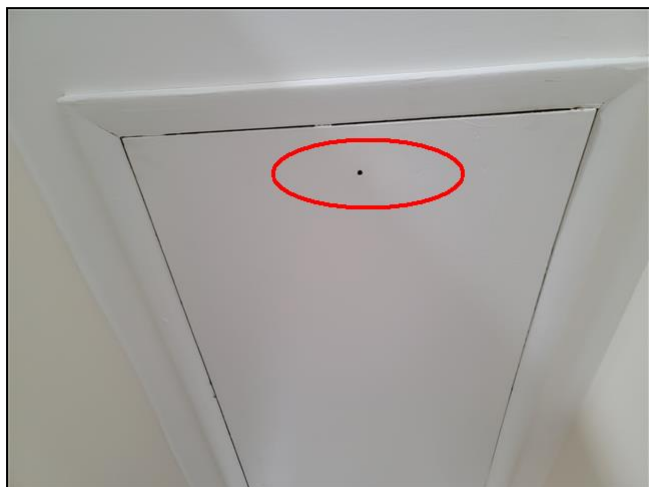
Estimated cost for all items listed above \$200- \$300+/-

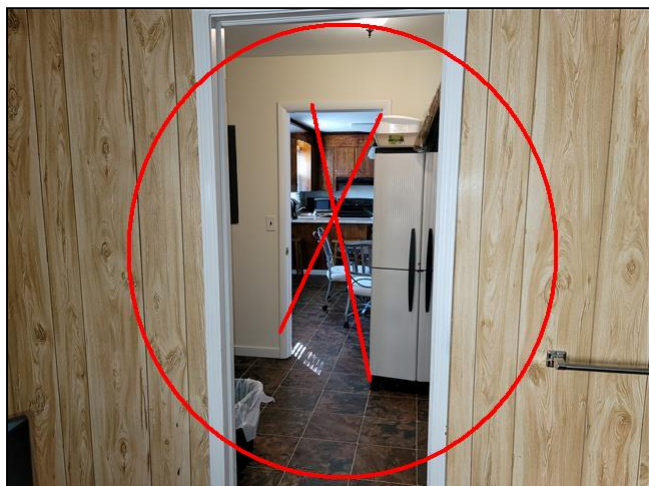
(8) Missing the two doors at the laundry room. If concerned have qualified company install as needed.

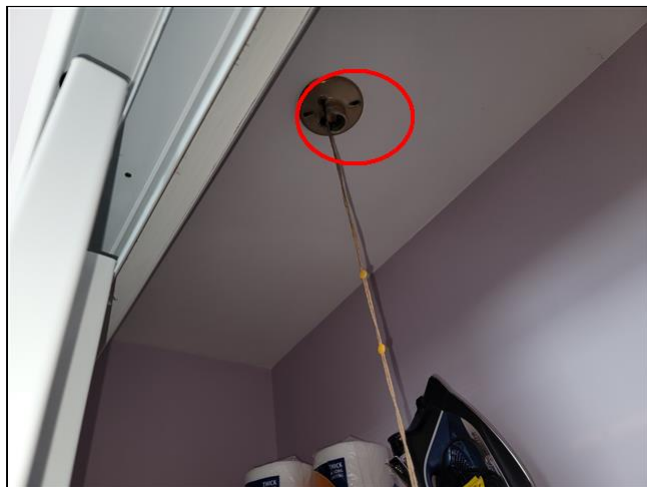
- ⚡ (1) Master bedroom closet was missing a light bulb.

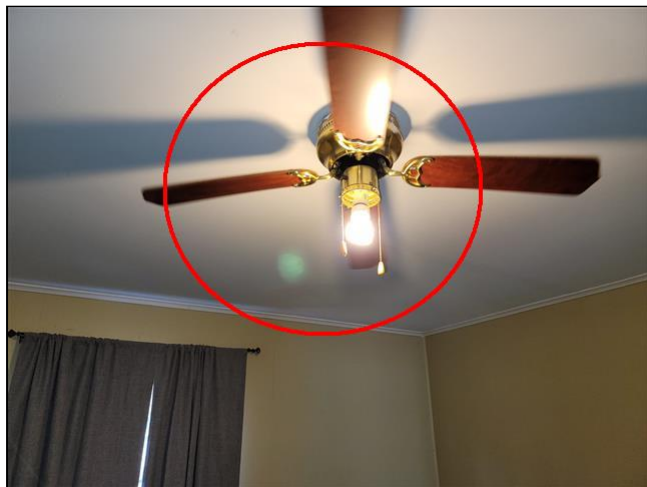
- ⚡ (3) Front right bedroom ceiling fan makes a clicking sound when operating. Also it's missing the bulb protection.

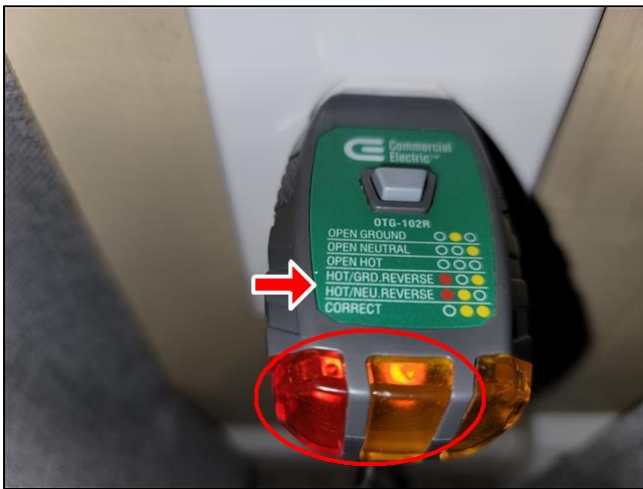
⚡ (4) All outlets in the front right bedroom have the hot and neutral wires reversed.

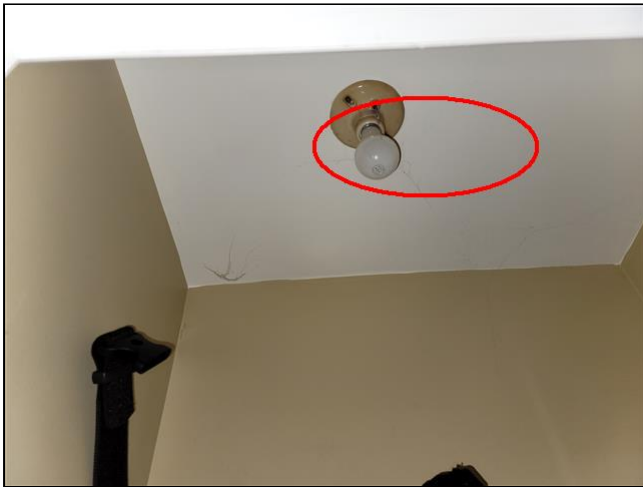
⚡ (5) Both front bedrooms and foyer closet lights are missing the pull chain (or it needs to be extended) to operate the lights.

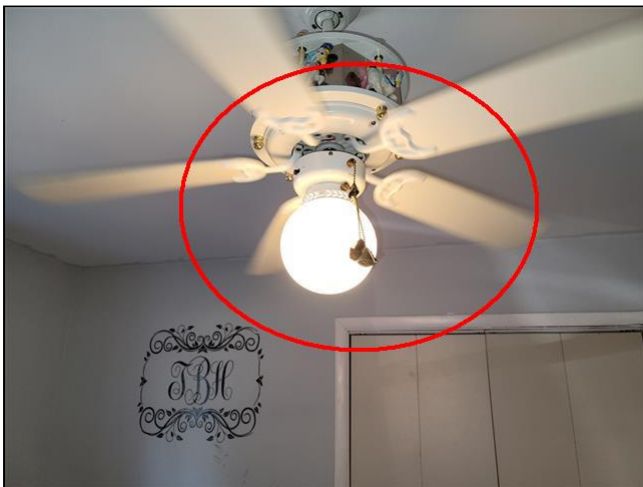
⚡ (6) The front left bedroom ceiling fan is not properly balanced. It wobbles significantly.

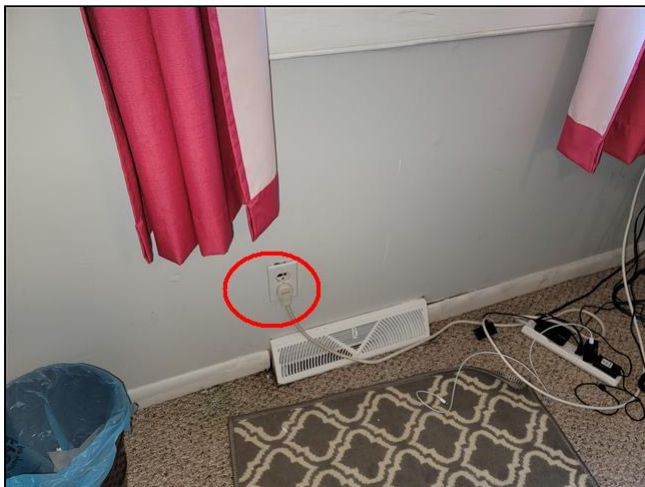
- ⚡ (7) Front left bedroom outlet at the front wall is ungrounded and it is loose at the wall. See wall section 4.5 regarding soft/spongy wall.

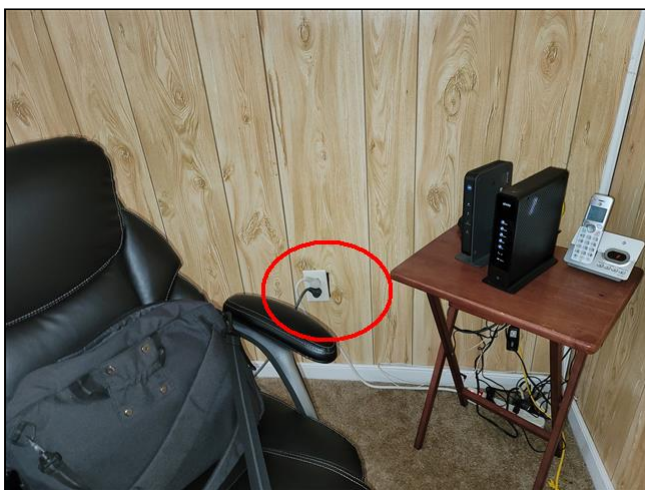
- ⚡ (8) The outlet in the right rear corner of the rear living room is loose.

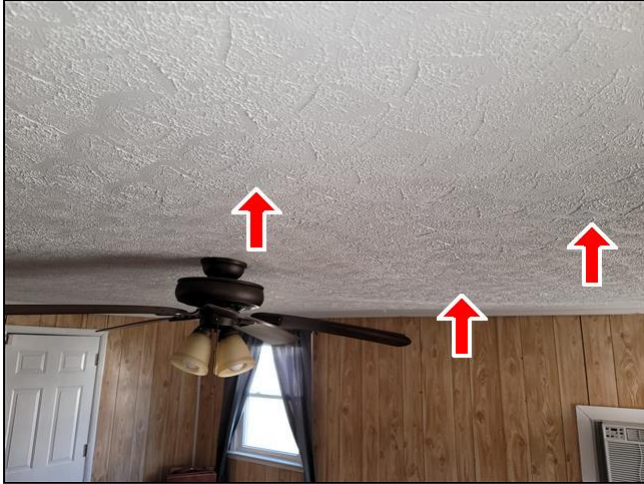
Have a qualified company evaluate and quote repairs & costs.

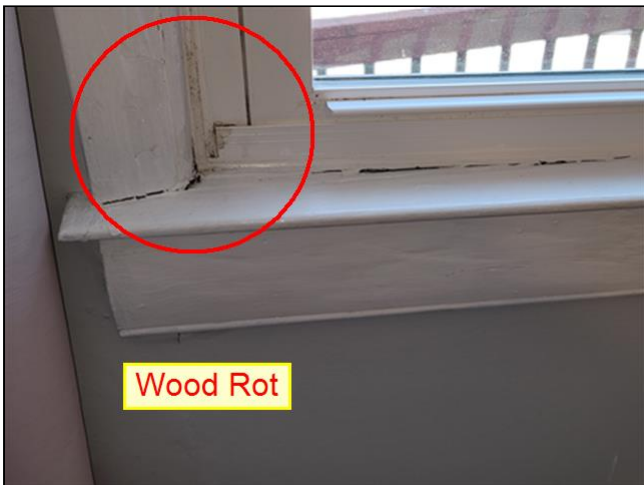
See section 6.2 regarding sub floor damage.

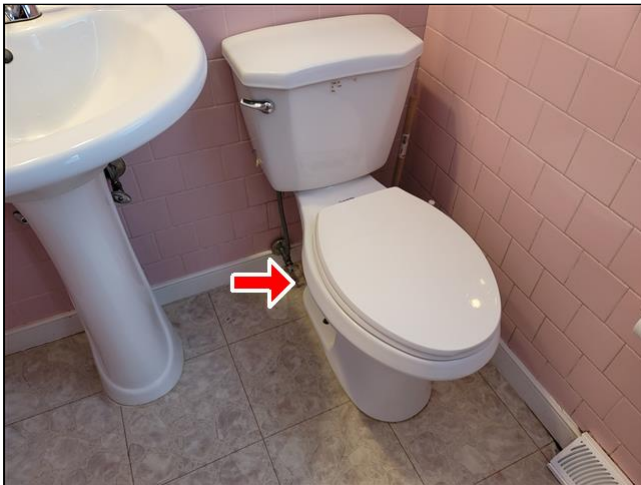
(1) The master bathroom and hall bathroom toilets are loose at the floor. Repairs may involve re-setting the toilet on a new wax seal. Have a qualified licensed plumber repair or correct as needed. \$125-\$175

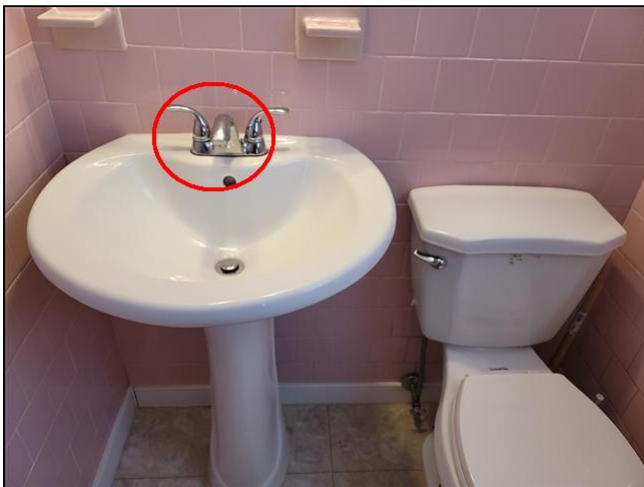
- (1) Master bathroom vanity sink water pressure appeared low and was reduced further when the toilet was flushed. Have this evaluated by a licensed plumber and corrected as needed. \$125- \$200 +/-

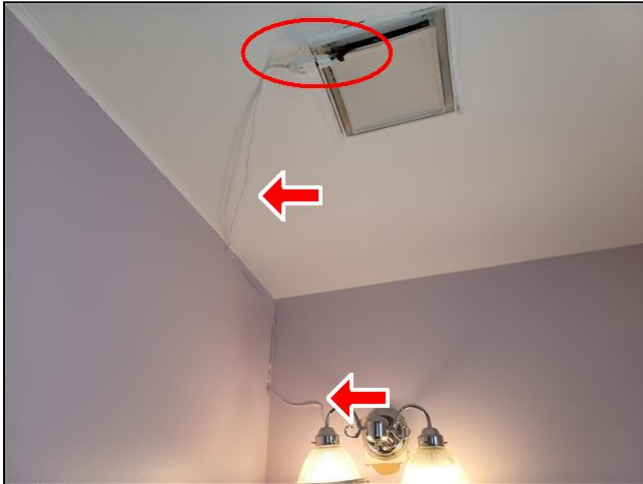
- ⚡ (1) Master bathroom exhaust fan is improperly wired. It has an extension cord running to it which is attached to the surface of the wall. The fan should have permanent wiring. Also, I could not verify if the fan worked because it was not plugged in. \$125 to \$175 +/-

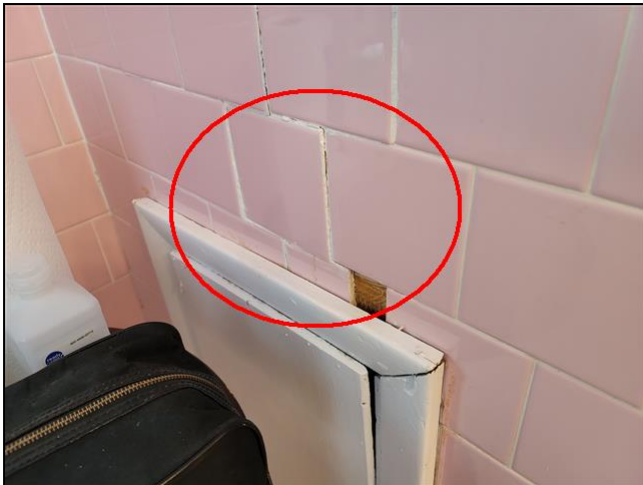
- 🏠 Master bathroom had some damaged & loose tile noted at the left wall and behind the toilet. \$125- \$175 +/-

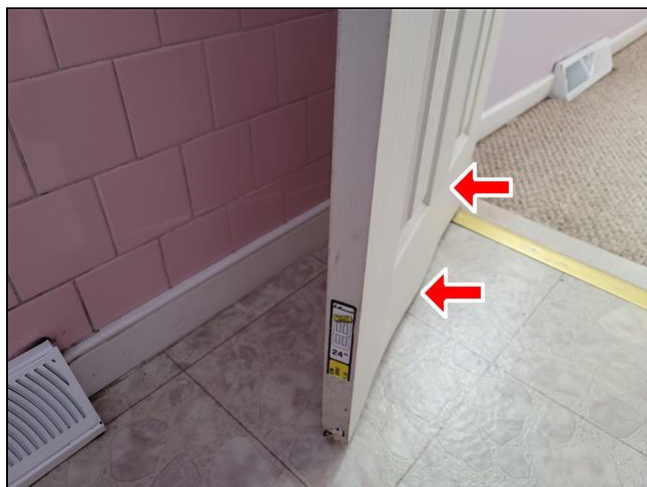
- 🏠 Master bath door is missing the solid block at the bottom of the door which is causing it to warp. Also, the door does not latch closed. \$175- \$225 +/-

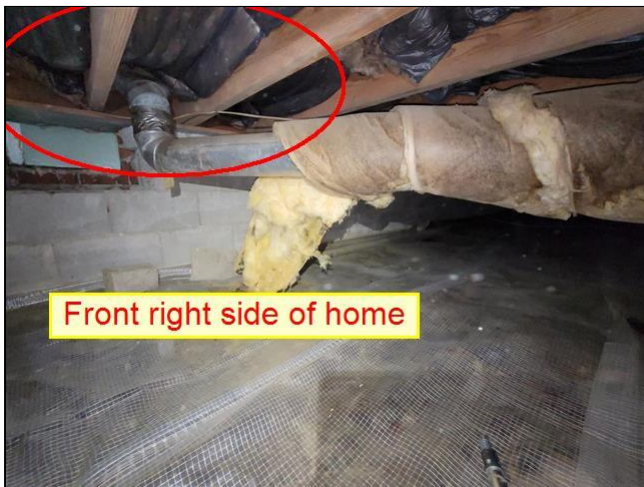
Have a qualified company evaluate and quote repairs & costs.

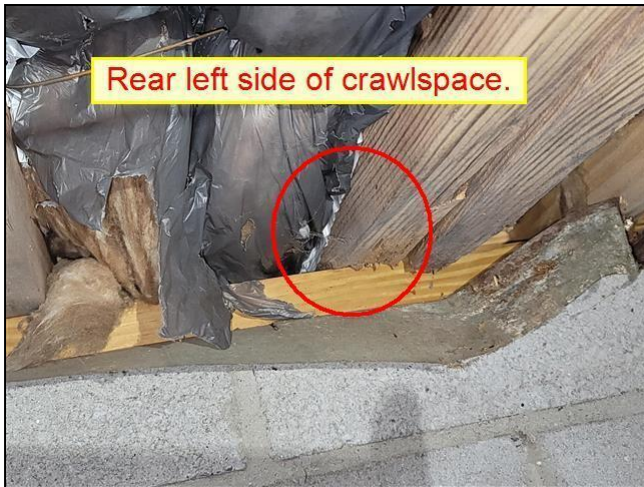
Have a qualified company evaluate and quote repairs & costs.

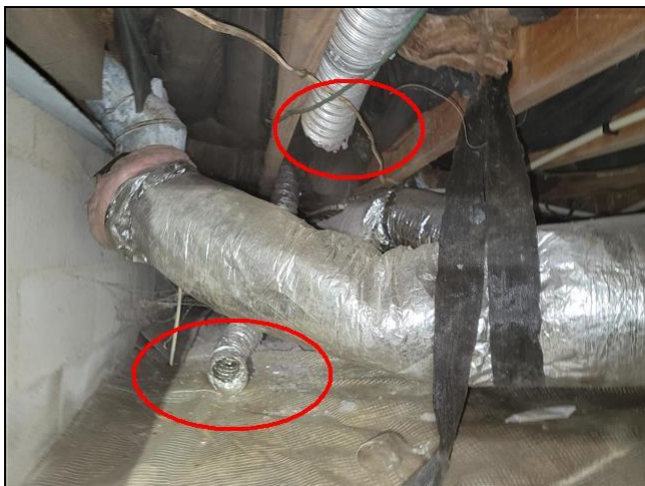
(1) Dryer vent is disconnected in the crawlspace. There is a significant amount of dryer lint in this area. Recommend to use smooth hard metal pipe as a dryer duct material and run it as straight as possible. \$125- \$150 +/-

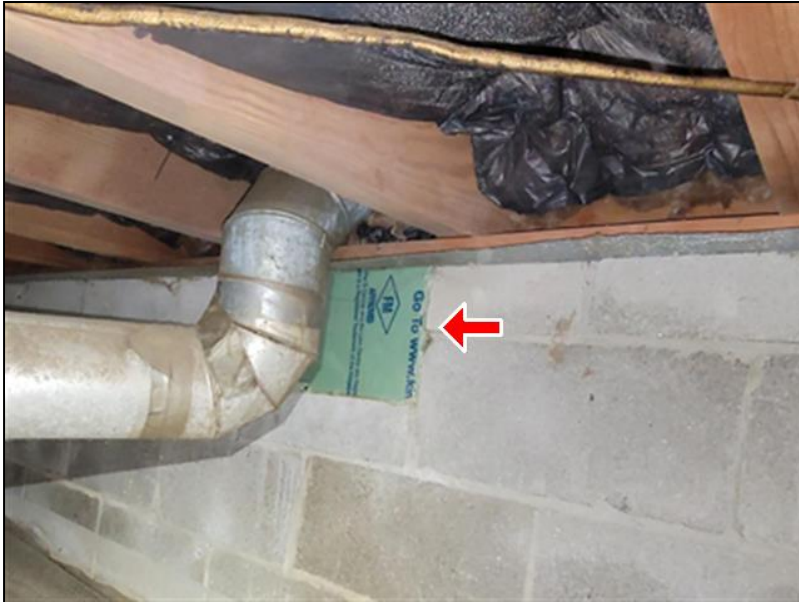
Note-Most of the crawlspace vents have been sealed closed with insulation from the interior of the crawlspace. If concerned, have a qualified company evaluate and correct if needed.

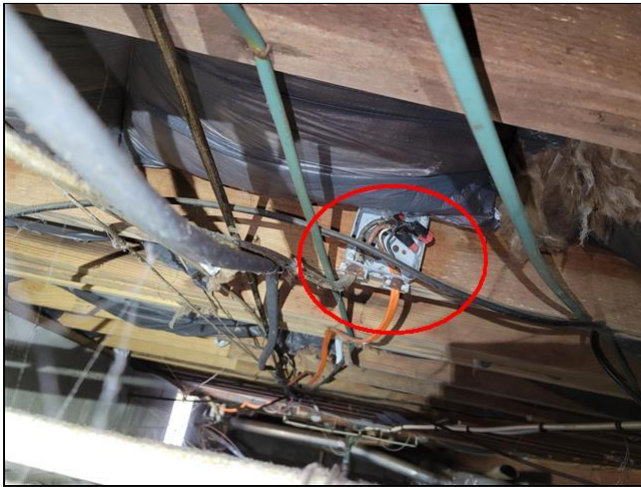
There is an open junction box noted in the left rear crawlspace. \$75- \$ 100 +/-

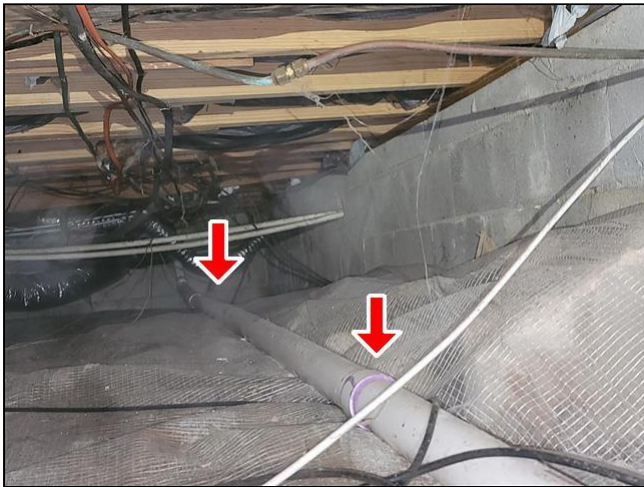
There's a pvc waste line located at the rear left part of the crawlspace that is not properly supported and doesn't appear to have the correct slope to drain. \$100- \$150 +/-

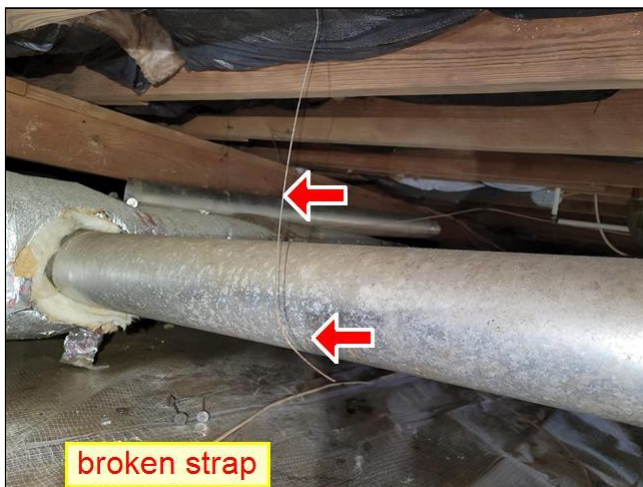
6.10 Item 1(Picture)

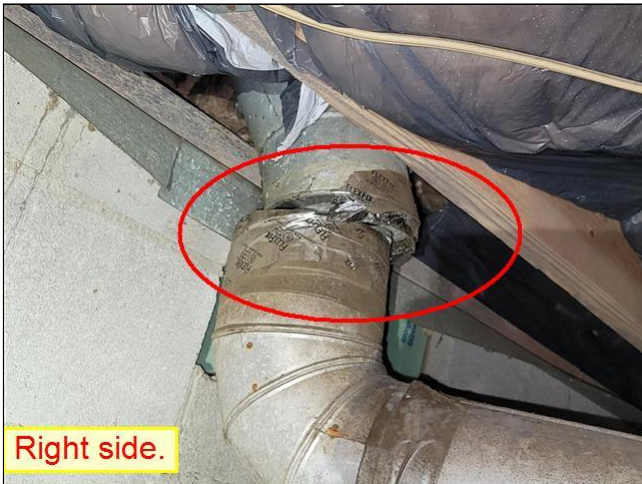
6.10 Item 6(Picture)

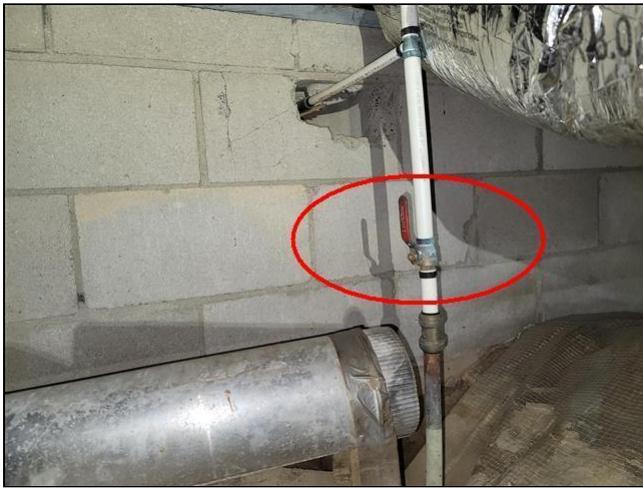
The main water shut off is located in the crawlspace. Not easily accessible. It's located in the front middle crawlspace.

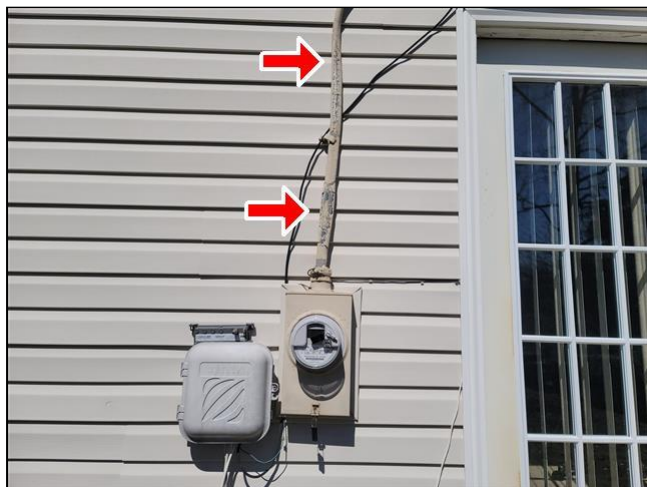
The electrical service conductors are frayed at wire sheathing outside and needs to be corrected. \$300- \$400 +/-

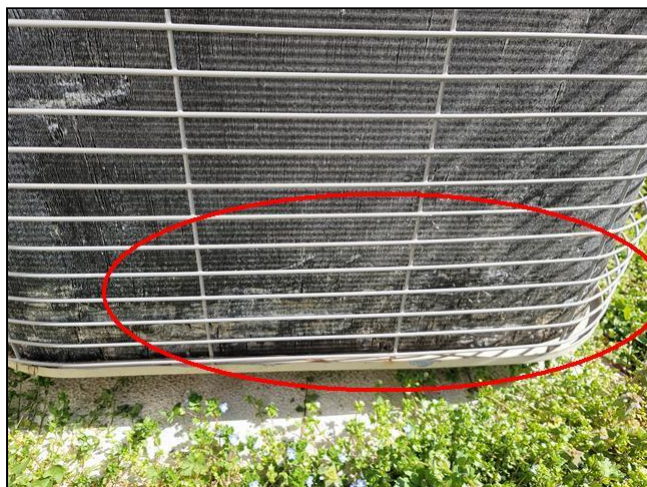
☒ (1) The fins on the outside unit were bent and should be corrected as needed by a licensed HVAC contractor. \$150-\$200 +/-
