# Inspection Report

## Customer Name Sample Report

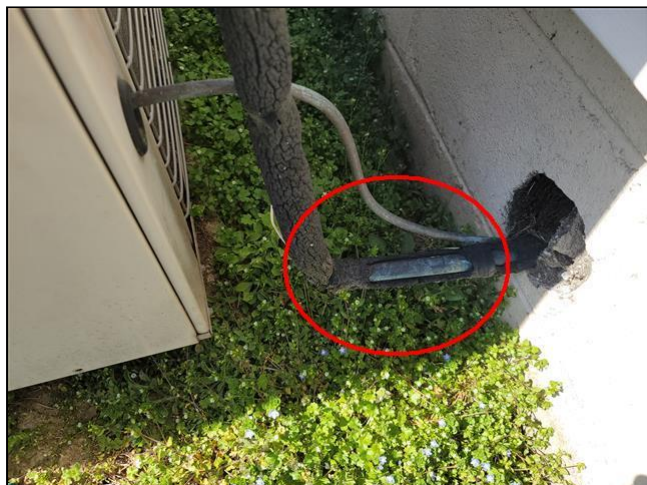
☒ (2) The foam sleeve on the suction line is missing/damaged in area(s) at the outside unit. Missing foam on suction line can cause energy loss and condensation. \$75-\$100

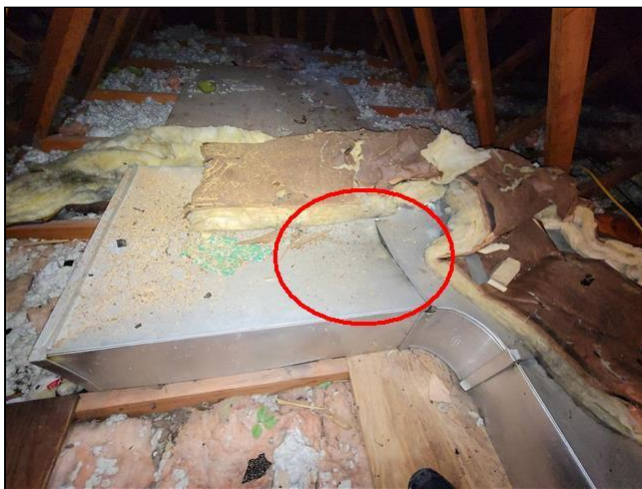
The return air duct in the attic has some openings and gaps noted. Also, the insulation on the duct work has mostly fallen off the duct work. \$250- \$350 +/-

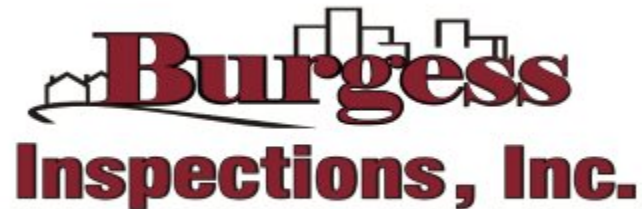
**Burgess Inspections, Inc**
