Confidential Pool Inspection Report

LOCATED AT:
6565 Main St
Midlothian, VA 23113

INSPECTED ON:
Friday, December 8, 2023

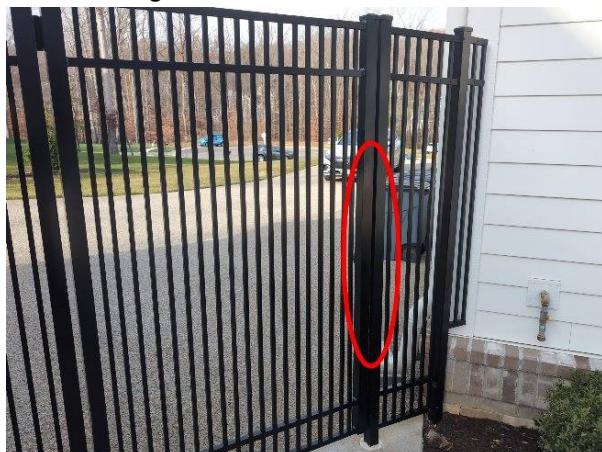
6: The front gate near the garage has the latch on the exterior. The latch is not easily reached from inside the gate. Correct as needed.

Unable to open from the inside

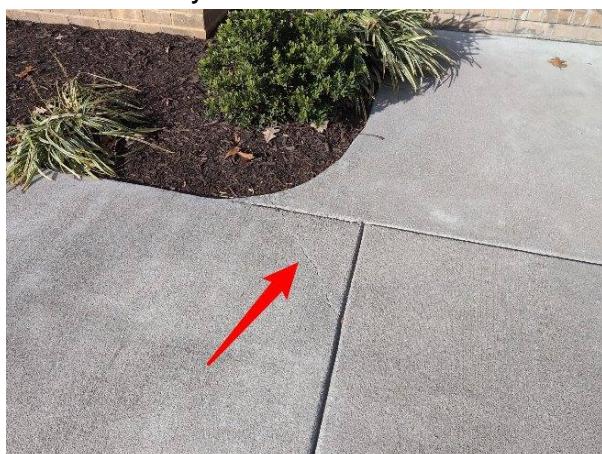
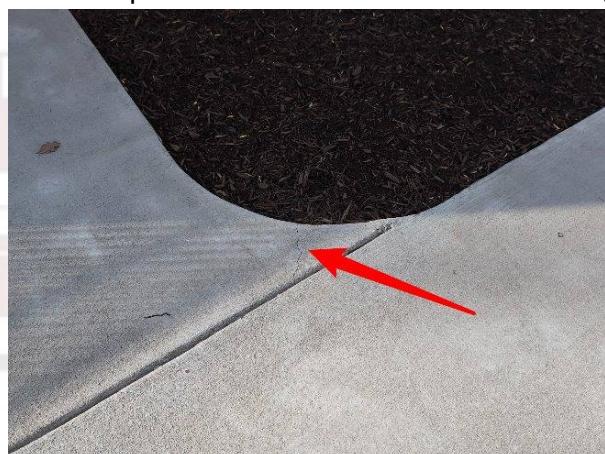
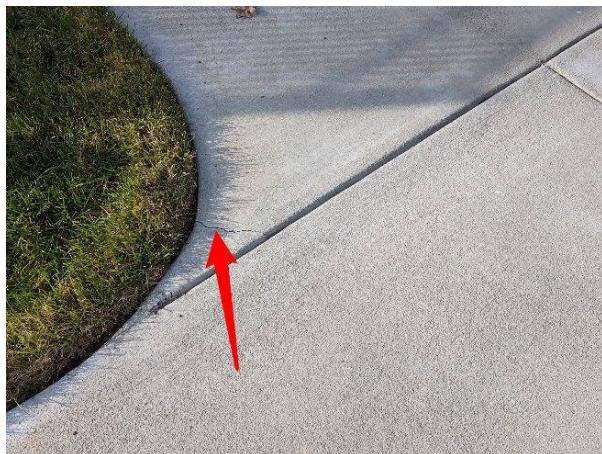
7: There was cracking observed at the pool deck. Sealing to prevent further damage during freeze/thaw cycles is recommended. Location: near the patio and near the entrance to the garage.

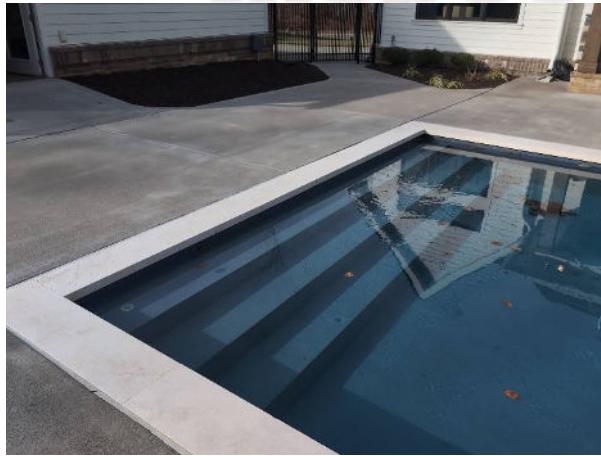
12: The handrail was missing and should be installed for safety.

Missing handrail

s-12: The handrail was missing and should be installed for safety.

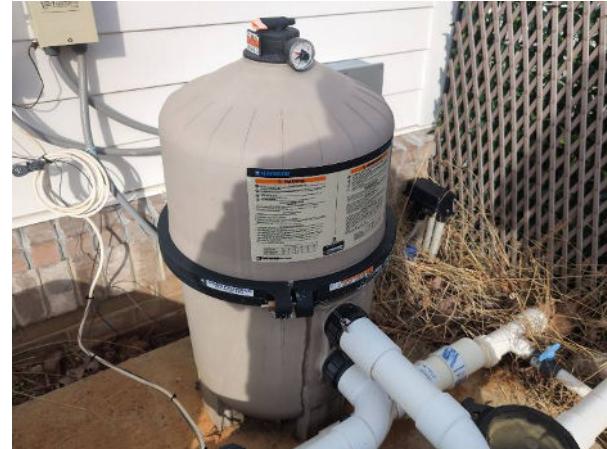
16: The pressure gauge was reading beyond 60 psi. This suggests that the filter is dirty or the gauge is not working. Recommend a licensed pool contractor evaluate and correct as needed.

Arrow points to the reading on the gauge.

s-16: The pressure gauge was reading beyond 60 psi. This suggests that the filter is dirty or the gauge is not working. Recommend a licensed pool contractor evaluate and correct as needed.

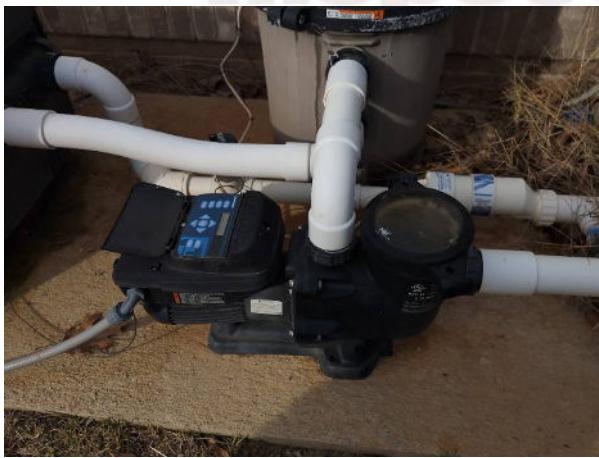
18: Pump Manufacturer: Hayward 2019

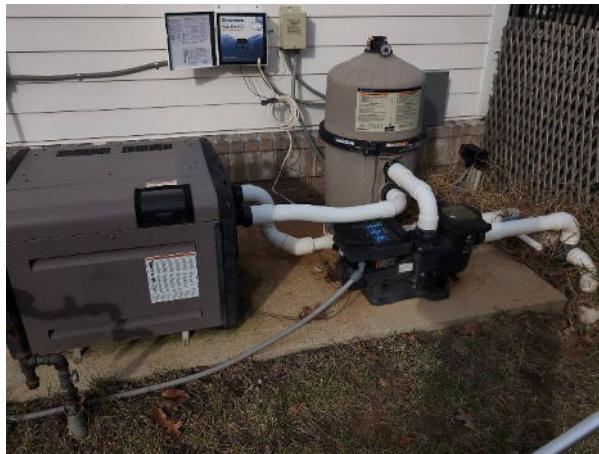
22: There were no issues observed with the visible piping.

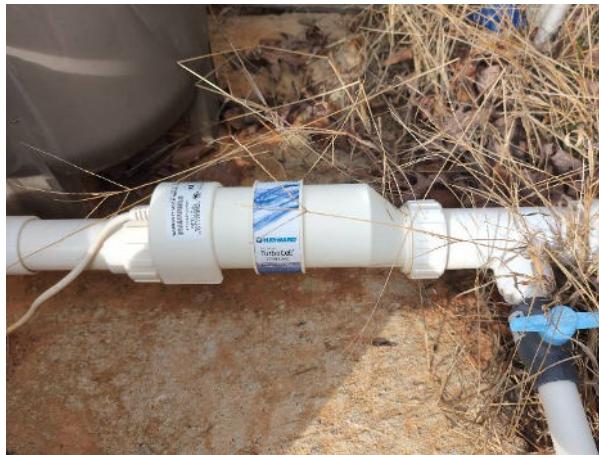
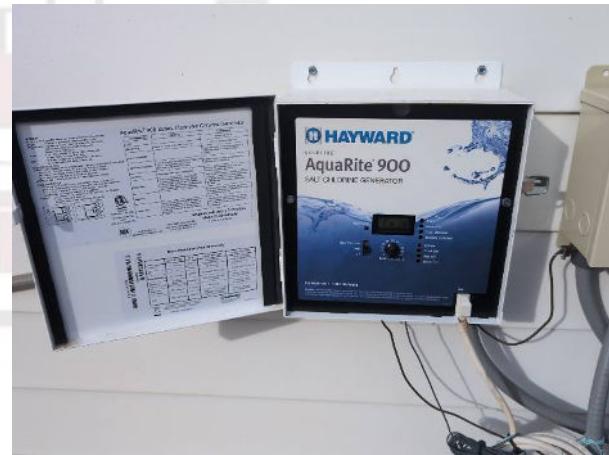
23: A salt cell was present. These typically have a life expectancy of 3-5 years, and require cleaning. Recommend asking seller the age of the cell and the service history.

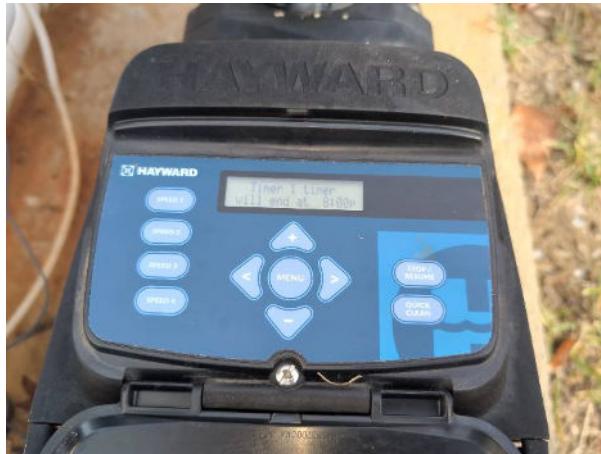
26: Inspected

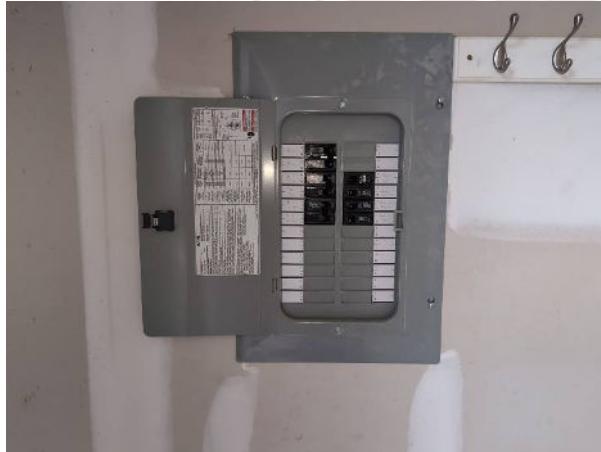
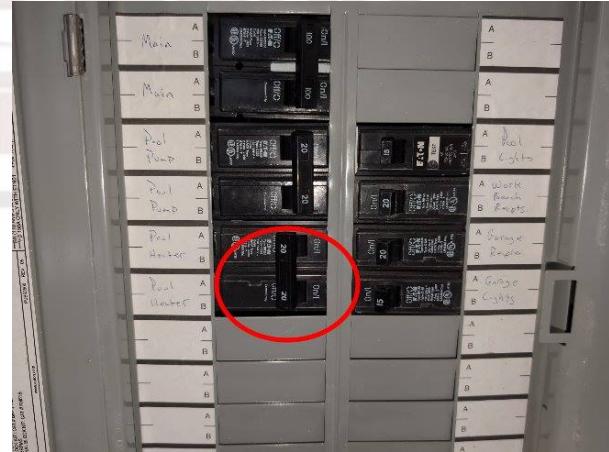
29: The electrical panel for the pool was located in the garage. The breakers are labeled.

Pool heater breaker is turned off.

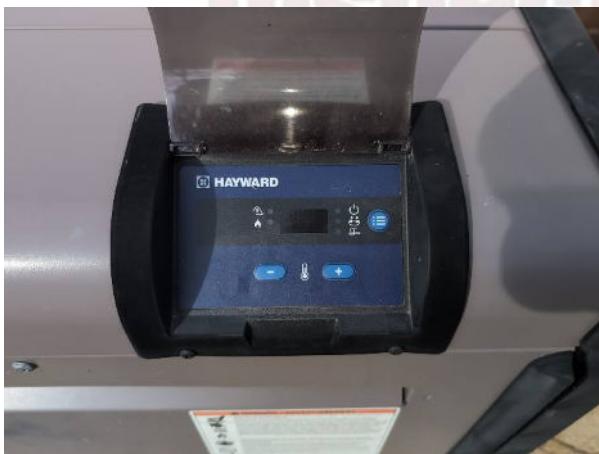
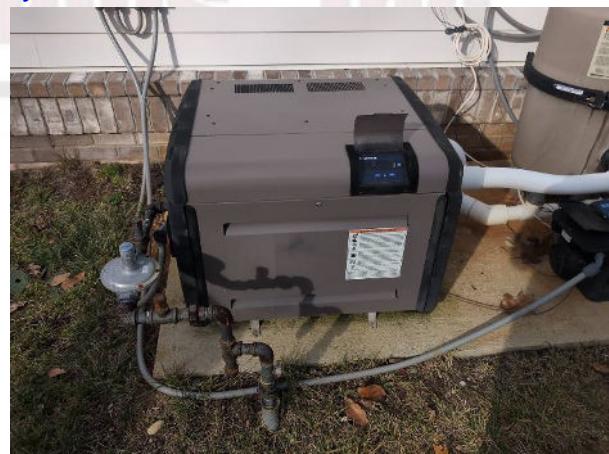
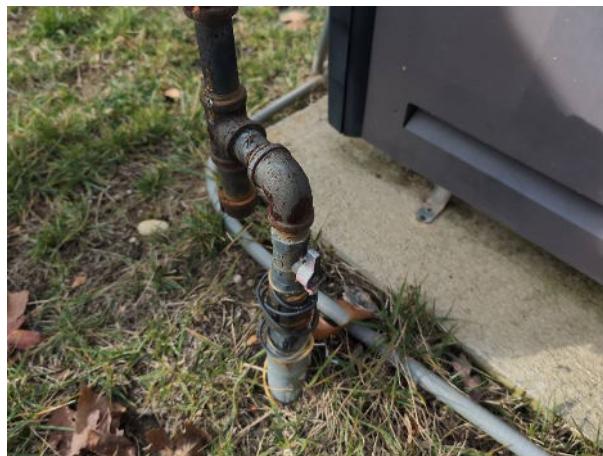
32: There was a natural gas heater installed.

33: The pool heating equipment was turned off at the breaker. Recommend checking with the current homeowner to determine the functionality.

s-33: The pool heating equipment was turned off at the breaker. Recommend checking with the current homeowner to determine the functionality.
