Confidential Mold Assessment Report

LOCATED AT:
8675309 Good St
Richmond, VA 23235

INSPECTED ON:
Wednesday, July 5, 2023

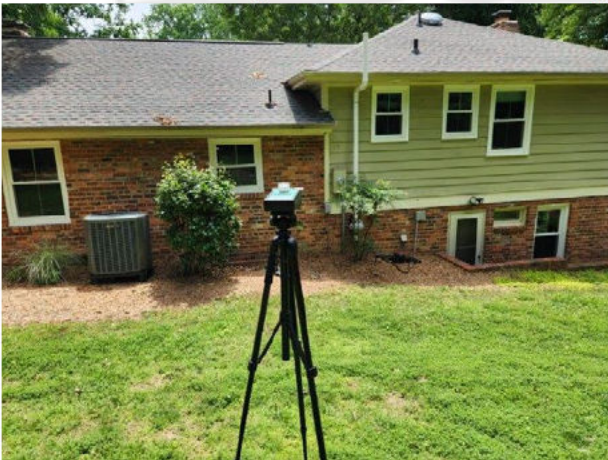
6: The exterior sample was taken in the back yard near the play ground.

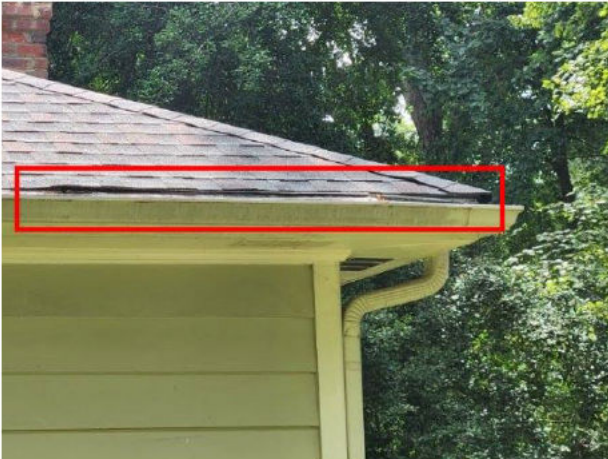
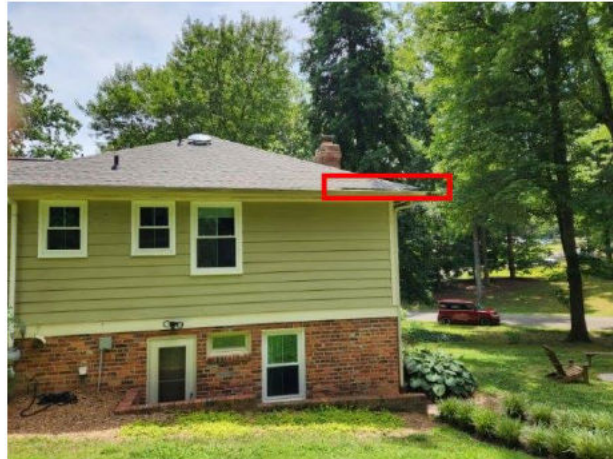
7: The rear left corner of the roof appeared to have loose shingles near the gutters. This can be conducive to moisture intrusion.

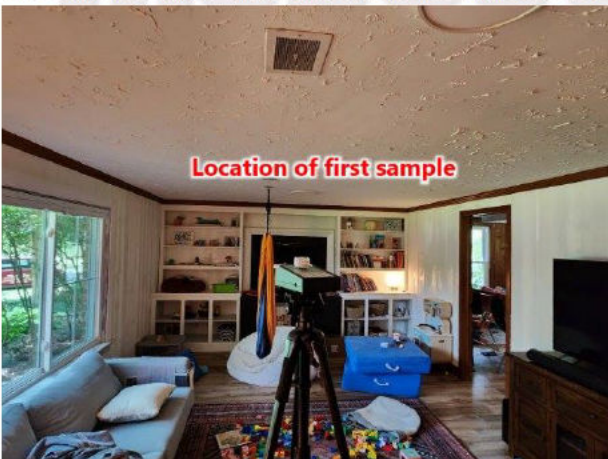
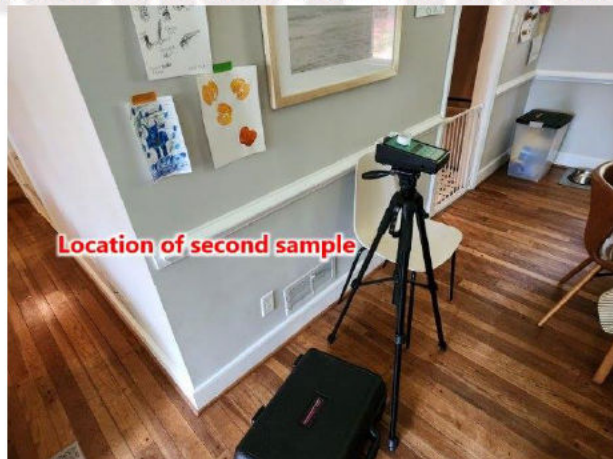
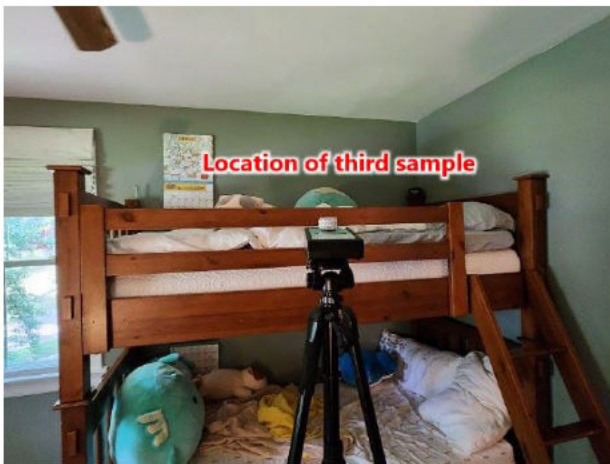
8: The first sample was taken in the lower level play room by the ceiling supply vent.

The second sample was taken on the mid level in the dining room at the wall supply.

The third sample was taken on the upper level in the rear front bedroom at the center of the room.

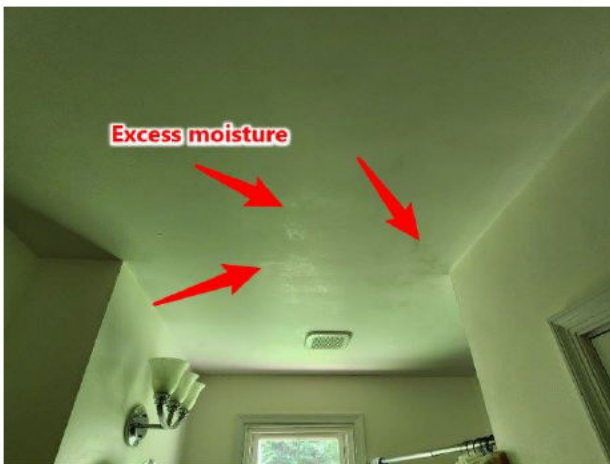
9: The upper level bathroom vent appeared to be functioning improperly as excess moisture was built up within the bathroom. This can be conducive to mold and moisture intrusion in the home.

Note: clients have stated that mold issues have occurred in the past in the bathroom.

12: Based on the results of the lab and the conditions within the house it is a strong possibility that the bathroom vent is the source of previous mold in the bathroom. It is recommended that the vent should be replaced/improved for proper ventilation/ removal of excess moisture buildup.
