## Inspection Report

### Company Name Sample Report

**Property Address:**  
1234 Main Street  
Central VA 12345

**Burgess Inspections, Inc**

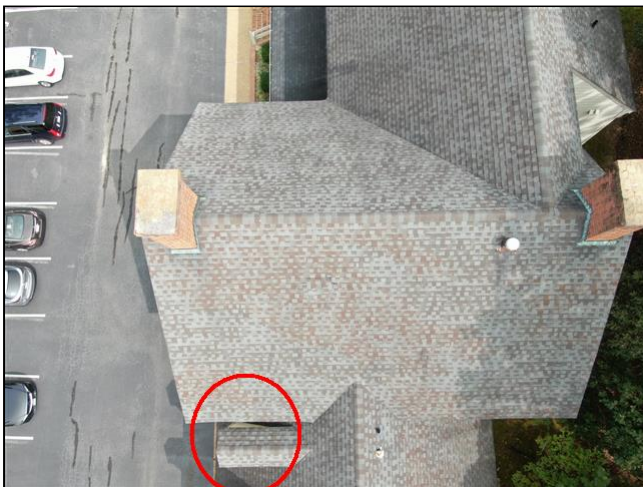
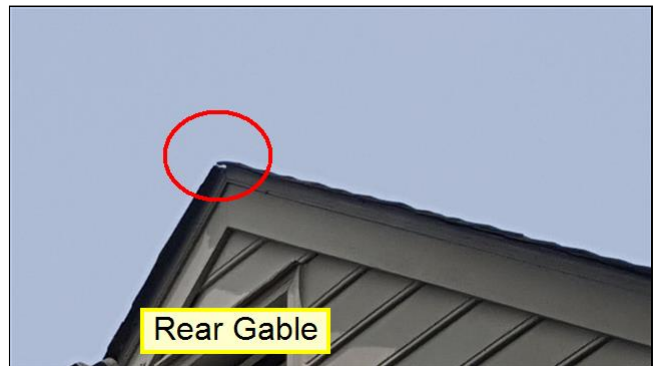
🏠 (4) There was a damaged ridge shingle noted over the roof dormer at Southside Insurance and over the rear gable end.

(2) Have a qualified licensed contractor repair or replace all roofing, Roof Structure, Chimney items as needed, the following was noted:

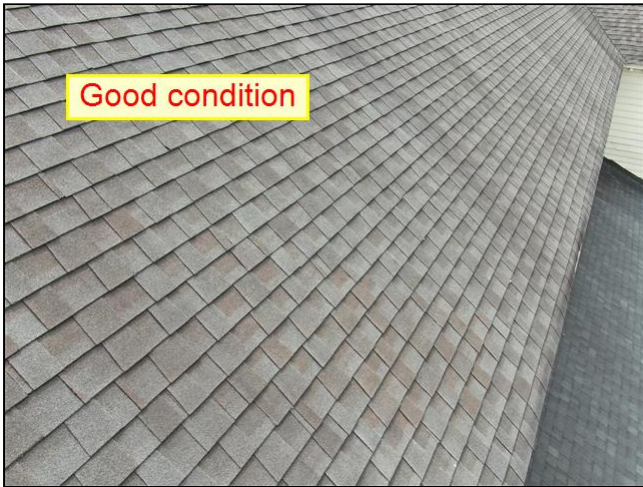
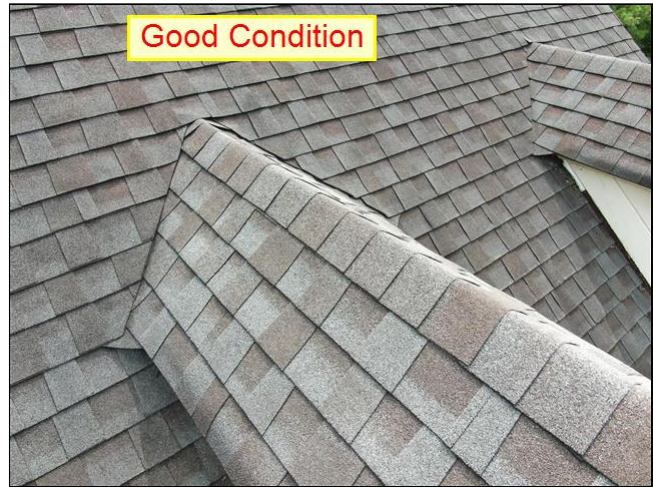
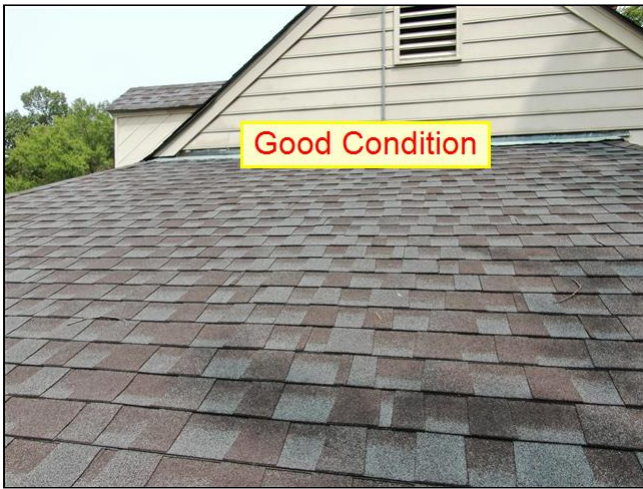
(5) In general, the roofing is in good condition.

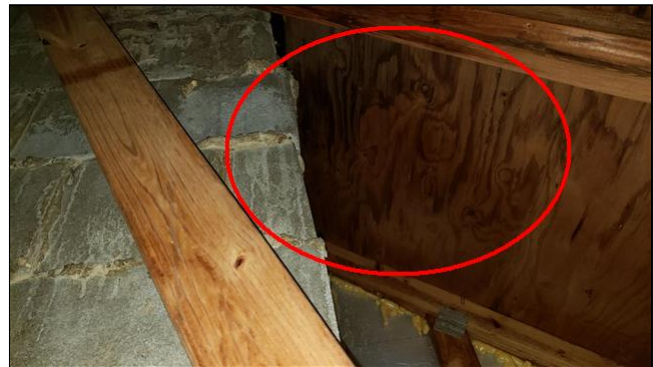
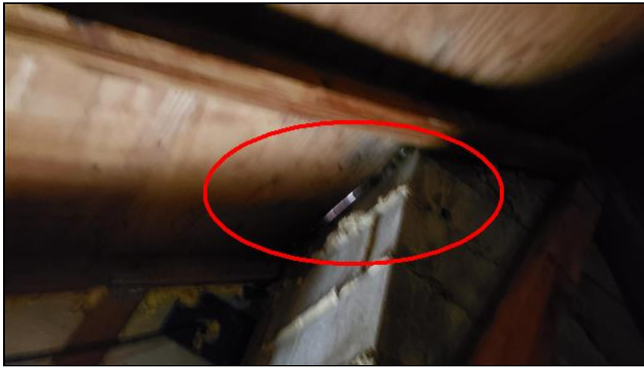
Some moisture stains noted in the knee wall attic space at the back office and also at the sides of the rear chimney chase in the upper attic. They were dry at the time of the inspection but it's beyond the scope of this inspection to determine if they will leak in the future.

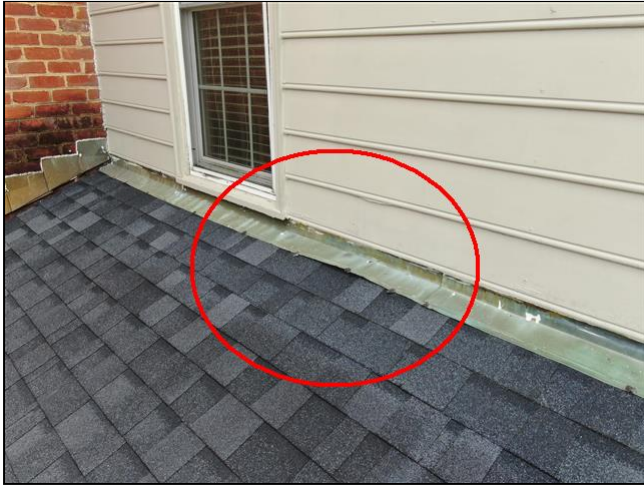
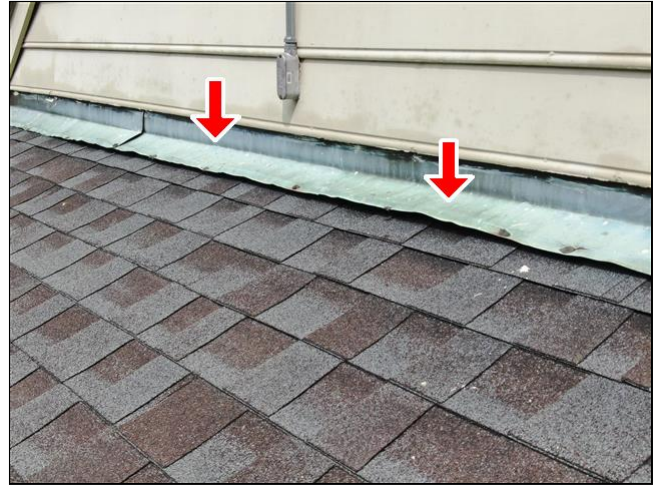
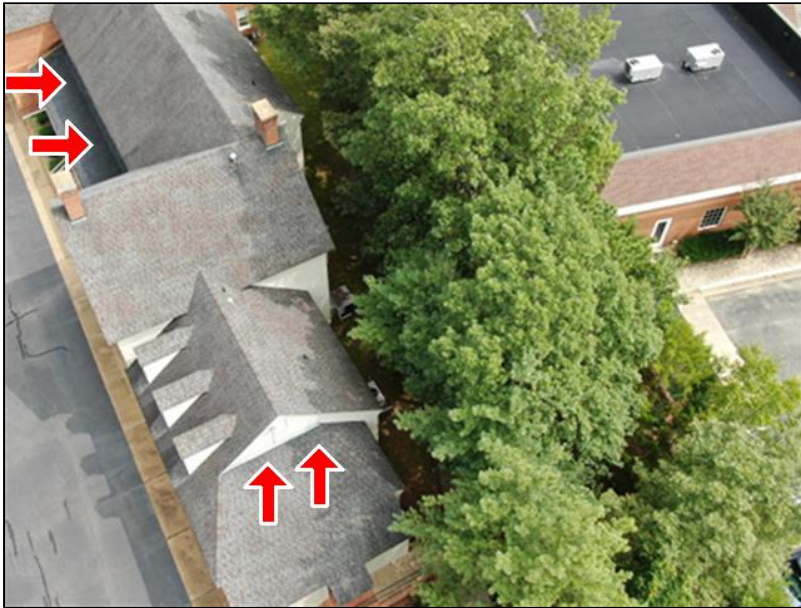
- 🏠 (1) The roof to wall flashings at the front entry low roof and the low roof over the far right side suite has nails that are withdrawing at a couple of places.

Refer to photos.

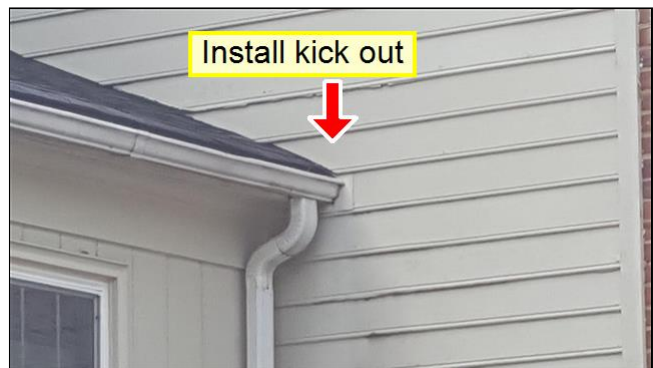
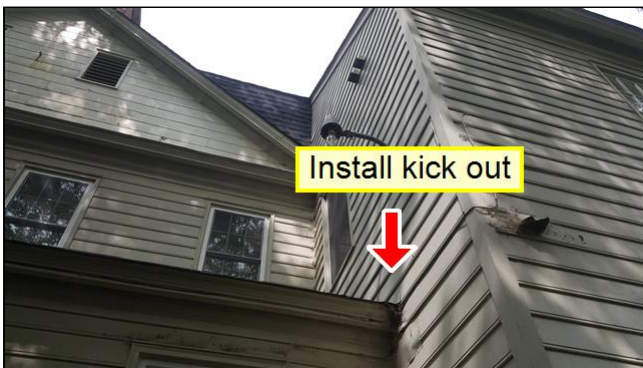
📍 (2) Moisture damage and staining was noted under the gutters that terminate against the siding. Install kick out flashing to help prevent moisture from overloading the gutter and running down the exterior wall.

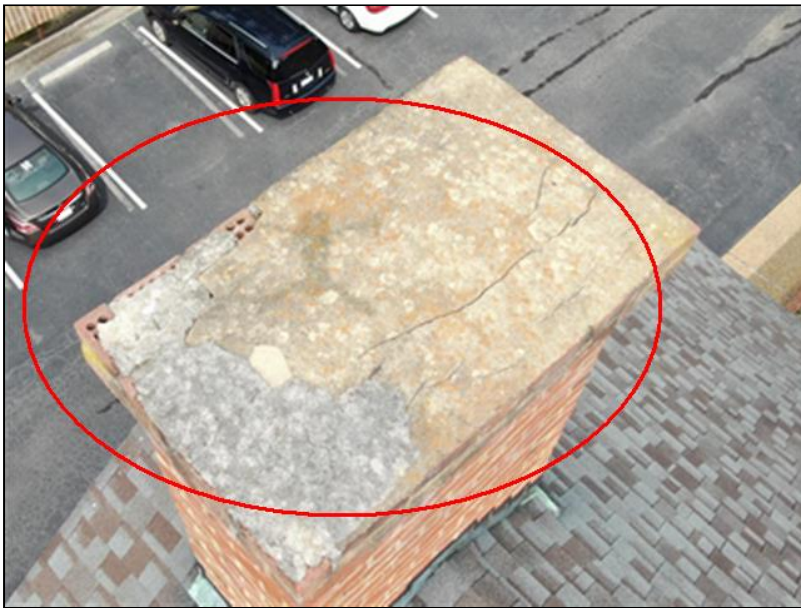
1.2 Item 2(Picture)

(1) The crown on all chimney caps are deteriorated and cracked. Have a qualified mason to repair all chimney caps as needed. Refer to photos for examples.

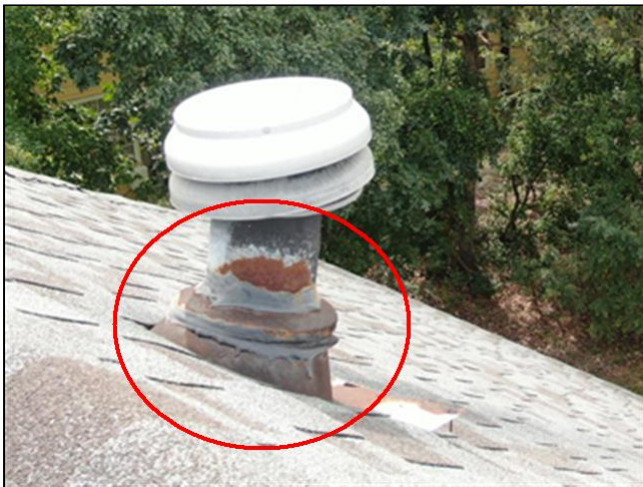
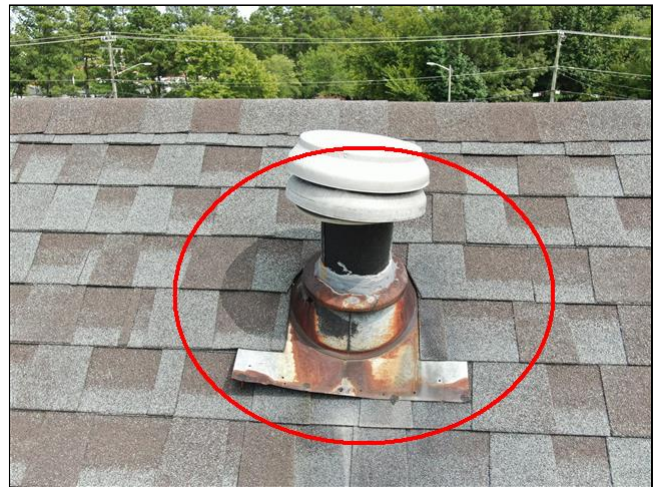
(2) The gas flue vents and flashings at the roof showed significant rusting. Refer to photos for examples.

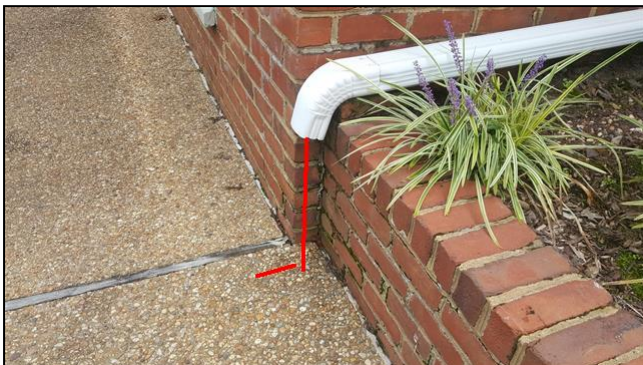
1.4 Item 1(Picture)

(1) Recommend extending the downspouts at the retaining walls to prevent splashing and extended moisture damage to the sealed aggregate sidewalk.

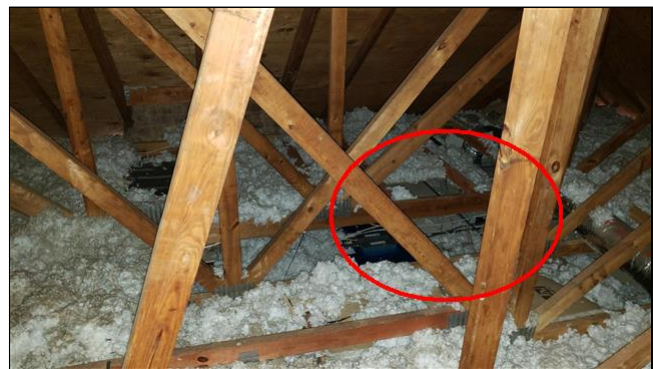
1.6 Item 2(Picture)

There were multiple random areas in the attic that were missing insulation.

Note- There were multiple areas where the drywall had collapsed as noted in section 5.0 allowing the insulation to fall through.

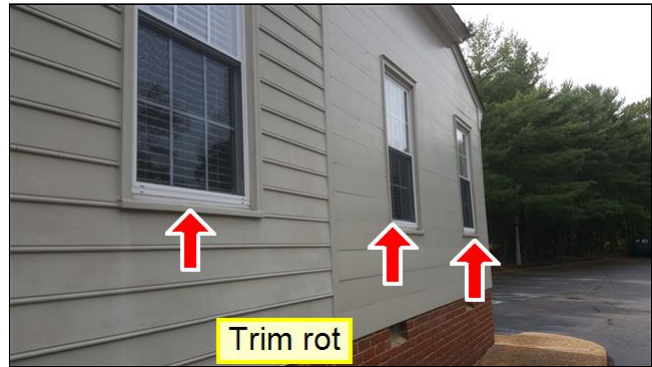
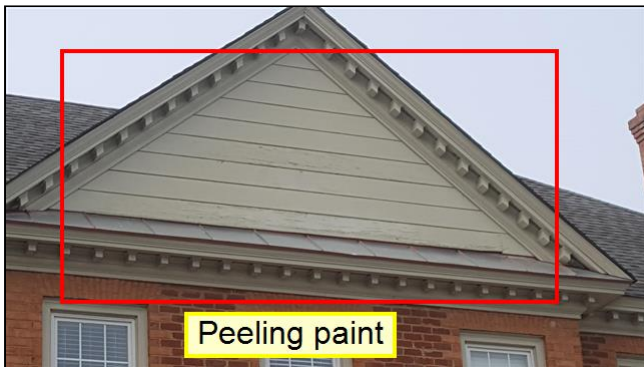
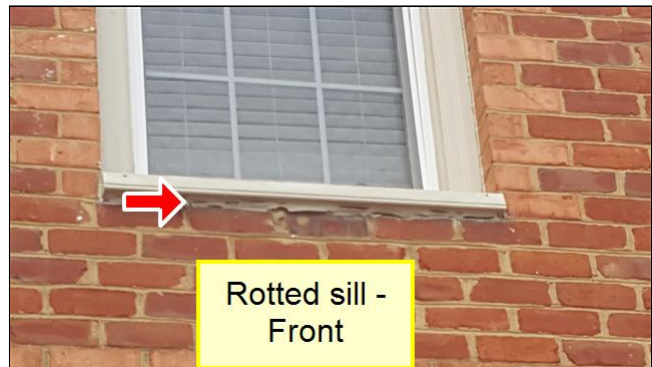
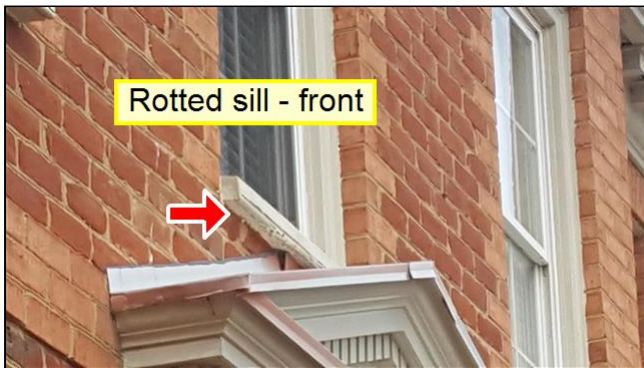
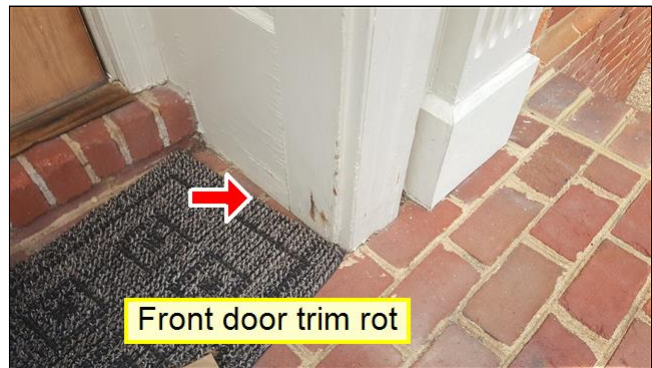
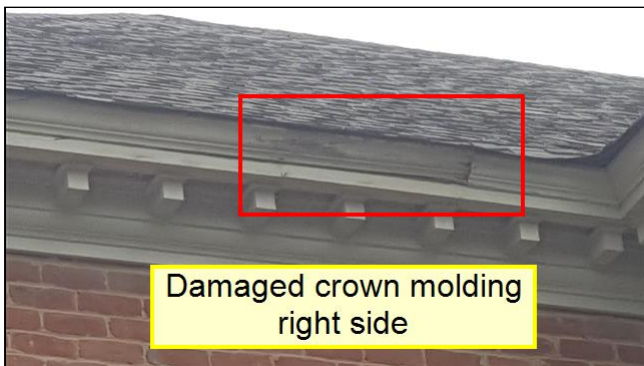
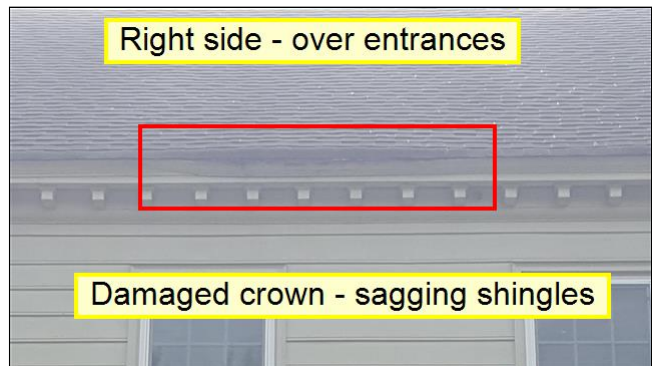
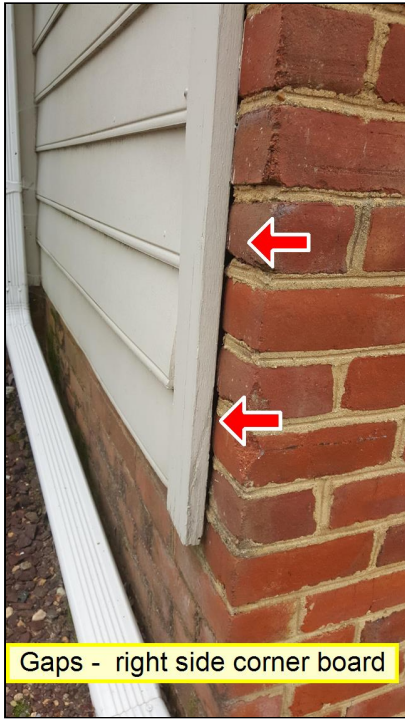
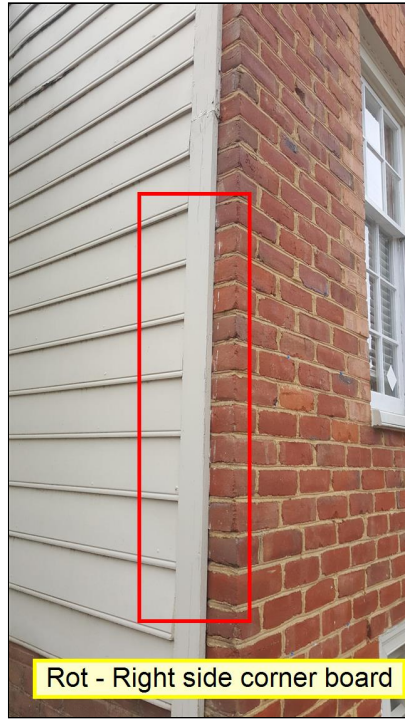
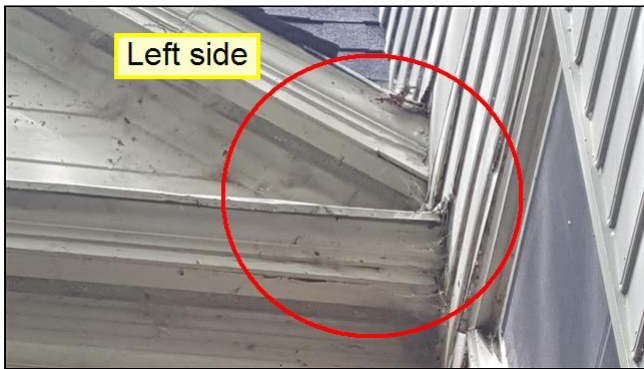
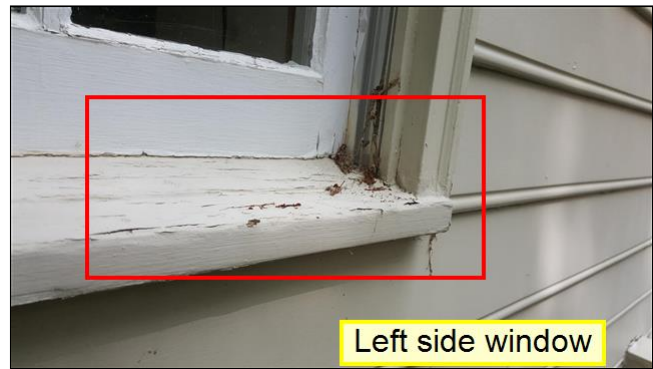
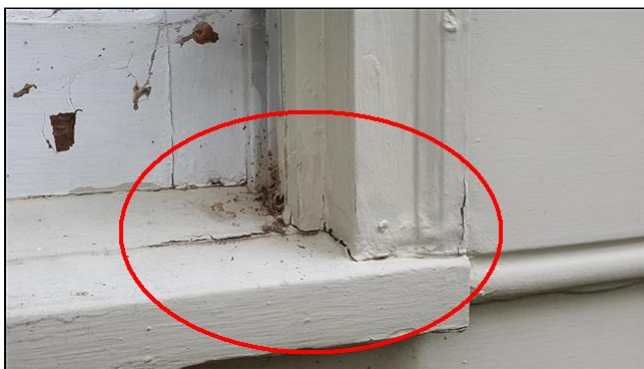
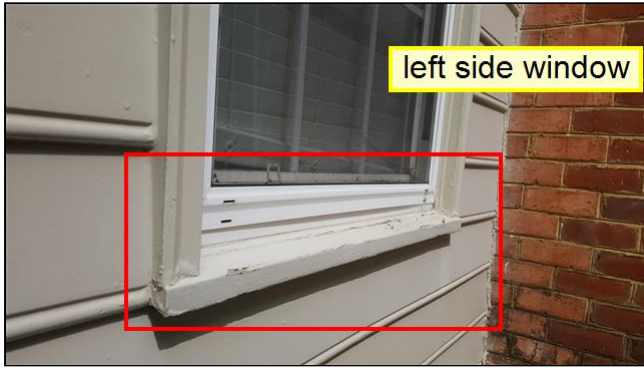
🏠 (5) Wood corner trim boards, crown moldings and window trim showed significant rot in areas. Damaged crown moldings indicate possible roof leaks in these areas. See photos for examples with locations. Correct all as needed. There is also bare wood in some areas from paint peeling, evaluate and seal all areas as needed.

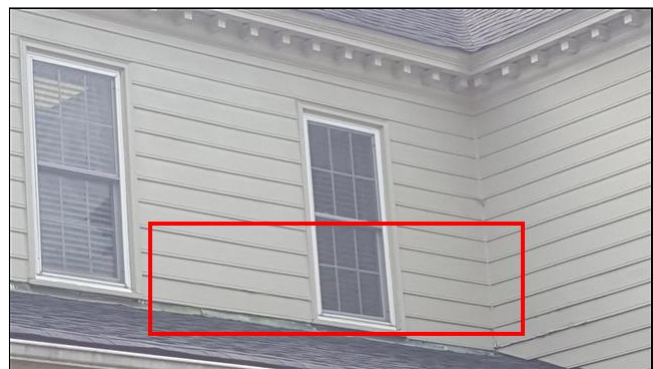
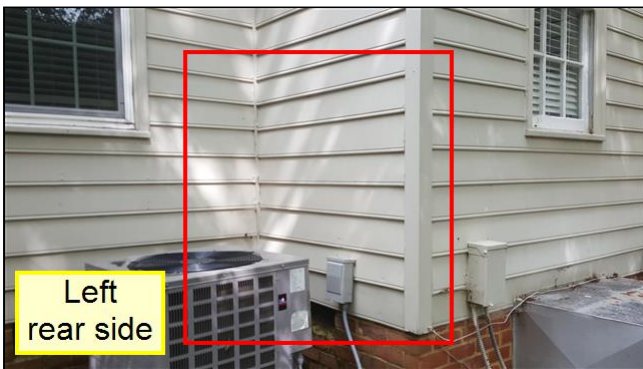
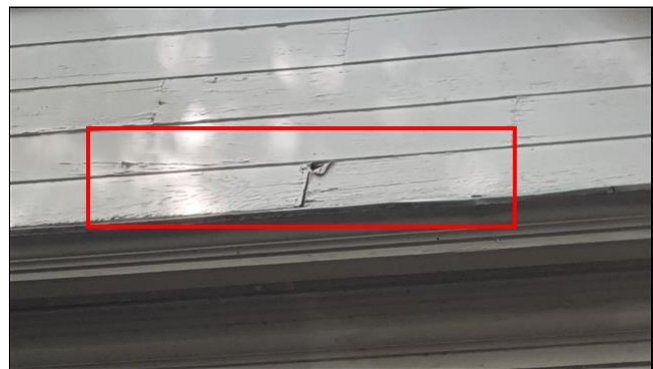
🏠 (9) Significant moisture damage and soft areas were noted on the right and left sides of the building at the composite siding. Evaluate and correct all as needed.

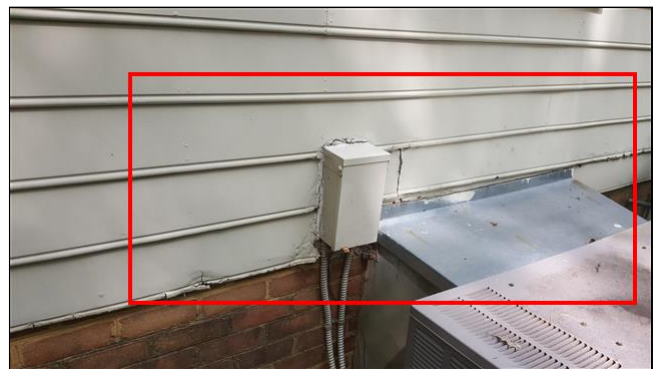
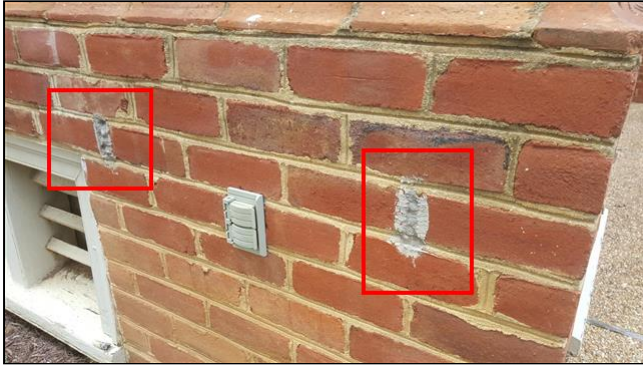
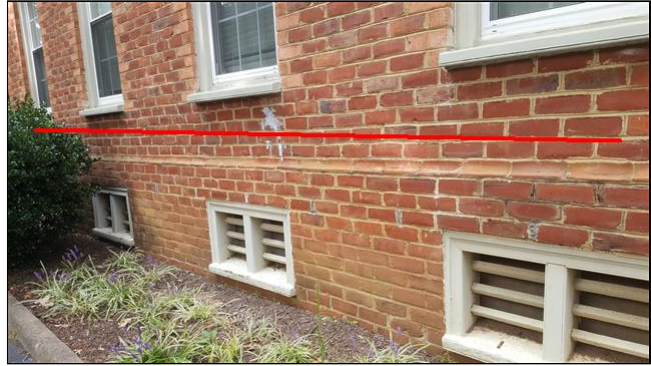
- 🏠 (10) Weep holes on the front left and left front sides have been filled in with mortar. This will restrict the water drainage from behind the brick veneer. Correct and clear all weep holes as needed.

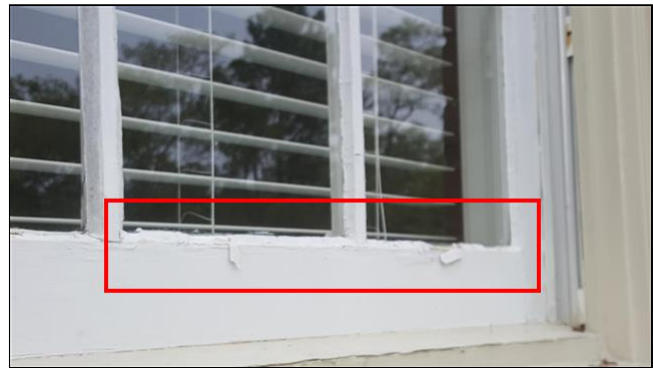
2.2 Item 2(Picture)

🏠 (1) Most of the single pane windows showed significant deterioration and glazing damage. Evaluate and correct all as needed.

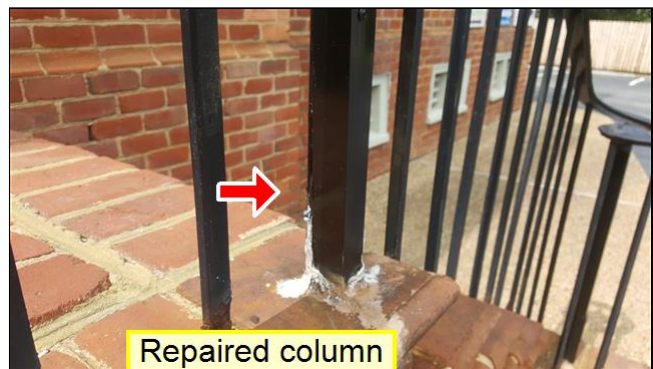
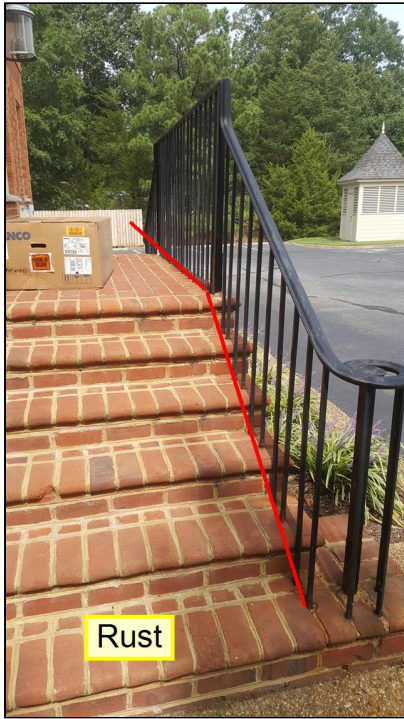
🏠 (1) Front entrance porch railings show significant rust at the bottom of the balusters. The railing columns have been previously repaired.

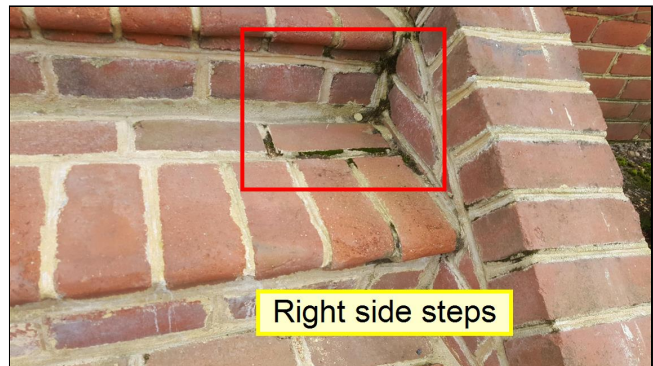
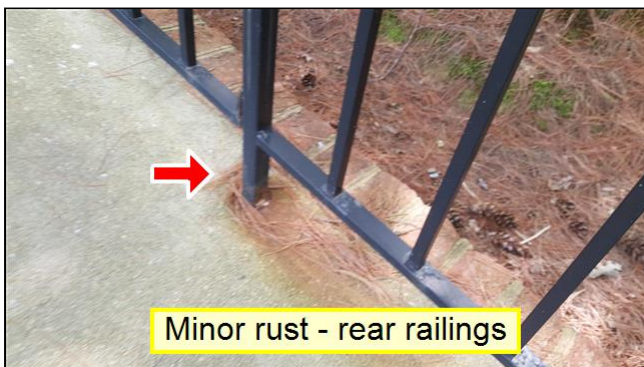
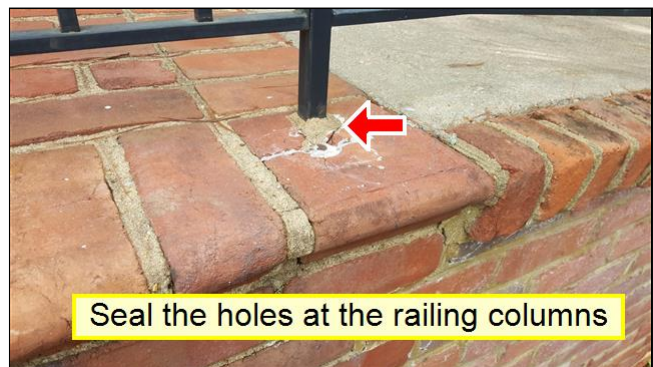
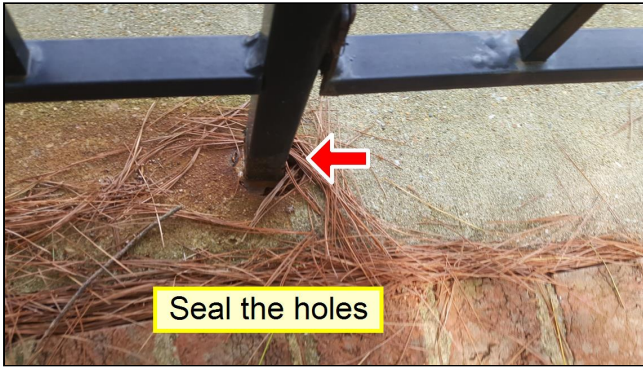
(2) All of the brick entrances and the rear ramp show minor to moderate damaged and/or missing mortar in areas. Correct all as needed to prevent future water penetration and settlement. Seal all of the holes that penetrate the rear stoop and ramp where the railing columns are installed.

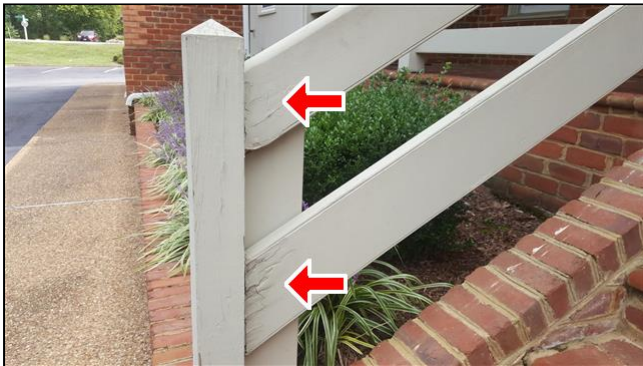
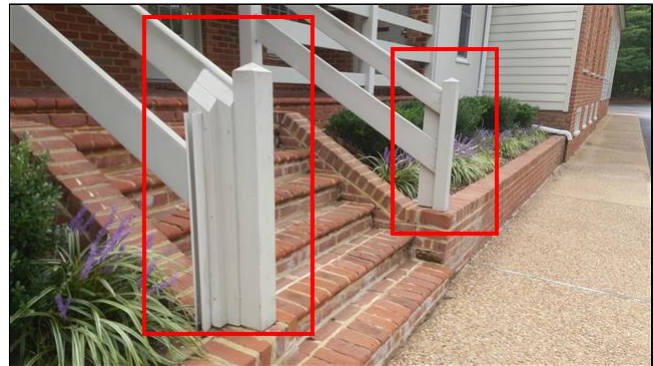
(3) Right side entrance stair railings show moisture deterioration at the columns and railings.

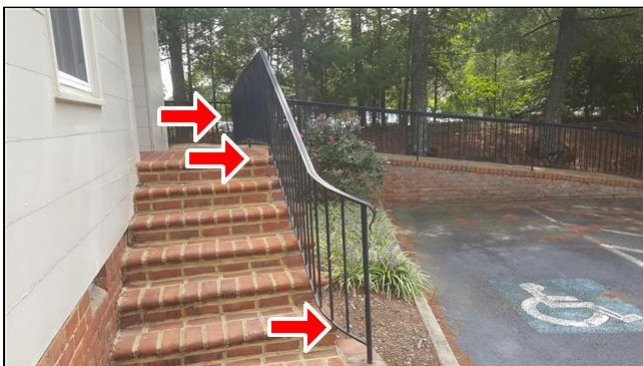
2.4 Item 12(Picture)

(5) Rear entrance railings are loose at the stairs and on the landing.

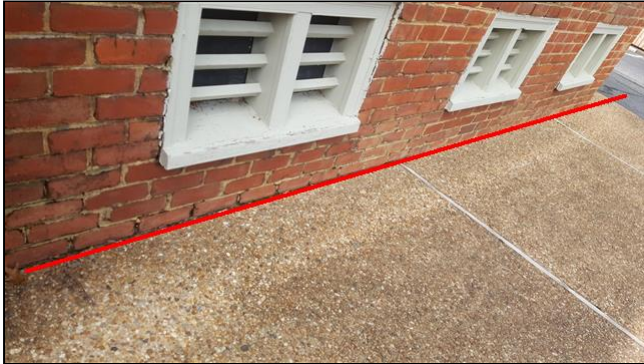
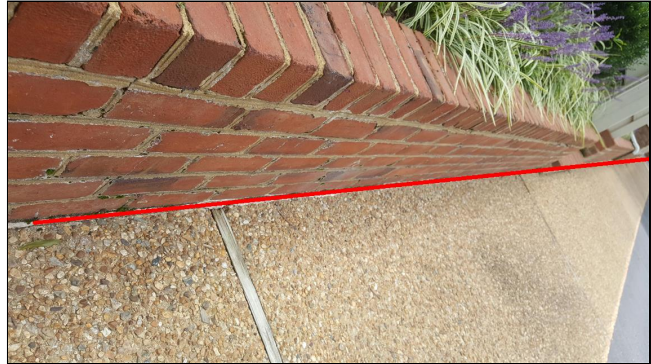
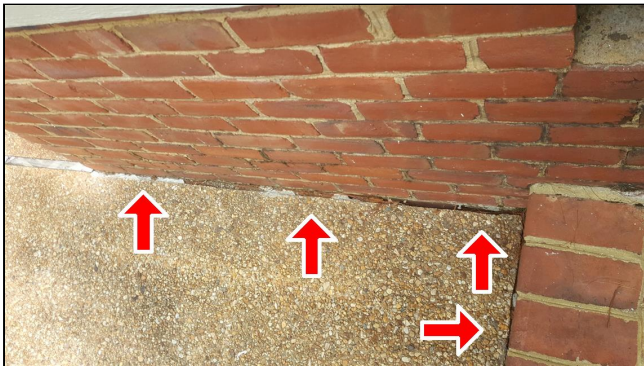
- (1) Sealed aggregate walkway around the building shows significant damaged and/or missing sealant where it meets the brick veneer and retaining walls. Seal all as needed to prevent moisture from eroding the compacted soil beneath these areas.

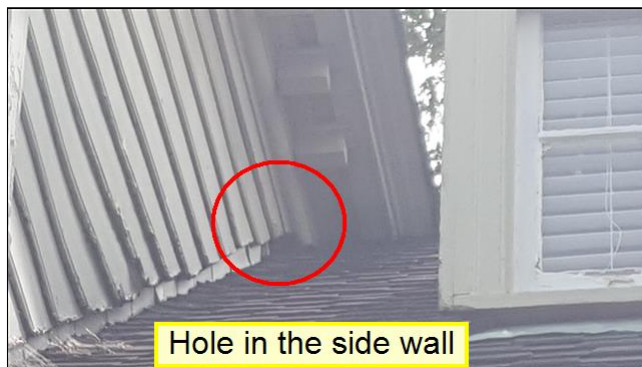
2.6 Item 2(Picture)

(1) Some holes and/or gaps were noted in the soffit area leading to the under side of the roof. Seal all areas to keep rodents, birds and insects from intruding in though these areas.

Hole in the side wall

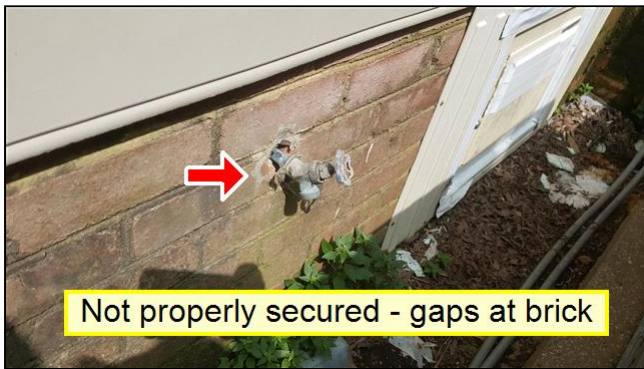
2.7 Item 1(Picture)

(2) Left side hose bib is not properly secured. Seal the gaps at the brick.

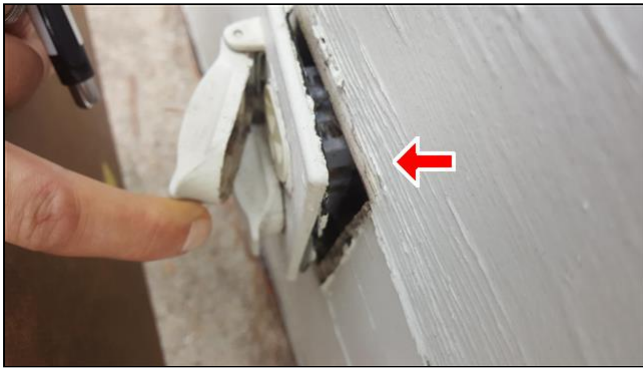
2.8 Item 3(Picture)

- ⚡ (3) Rear exterior receptacle junction box is not properly secured to the wall.

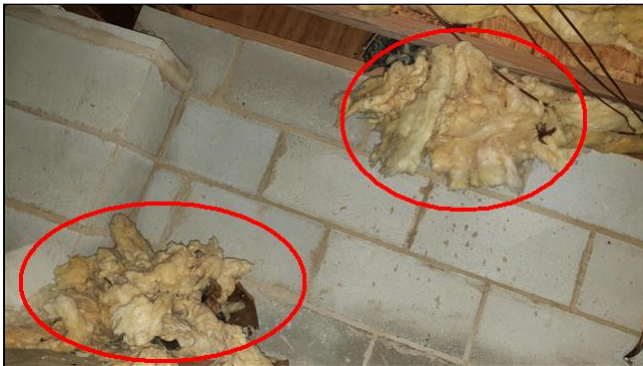
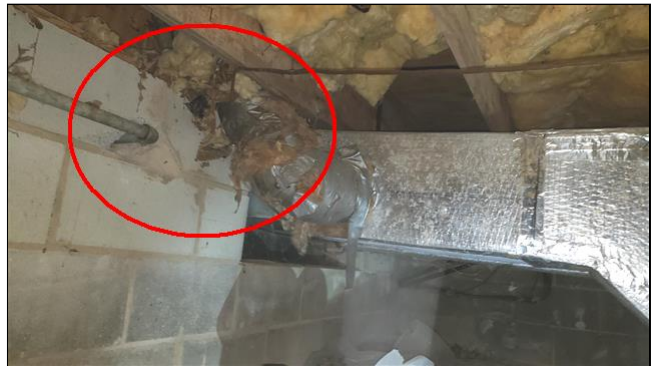
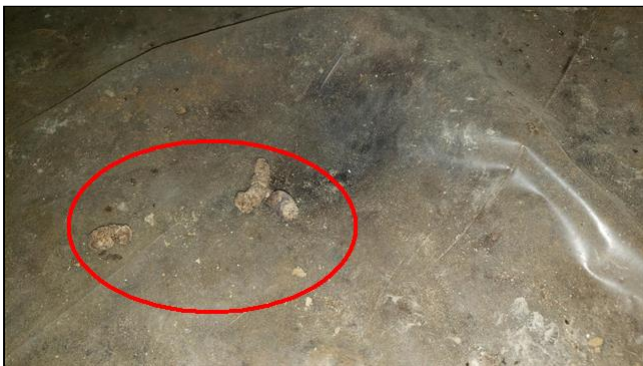
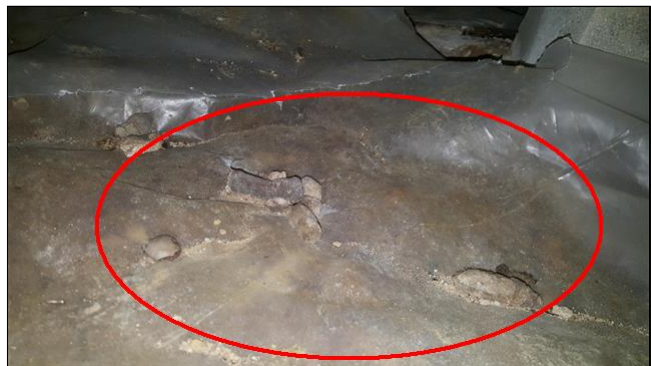
(1) There is evidence of animals in the crawlspace. Have all nests and associated debris from animals removed by a qualified person in this field and seal properly so they can not get back into the crawlspace.

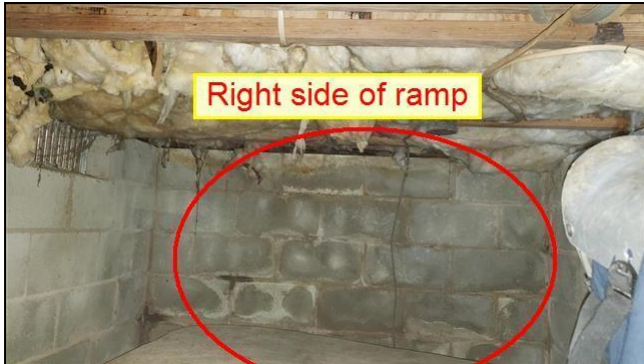
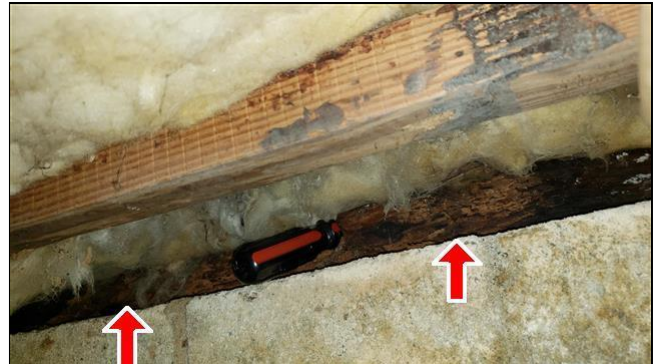
**🏠 (2) Suite B-(single story unit at the right end of the Bldg.):**

**Crawlspace-**There is significant amount of wood rot at the sill plate due to moisture intrusion noted on both sides of the ramp. It appear to be actively leaking due to the dampness of the wall and the wood. Have a qualified licensed contractor evaluate to determine the cause and correct as needed.

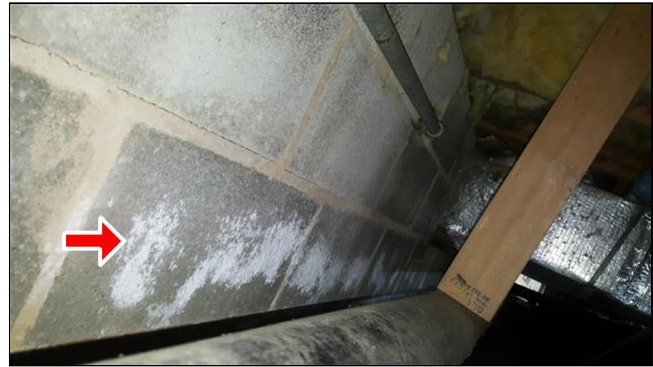
3.0 Item 11(Picture)

(4) White efflorescence (powder substance) on block wall indicates moisture is in contact with the masonry. This does not necessarily indicate that intrusion will occur. I recommend checking the gutters and the downspout drain lines for proper operation. Also, a water proofing paint could be applied to the interior side of the block if necessary. Efflorescence is found on many homes without water intrusion occurring inside the building. But, it should alert you to the possibility that future steps may be needed.

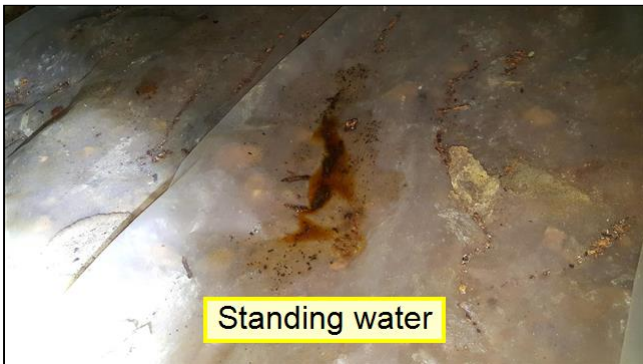
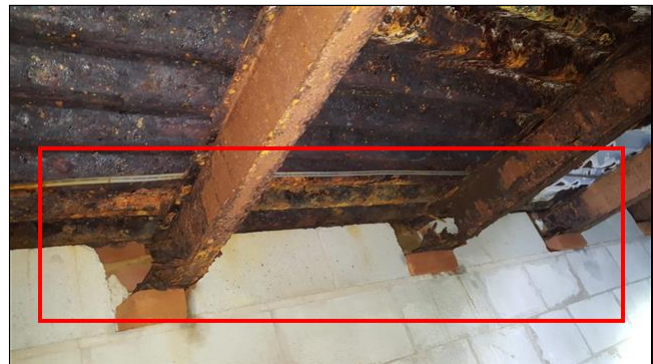
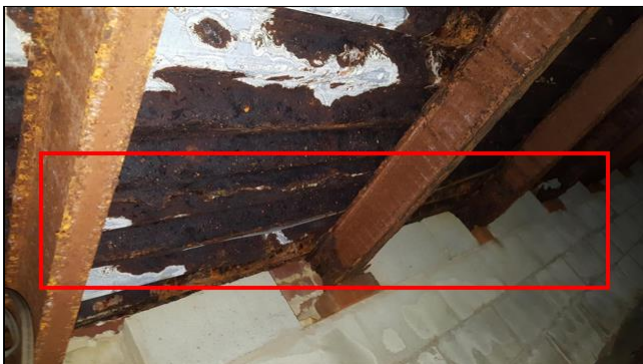
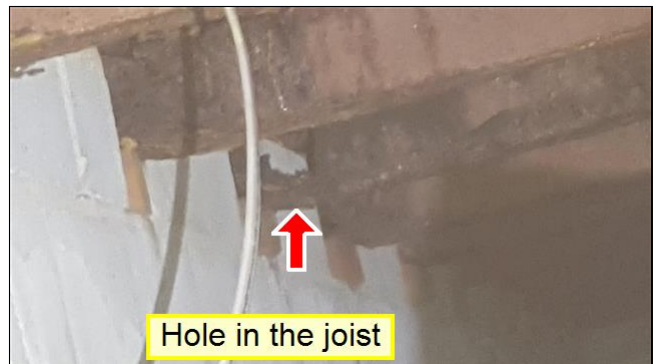
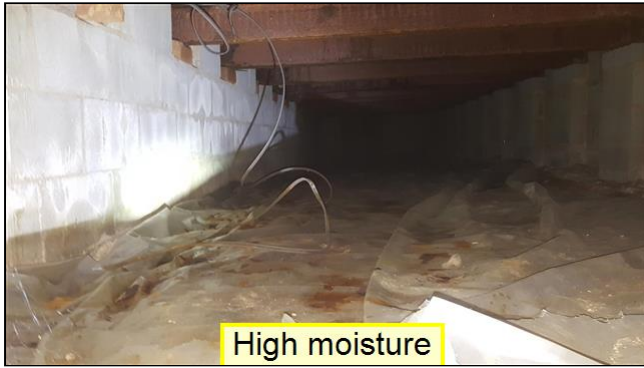
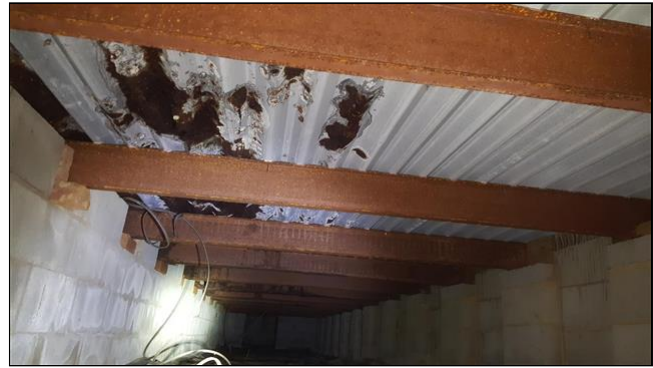
Right side entrance landing has significant steel floor joist damage and deterioration. There is a high moisture presence in this area. Standing water was noted on the ground. Evaluate and correct as needed.

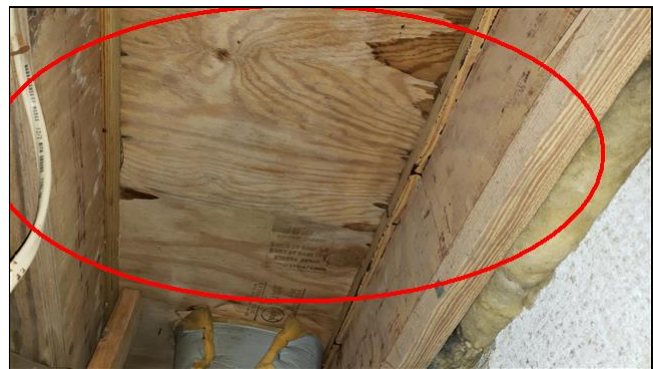
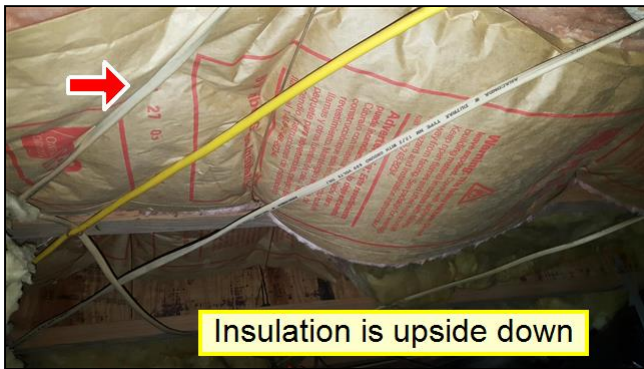
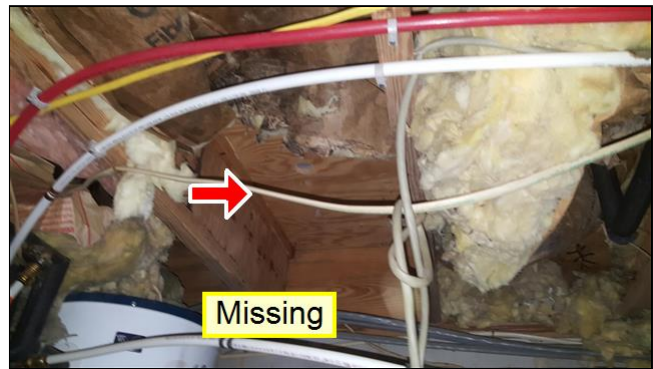
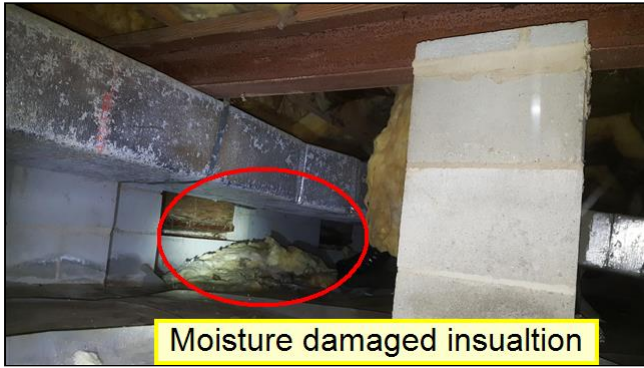
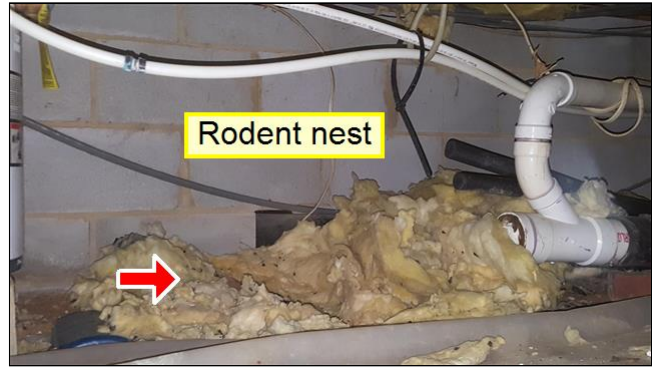
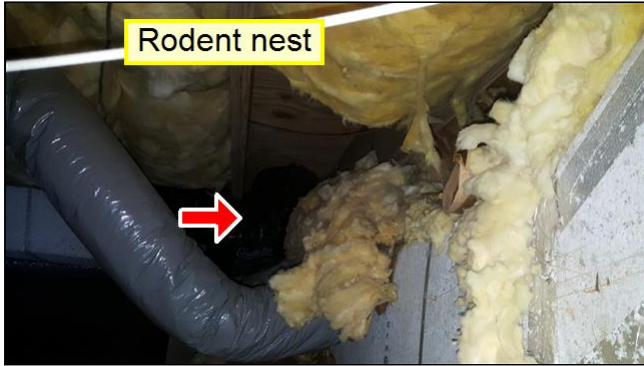
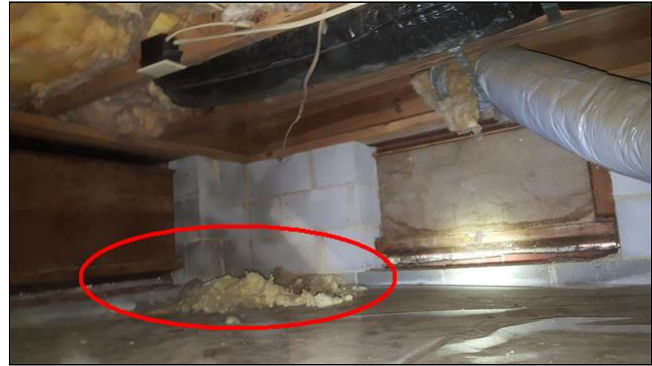
There were multiple sections of insulation that were missing or have fallen down throughout the crawlspace. Some of the insulation has been damaged and pulled down by rodents. Also, some areas towards the front have fallen due to previous and/or active high moisture content. Some areas in the front crawlspace had insulation installed upside down, with the vapor barrier to the ground. Correct all floor insulation as needed.

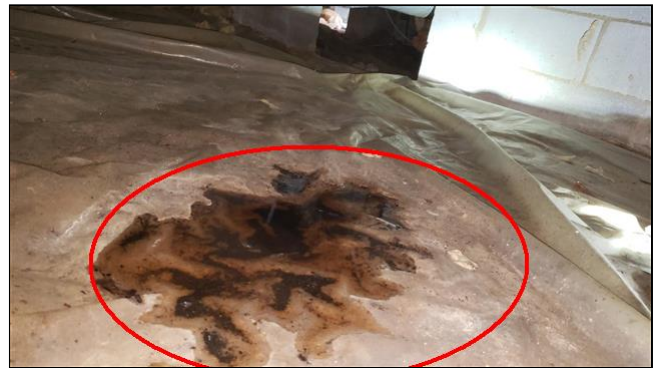
4.0 Item 2(Picture)

**Crawlspace-**There is a clean out plug on a waste line that is leaking.

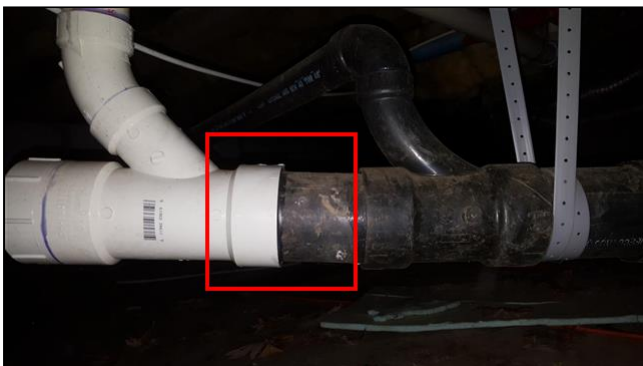
4.0 Item 3(Picture)

(2) There is an ABS to PVC connection, near the duct taped crawlspace entrance, that is not joined with the proper adhesive. The proper adhesive is a green color.

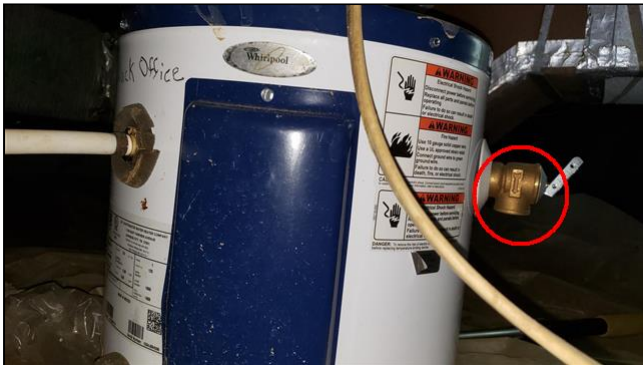
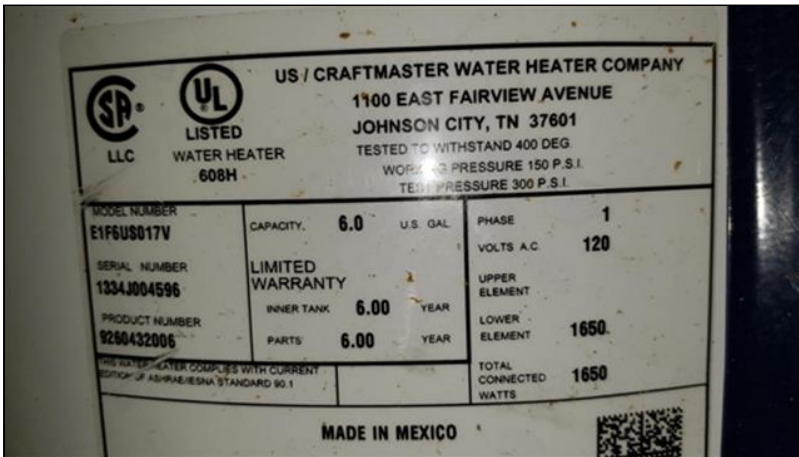
Crawlspace-2013 Craftmaster 6.0 gallon water heater

Missing pressure relief line. Have a qualified company install pressure relief line and terminate it at the exterior of the building (pointing downwards within 6 inches of the ground).

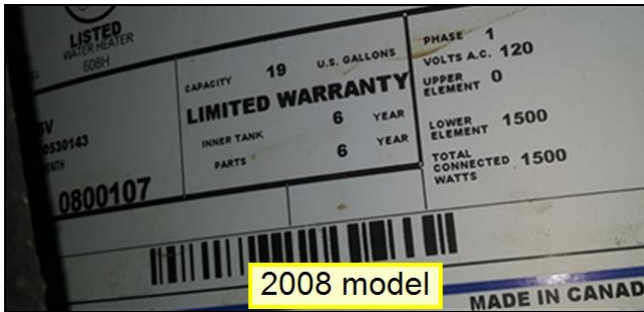
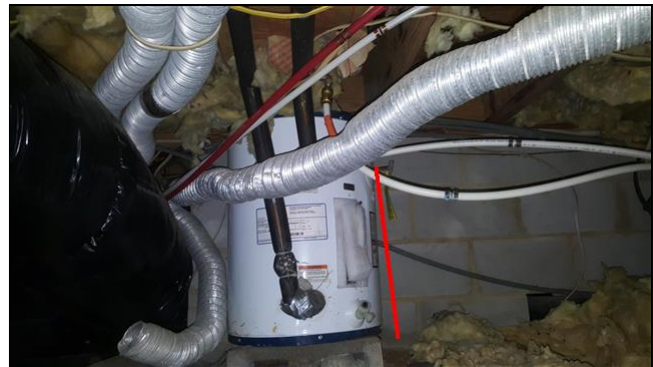
(2) There is a 2008 model, 19 gallon, electric water heater under the front offices.

The water heater is Missing a pressure relief line. Have a qualified company install pressure relief line and terminate it at the exterior of the building (pointing downwards within 6 inches of the ground)

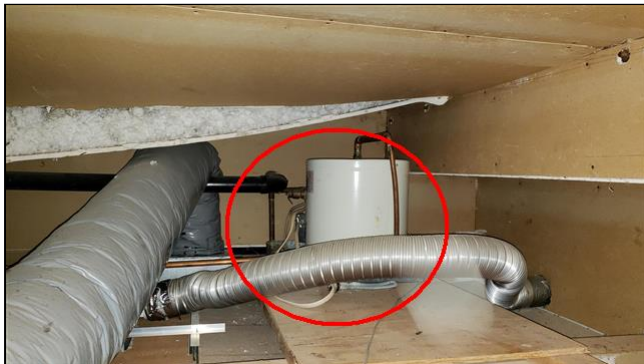
4.2 Item 5(Picture)

(3) Suite B-(single story unit at the right end of the Bldg.):

Water heater is located above the suspended ceiling over bathroom.

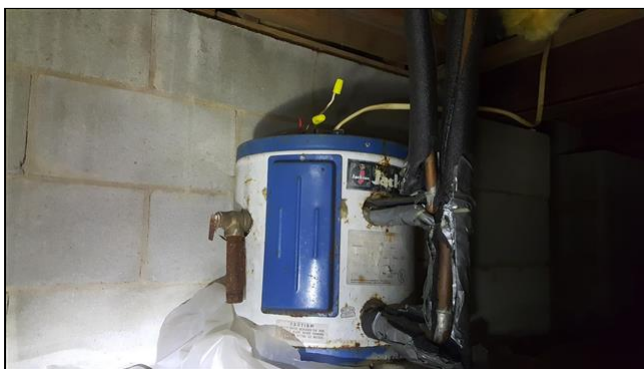
4.2 Item 6(Picture)

(4) Note: There is an old water heater plumbing into the system, that is no longer in use under the 2nd to last rear crawlspace entrance.

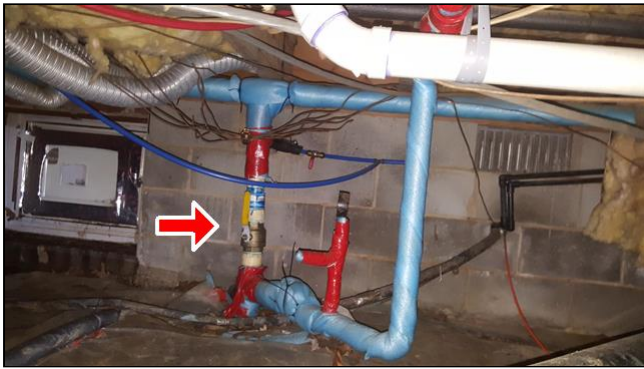
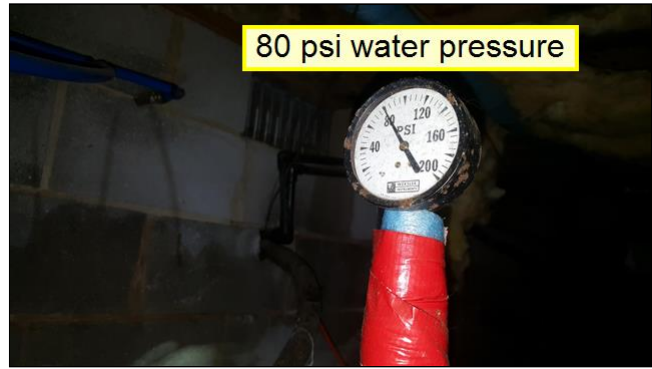
Main water shut off is located near the duct taped crawlspace entrance. Left middle side.
