## Inspection Report

### Company Name Sample Report

**Property Address:**  
1234 Main Street  
Central VA 12345

**Burgess Inspections, Inc**

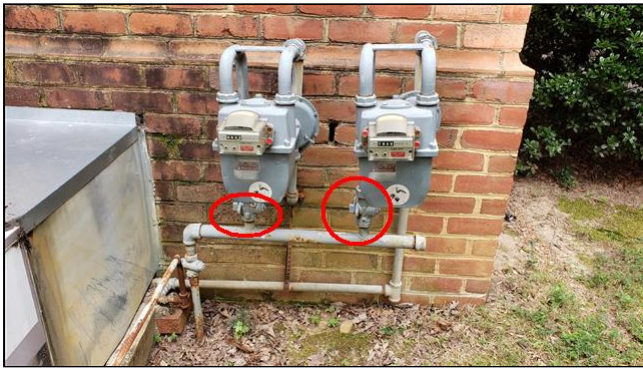
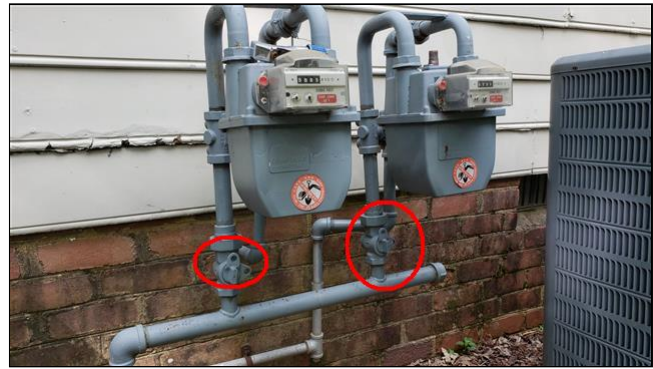
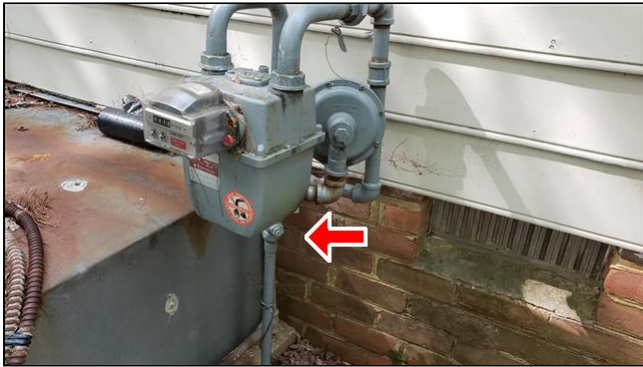
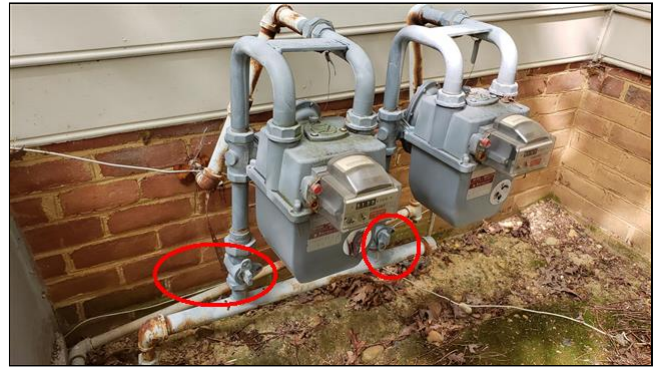
All gas shut offs are located at the rear of the building.

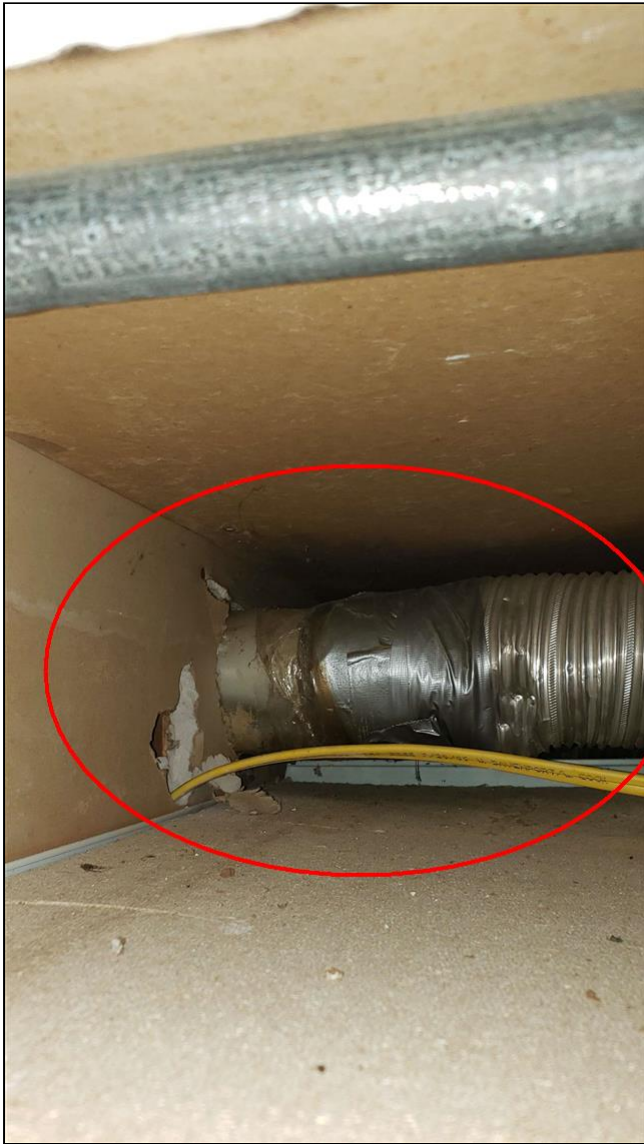
5.0 Item 2(Picture)

Ceiling tile moisture stain noted in rear right office. It appears it may be caused by bathroom exhaust duct located directly above the stain.

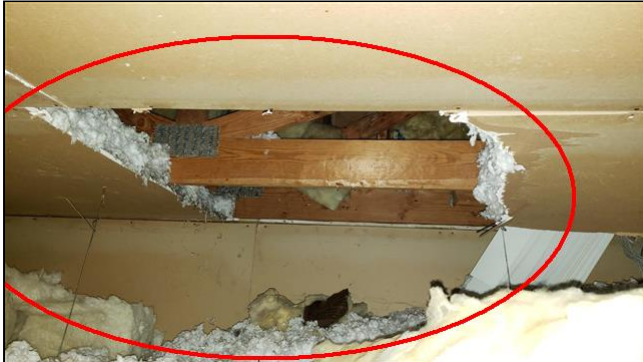
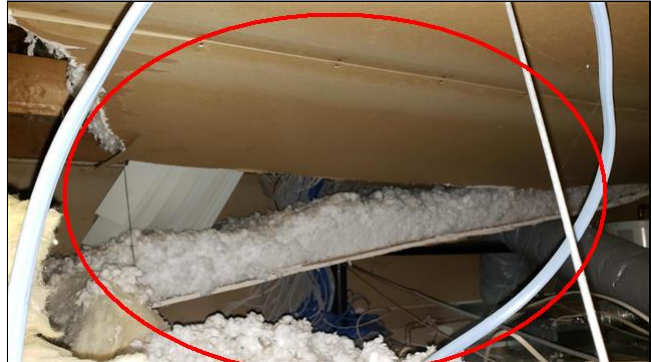
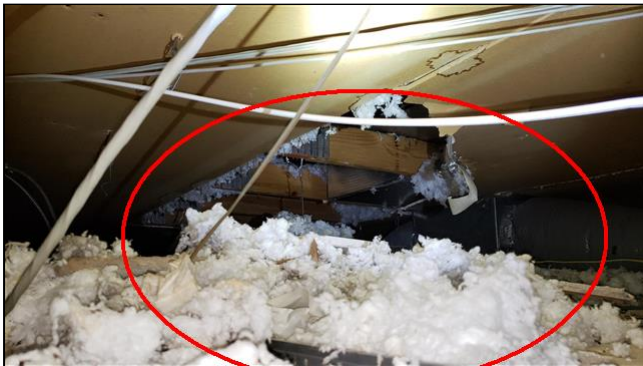
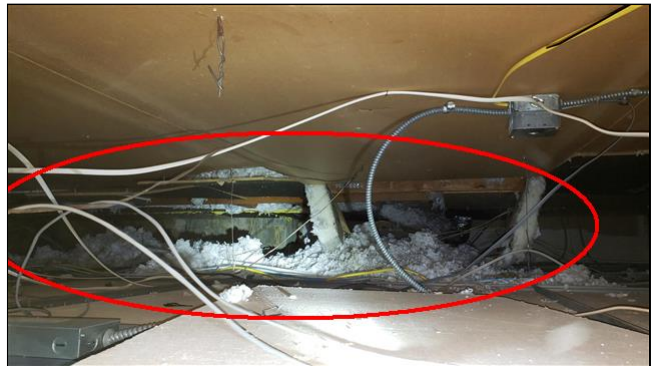
River City Elite Suite:

Drywall has come down in sections above the suspended ceiling allowing the Insulation to also drop. Correct drywall and insulation as needed.

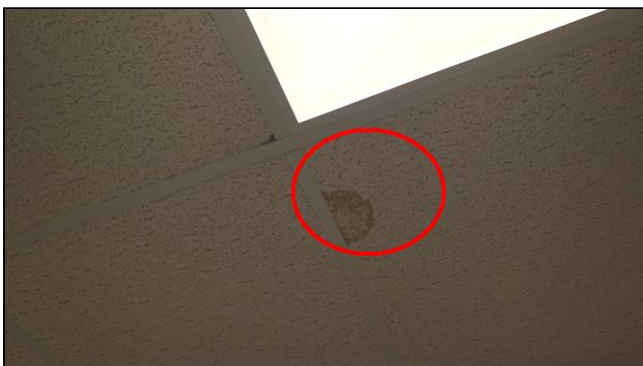
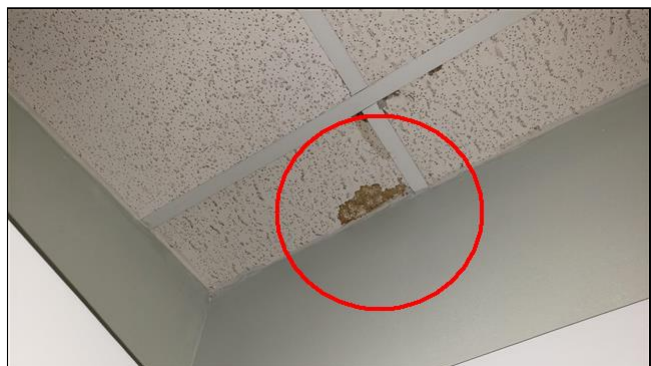
Moisture stains were noted in the right front office and the center rear office. Possibly due to HVAC located in attic. It appears that there were repairs done previously.

Refer to section 8.0 (2) regarding condensate line.

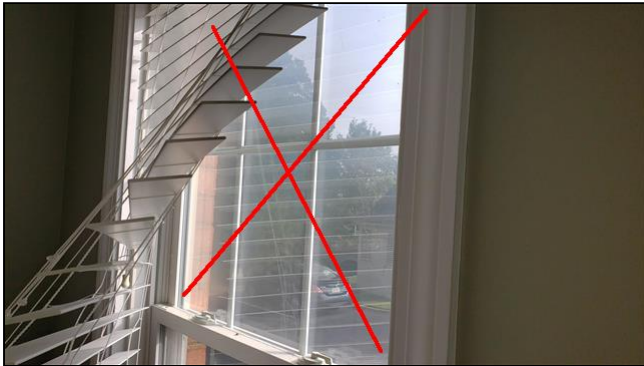
5.4 Item 1(Picture)

(1) Taylor Made Suite:

Upper sash of one of the windows in the left corner office has failed.

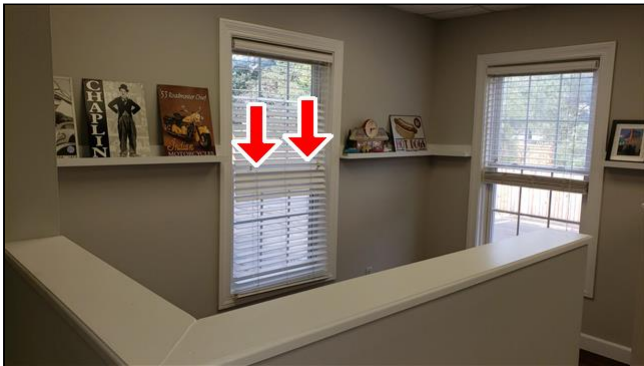
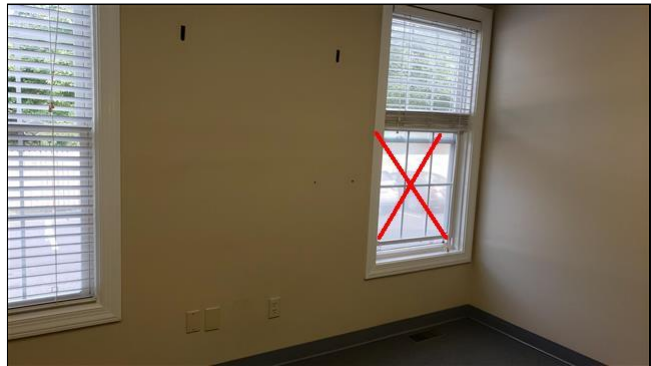
A- Could not latch two windows closed in the front rooms.

B- Front left office -thermal seal has failed in the lower sash of the right window.

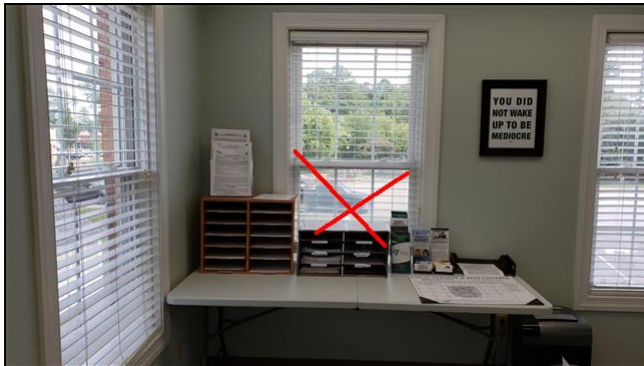
5.4 Item 4(Picture)

(4) River City Elite Suite:

Front left corner of office (Copy room) has a damaged thermal seal noted in the lower sash.

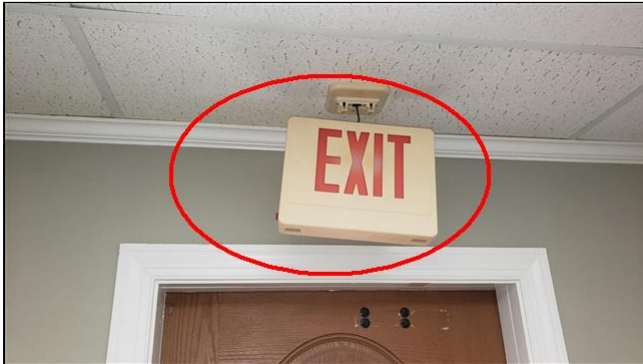
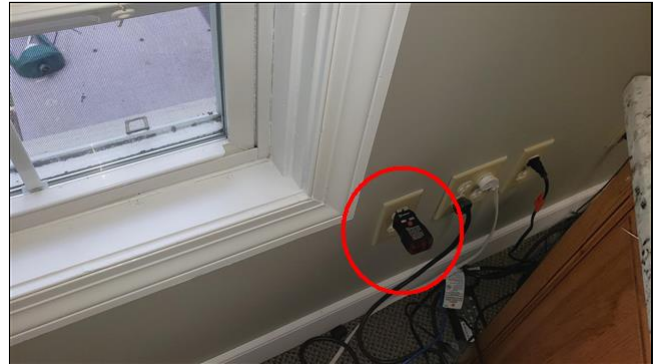
A. Emergency exit sign is hanging by the wires.

B. Front right office outlet on right wall does not work and it's loose at the wall.

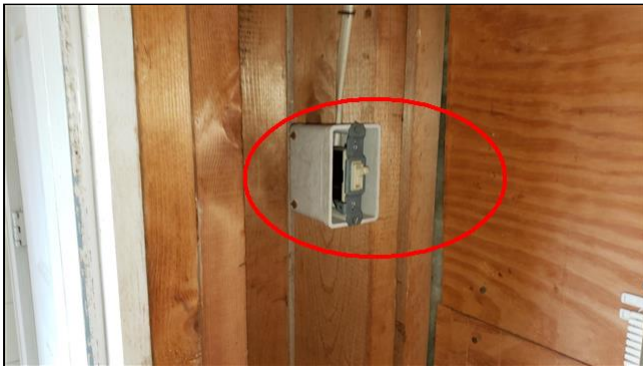
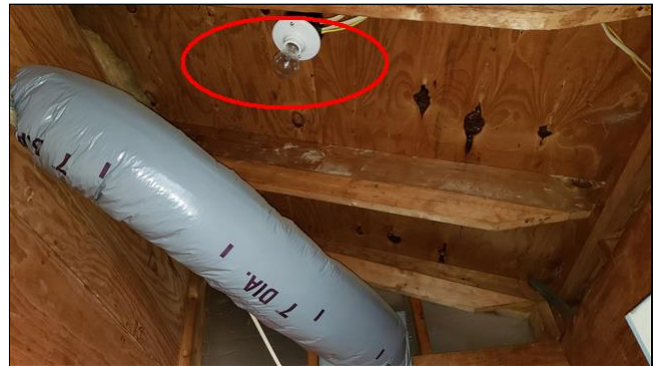
**⚡ (3) Suite B-(single story unit at the rear end of the Bldg.)**

Exterior storage room by entry- light did not come on and the wall switch is missing a cover plate.

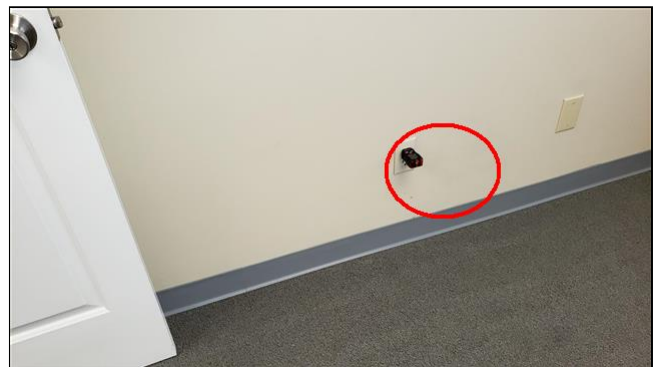
5.6 Item 7(Picture)

**⚡ (4) Suite B-(single story unit at the right end of the Bldg.):**

A. Open junction box and unsecured wires noted above suspended ceiling.

B. Loose Outlet noted in front left office.

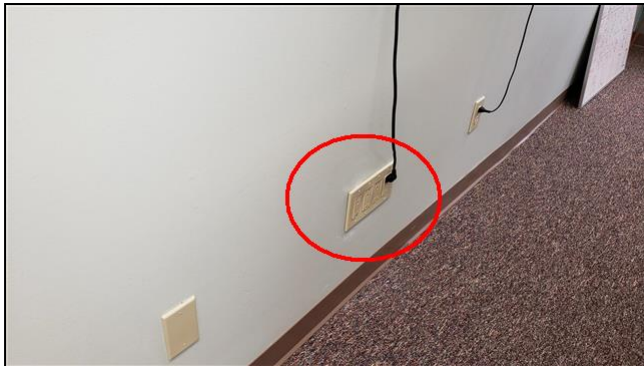
5.6 Item 8(Picture)

(5) River City Elite Suite:

Loose Outlet noted in large meeting room.

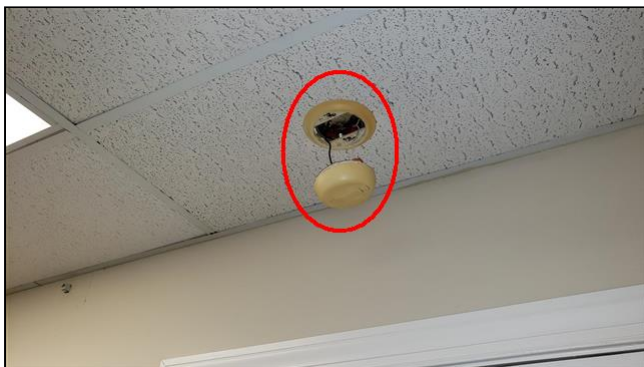
5.8 Item 1(Picture)

**Southside Insurance Suite:**

Smoke detector at entry is not functioning.

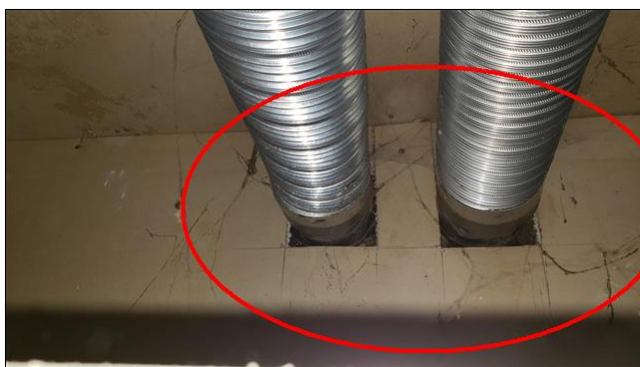
6.0 Item 2(Picture)

Moisture stain noted at the ceiling. Most likely due to bathroom exhaust ducts located directly above the ceiling stain.

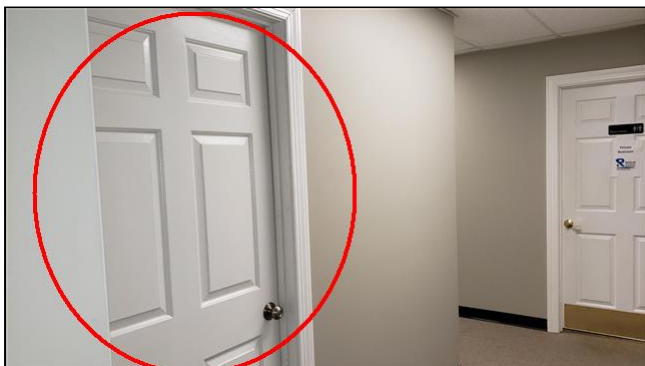
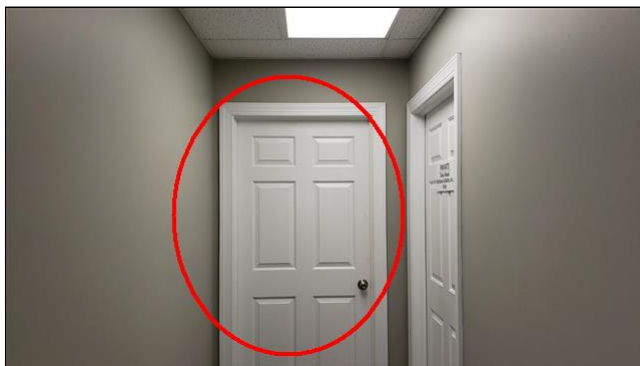
Taylor Made hallway-

I could not obtain access to the first floor left end of the building- storage room and phone room.

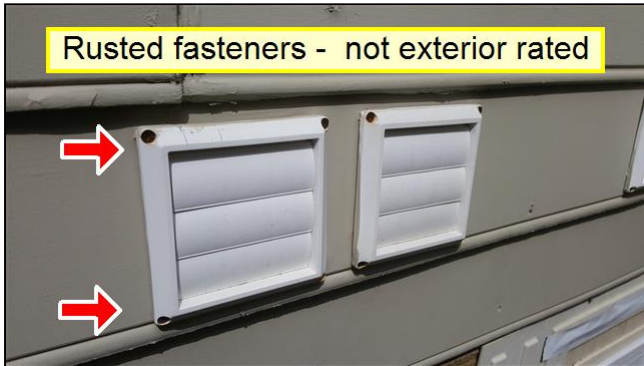
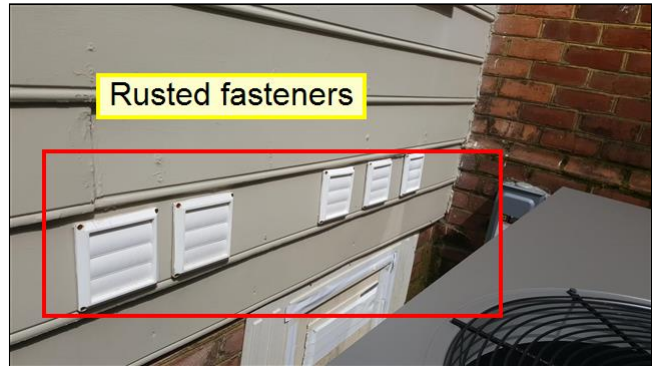
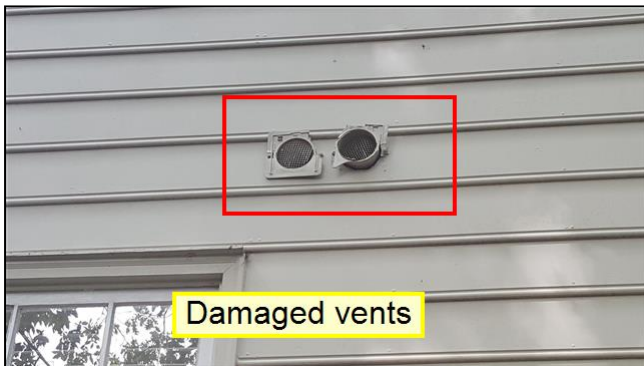
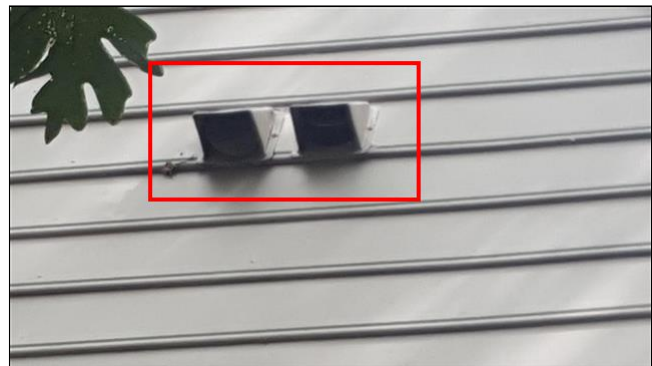
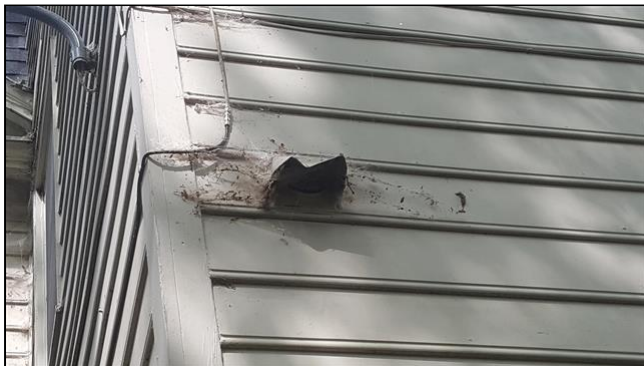
(1) All of the exhaust vents on the left side of the building are damaged and need repair or replacement. The 6 vents towards the rear of the building have damaged dampers or gaps that will allow insect intrusions. Replace all vents with damaged dampers and correct the gaps. Also, the 5 vents towards the front are installed with fasteners that are not rated for exterior use. Install exterior rated fasteners on all as needed.

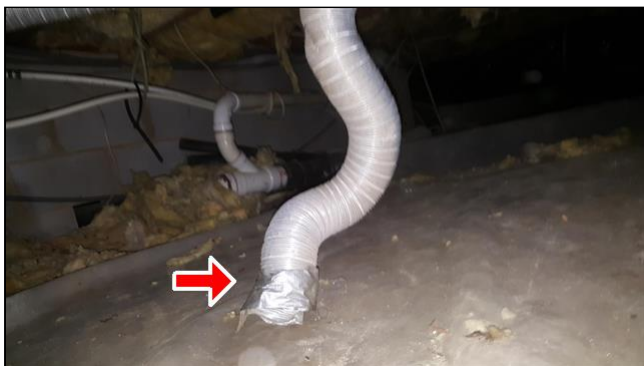
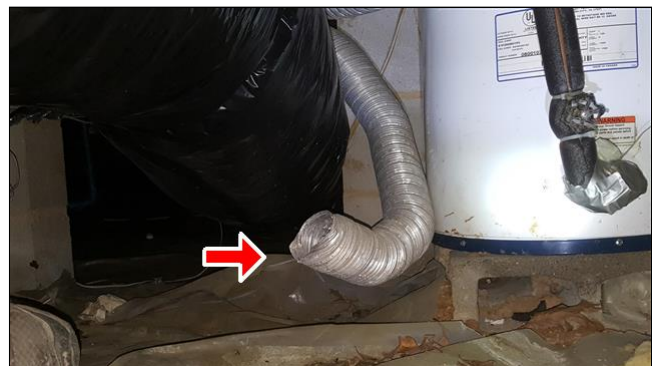
6.8 Item 7(Picture)

(2) There is an exhaust duct that has separated and is hanging in the front crawlspace.

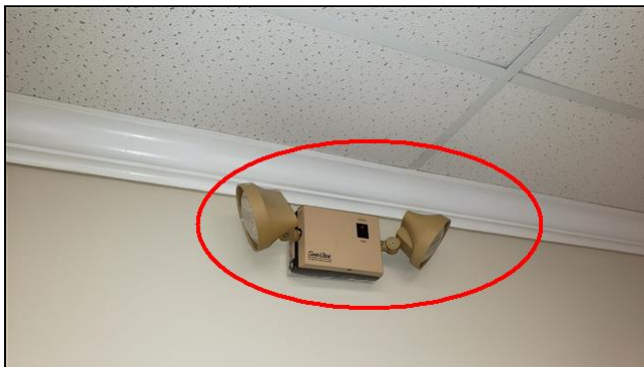
7.3 Item 1(Picture)

(1) None of the emergency lights operated when pressing the test buttons. The lights were located in the stairwells and also in RichLaw suite.

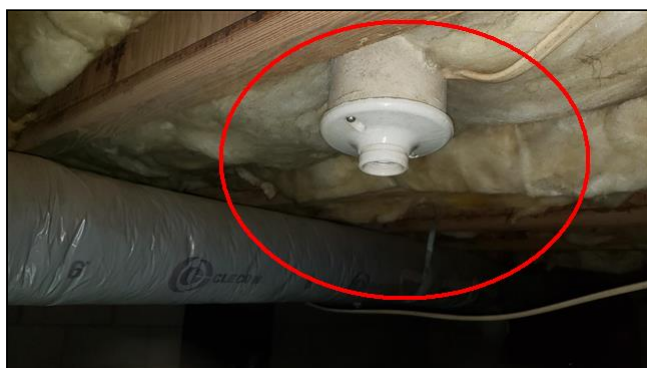
7.3 Item 2(Picture)

🏠 (2) Many of the lights in the crawlspace were not operating at the time of the inspection.

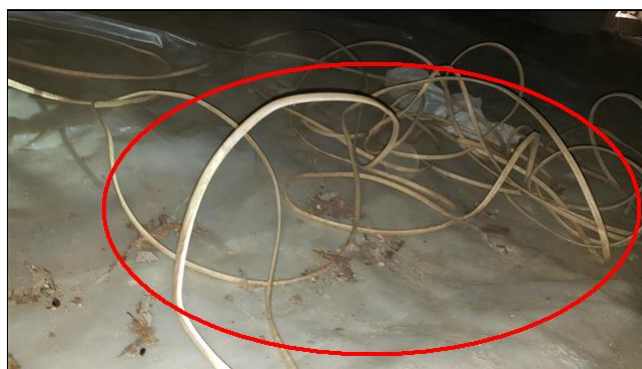
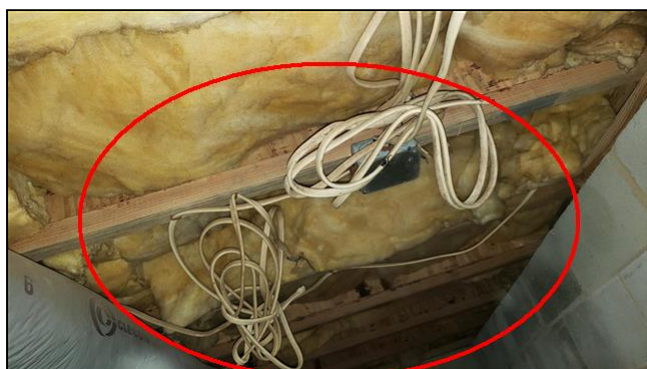
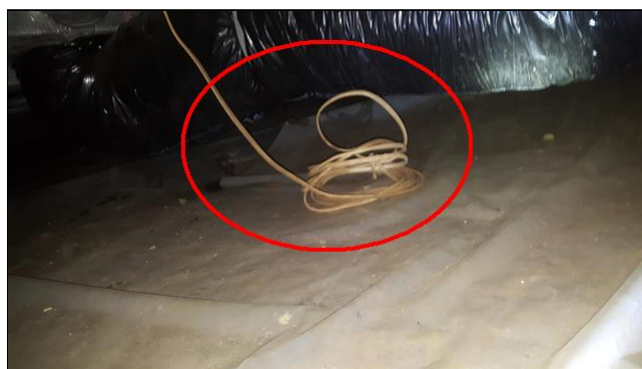
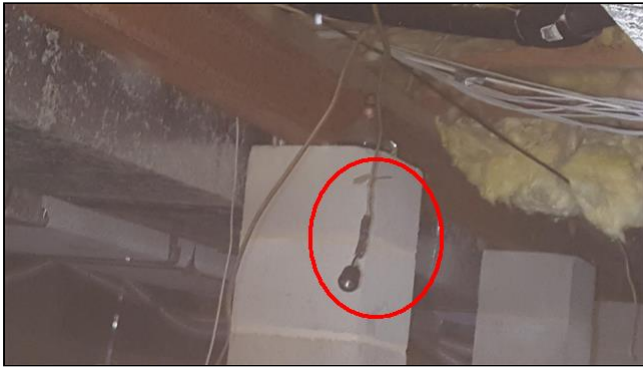
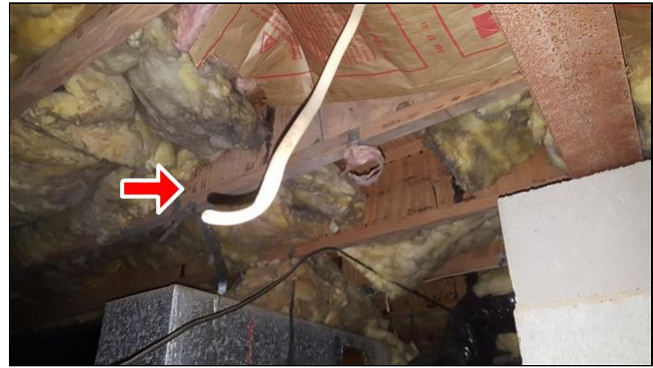
There was excess electrical wire noted throughout the crawlspace at multiple locations that was not properly terminated. Have a licensed electrical contractor remove all unused wire and properly terminate all wiring that is in use.

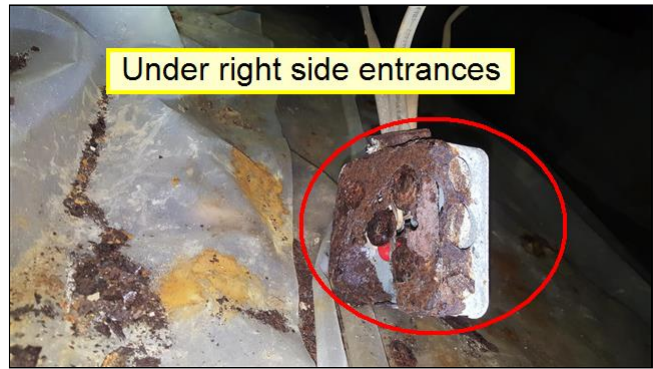
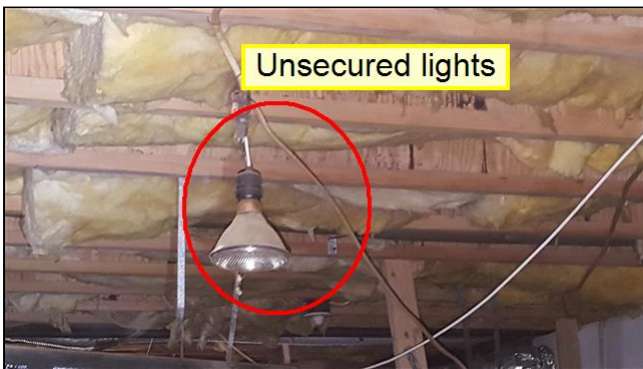
⚡ (4) Damaged and/or exposed junction boxes and unsecured lights were noted in the middle and front crawlspaces. Correct all as needed.

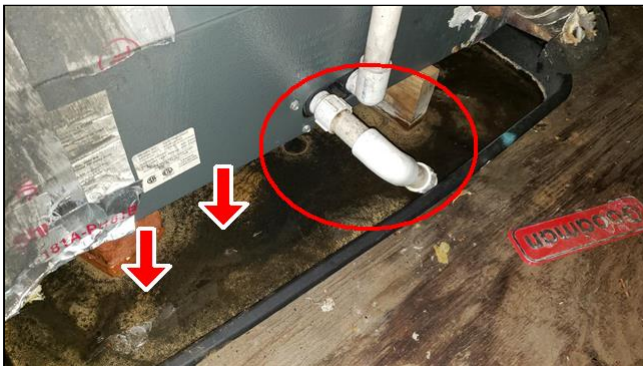
8.0 Item 1(Picture)

(2) River City Elite Suite:

Primary condensate is not ran properly. Currently it is running into the secondary pan which is then piped to the exterior. Condensate line should be ran directly to the exterior (not by way of pan). Then the pan has a secondary condensate line or shutoff switch. Currently the pan has a significant amount of water in it.

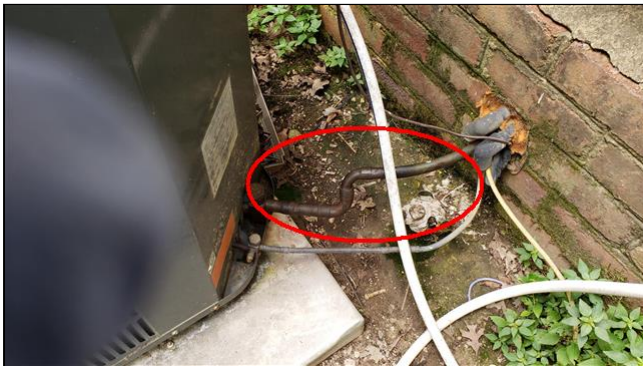
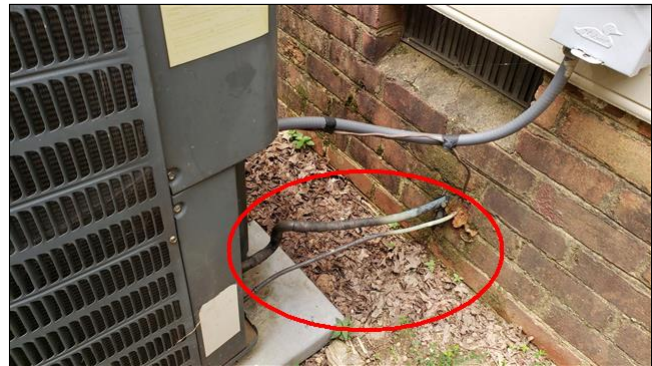
(3) All condenser units have missing or damaged insulation at the line sets located directly behind the condenser units.

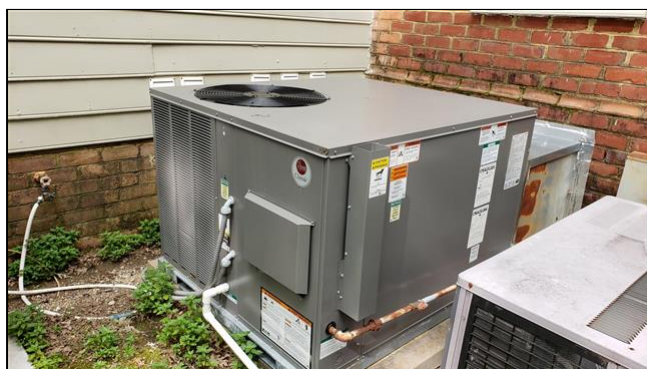
8.0 Item 21(Picture)

(13) Taylor Made Suite:

Left side of office-2019 Rheem package unit information.

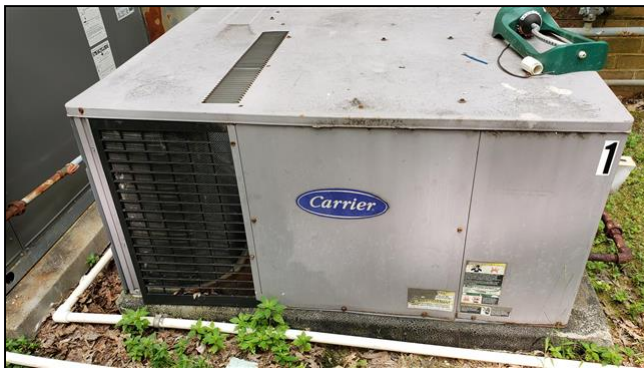
8.0 Item 23(Picture)

(14) Taylor Made Suite:

Right side of office-1998 Carrier package unit information.

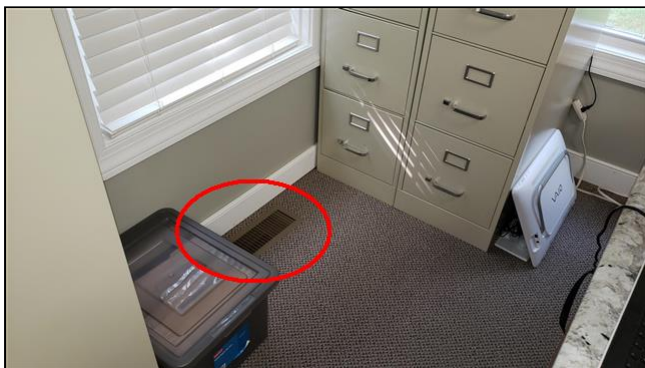
8.5 Item 1(Picture)

(1) Taylor Made Suite:

No air is coming out of one of the vents in the rear right office and one in the kitchen.

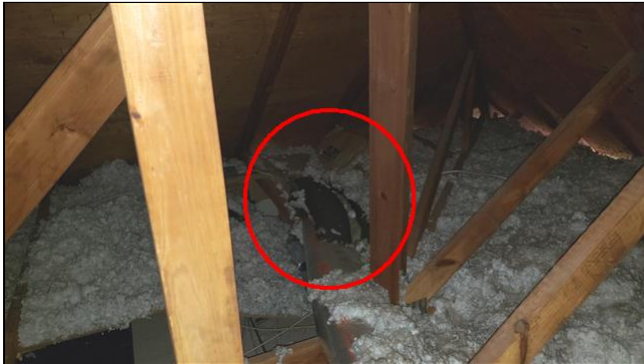
8.5 Item 3(Picture)

(2) River City Elite Suite:

Attic-Damaged HVAC insulated duct noted in the right rear corner.

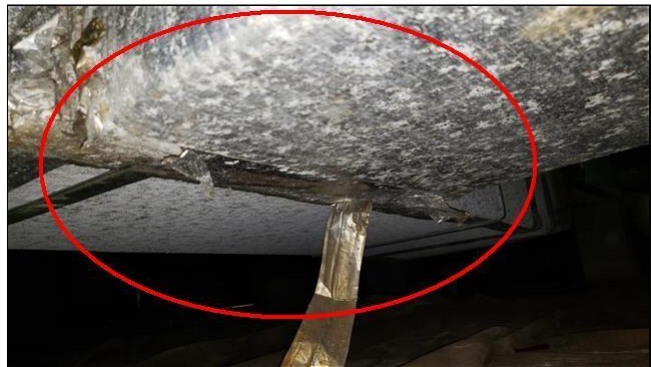
8.5 Item 5(Picture)

Return air duct in crawlspace has a large opening in the bottom of the duct. Also, some of the seams are coming loose at other sections of the duct. Have a qualified company correct as needed.

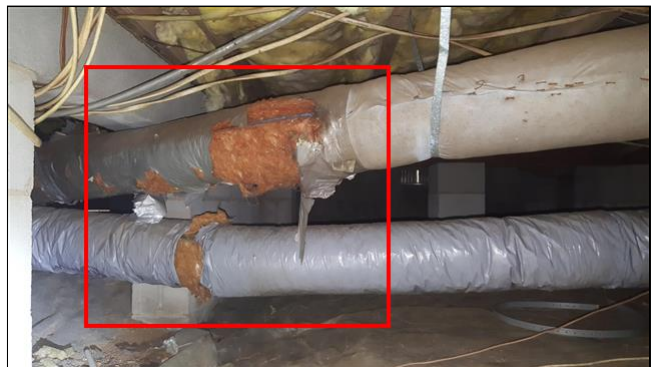
8.5 Item 7(Picture)

(4) The insulation is damaged/ coming loose on HVAC ducts noted in multiple locations through out crawlspace

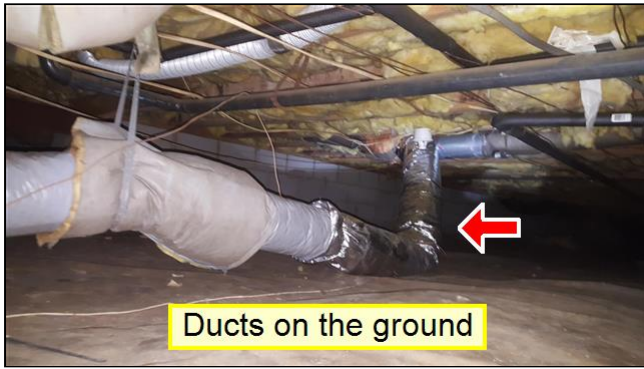
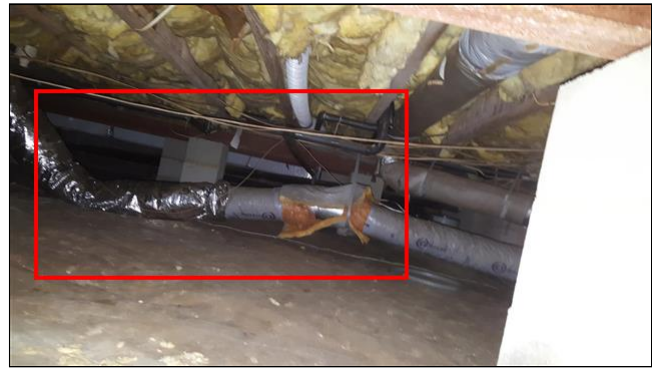
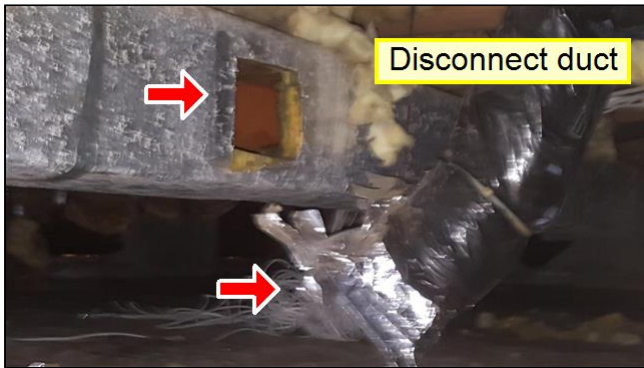
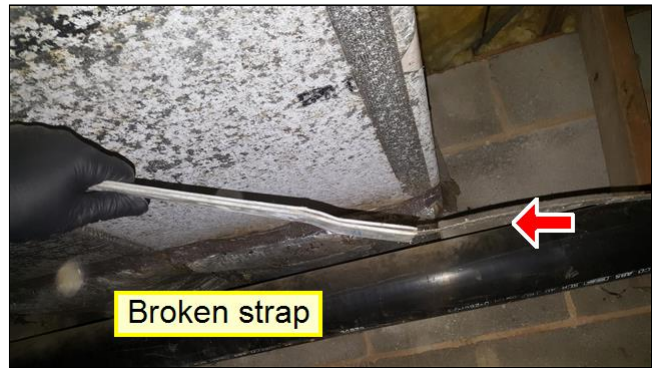
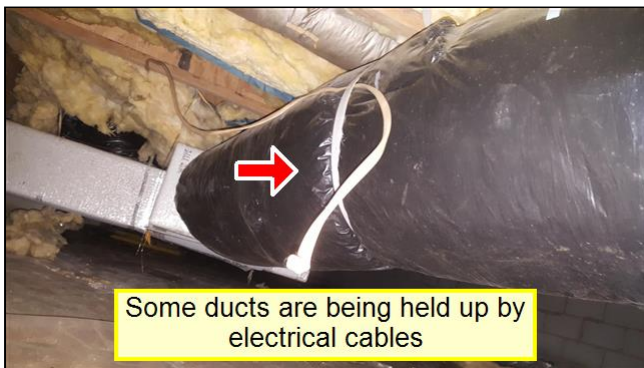
(5) Some of the supply ducts are not properly secured and have fallen to the ground. One duct in the front crawlspace is not connected at all.
