Confidential Inspection Report

Property Address:
123 Main St
Richmond, VA 23236

Inspector Name
State License: 3380001234 NRS Exp 1-31-2024
Burgess Inspections
530C Southlake Blvd
N. Chesterfield, VA 23236
(804) 794-1423

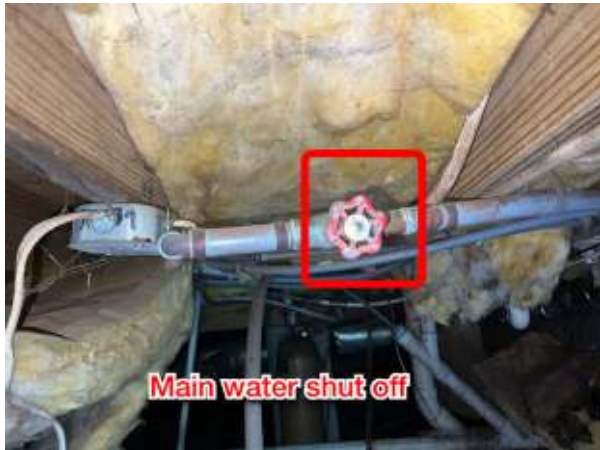
69: The main water shut off is located in the crawl space.

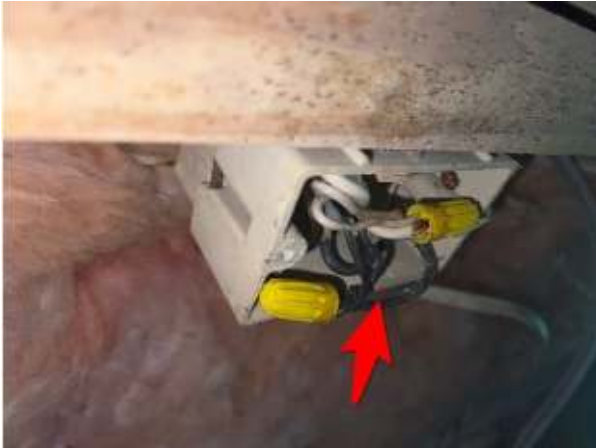
76: Open junction boxes in the crawl space that need covers installed.- \$100

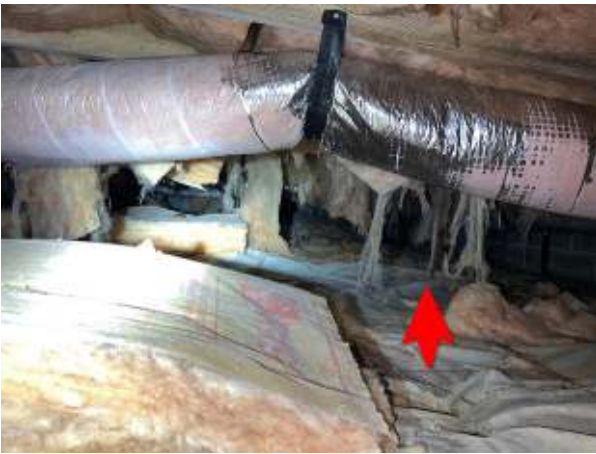
104: In the crawl space, there was a higher than normal level of fungi on the joists and ground. The insulation was feathered/hanging which is a sign of moisture. The vapor barrier was missing in many areas especially around the foundation walls. The ground was damp in these areas.- \$1000-2000
