## Confidential Inspection Report

Property Address:  
123 Main St  
Richmond, VA 23236

Tuesday, August 30, 2022  
John Maxwell  
123 Main St  
Richmond, VA 23236

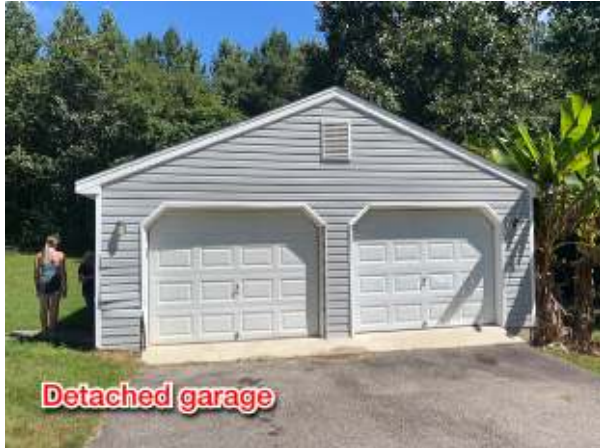
30: The front left corner of the garage has been damaged. The garage door frame has been compromised along with the front left wall.

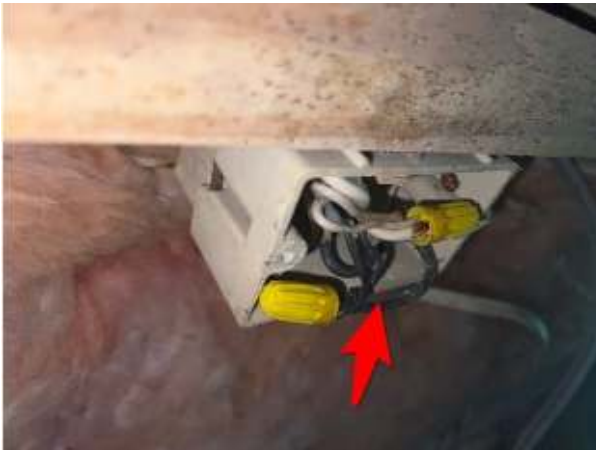
76: Open junction boxes in the crawl space that need covers installed.

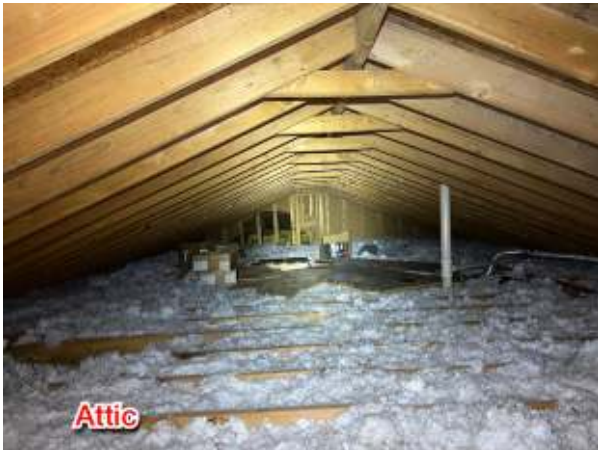
**97:** Minor rot to a rafter in the attic underneath the area where the roof is improperly installed over the addition.

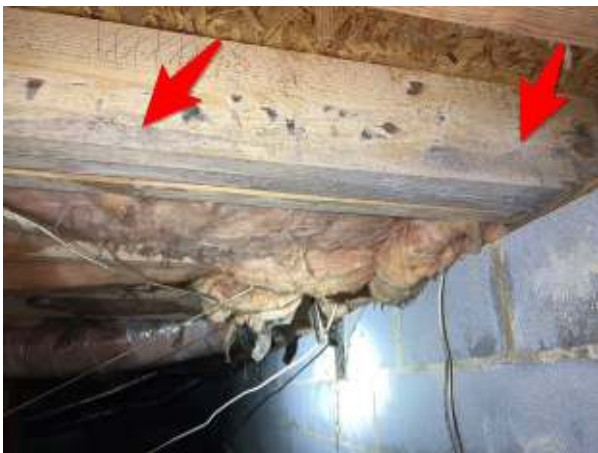
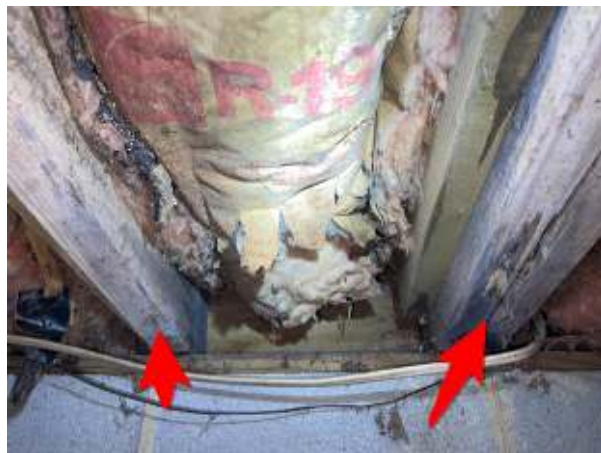
**104:** In the crawl space, there was a higher than normal level of fungi on the joists and ground. The insulation was feathered/hanging which is a sign of moisture. The vapor barrier was missing in many areas especially around the foundation walls. The ground was damp in these areas.
