Five Point Inspection Report

LOCATED AT:
1 Lonely Number St
Richmond, VA 23225

INSPECTED ON:
Tuesday, July 8, 2025

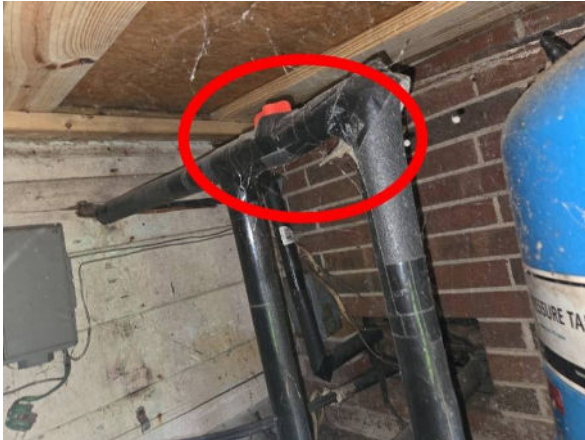
DESCRIPTION OF MAIN WATER SHUT-OFF DEVICE

28: The main water shut off was located outside near the well equipment.

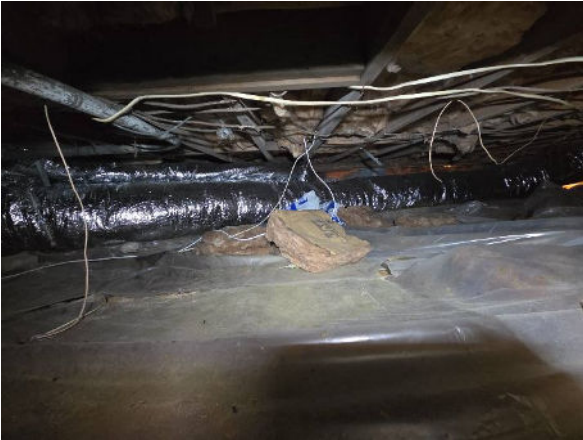
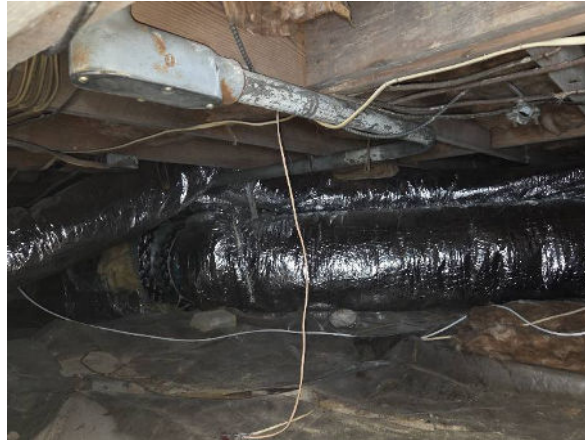
48: There was a duct that was in contact with the ground surface of the crawl space.
\$150 to \$250

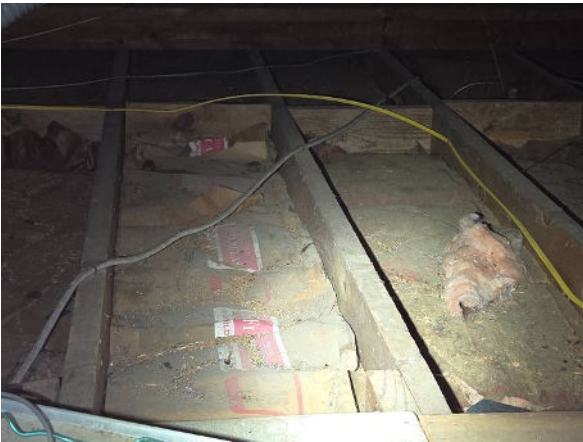
52: Insulation has settled over time. Adding insulation in the attic will help with energy efficiency of the home

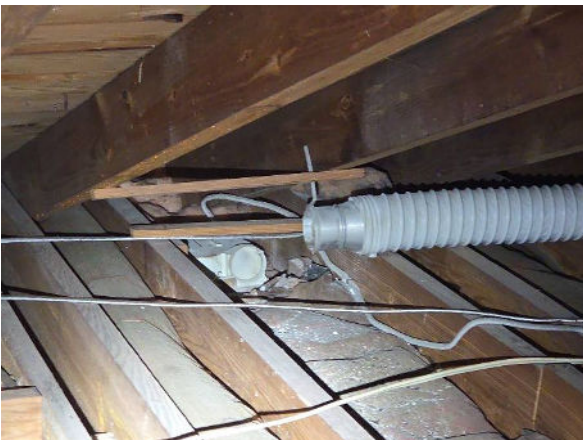
54: The bathroom exhaust vent was not connected in the attic.
\$75 to \$125

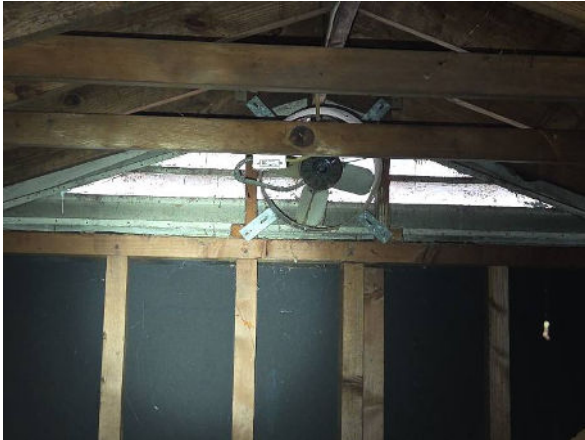
55: Attic fan did not operate at the time of the inspection.

\$150 to \$250
